Former Highgate Chapel

Existing Retaining Wall Elevation  
Condition Survey - Bay 12

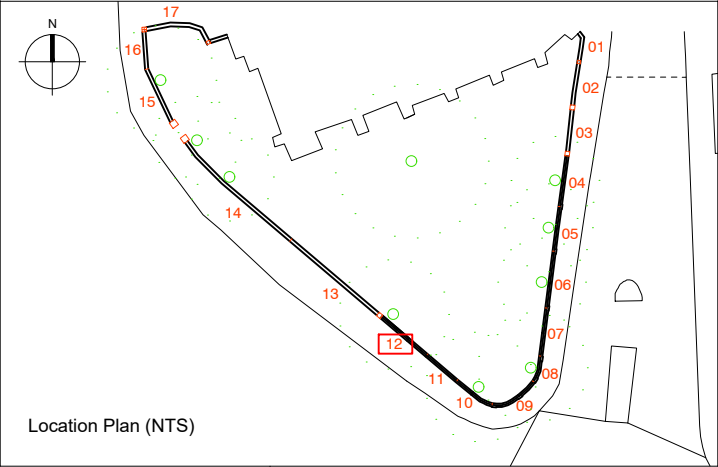
Masonry Wall Repairs

No. brick repairs: 0

m<sup>2</sup> of repointing: 7.5

The above are approximate quantities based on a limited visual survey. For information purposes only.
