# GEOSHIELD Verification Report

SURVEY AREA: Block D1 - Core - Middle and Upper

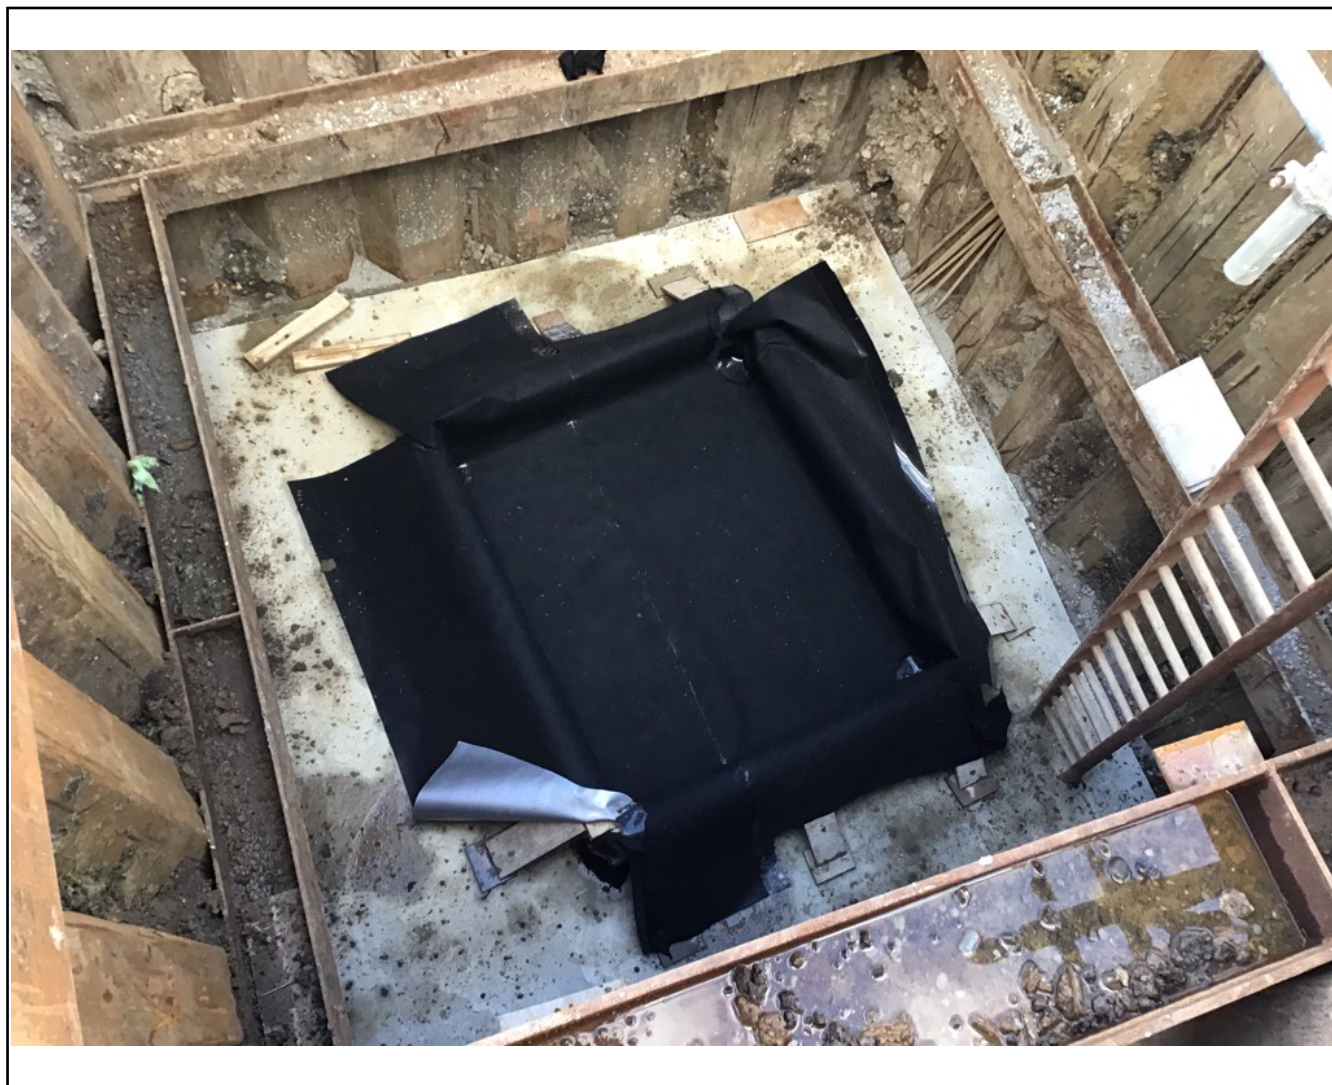
Pump Chamber Base

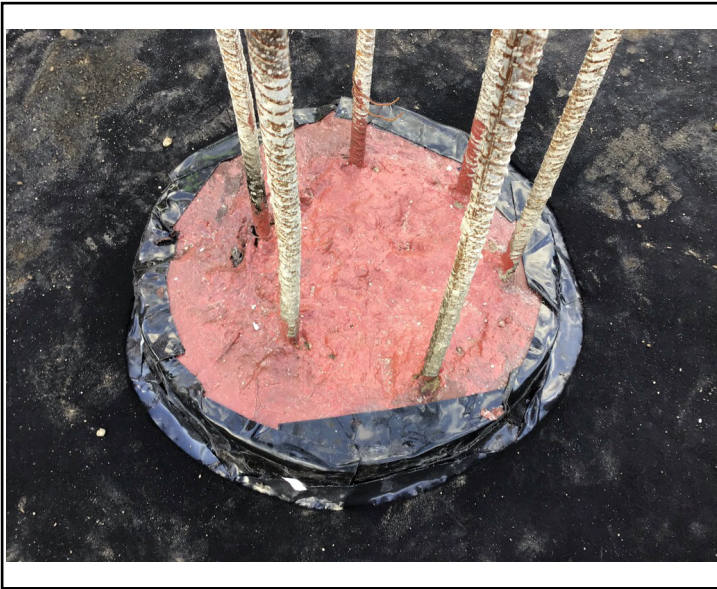
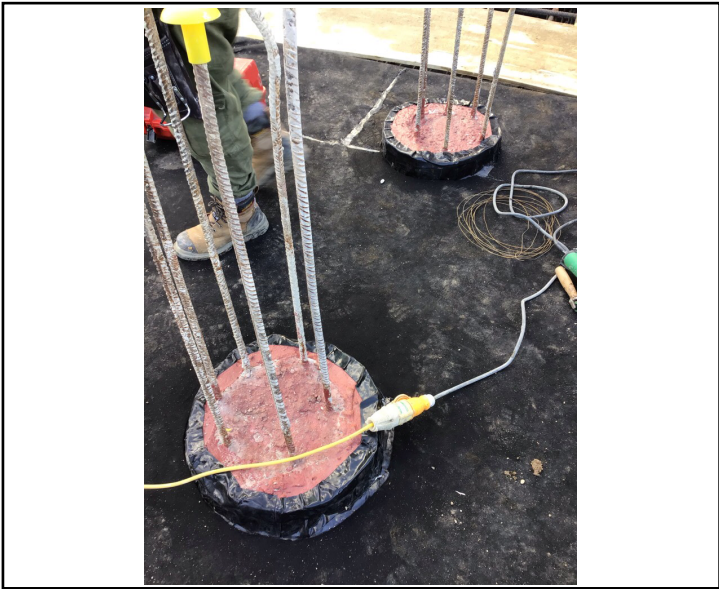
LOCATION/GRID LINE: Block D1 - Core - Middle and Upper

NOTES: Pile heads sealed to high standard. All works visually

inspected and tested with pick and probe to ensure good bond achieved. Double sided

tape installed around all pile heads to seal to Pudlo GP Ultra + Gas Barrier. Good

covering of Pudlo Liquid Gas Barrier to all pile heads.
