# Science Block, Highgate School

## Structural and Civil Engineer's Basement Impact Assessment Report

This Basement Impact Assessment Report (BIA) has been produced to supplement the planning application for the proposed development of the Science Block at Highgate School, located in the London Borough of Haringey.

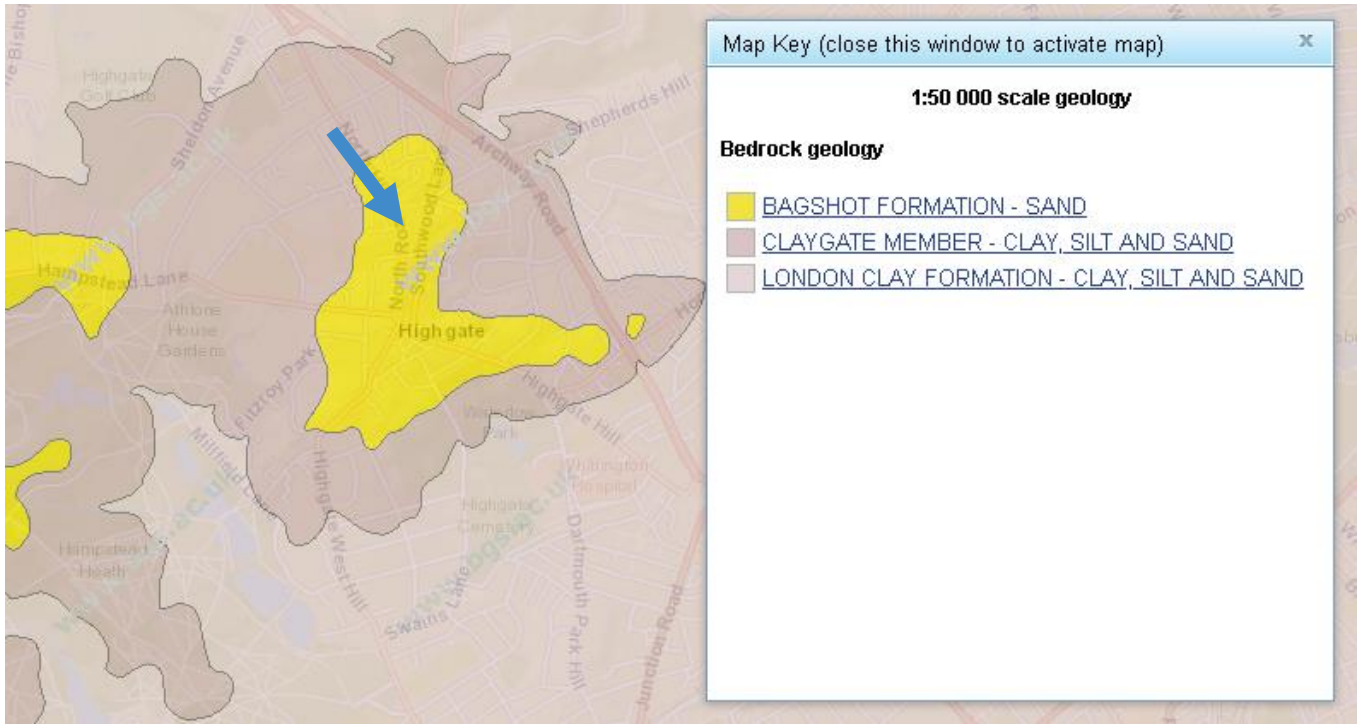
Figure 4 - Extract of geological map showing Highgate. Contains British Geological Survey materials © NERC [2019]

As shown on figure 4 the site is underlain by a layer of Bagshot Formation sand, over the Claygate Member over London Clay.

Ground conditions were found to be broadly in line with those indicated by the Geological Survey maps. Below the (0.4m) fill, Bagshot formation (CLAY/SAND) was found to 11.5m bgl over the Claygate member proven to 15m.

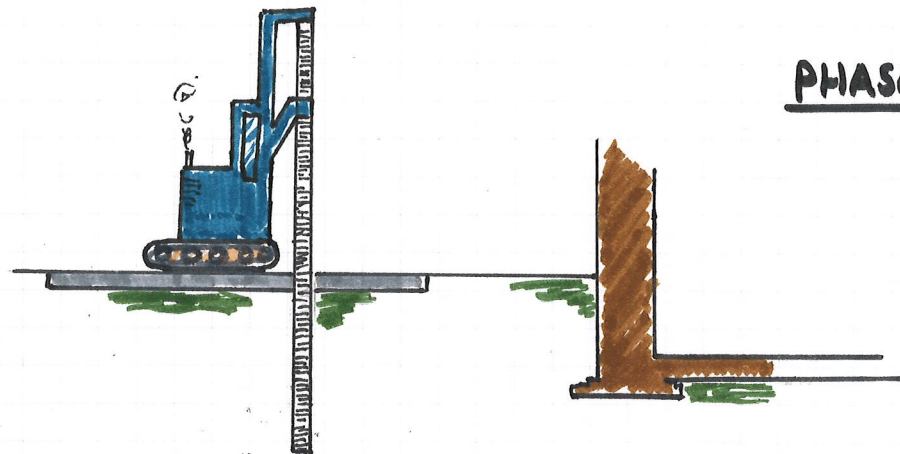
### PHASE 1 - PILING

1. INSTALL PILING MAT
2. INSTALL CFA RC PILES
3. CAST CAPPING BEAM

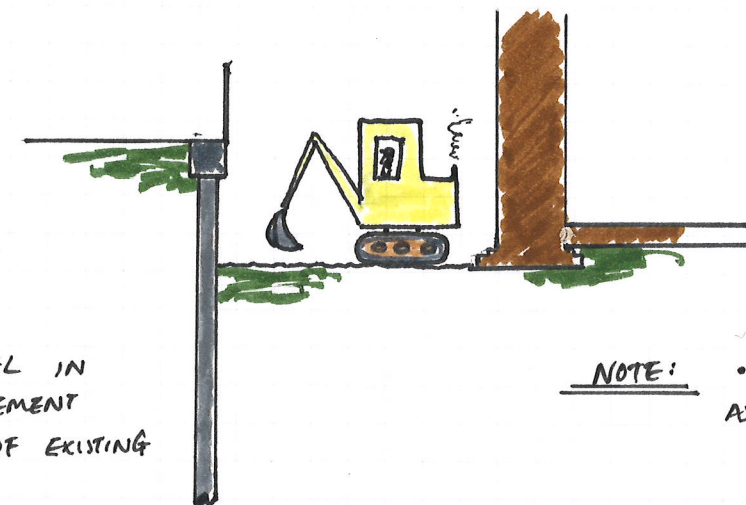
### PHASE 2 - REDUCE DIG

1. REDUCE LEVEL IN PROPOSED BASEMENT TO BOTTOM OF EXISTING FOUNDATION

NOTE: • PILES DESIGNED AS PERMANENT CANTILEVER.

- i. Reduce level in proposed basement to bottom of existing foundation

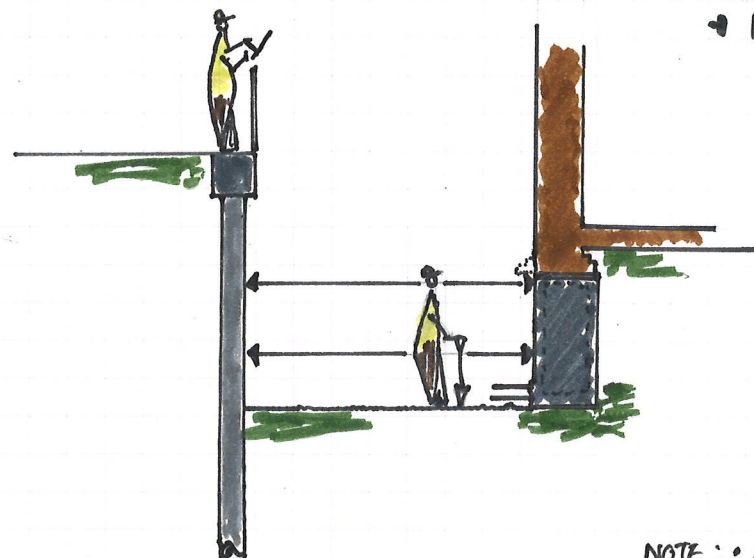
### PHASE 3 - UNDERPIN + PROP + REDUCE DIG

1. INSTALL RC UNDERPINS IN NON SEQUENTIAL ORDER / INSTALL PROPPING AGAINST PILED WALL

NOTE: • MIN 48HRS CONCRETE CURING BEFORE PROCEEDING TO ADJACENT PIN  
• INSTALL HYDROPHYLLIC STRIPS  
• INSTALL DRY PACK BETWEEN EXISTING FOUNDATION AND TOP OF PIN.

- i. Install RC underpin in non-sequential order.
- ii. Install propping against piled wall.
- iii. Dry Pack installed to joint between existing foundation and top of underpin – Allow 48hours curing before proceeding with adjacent pins

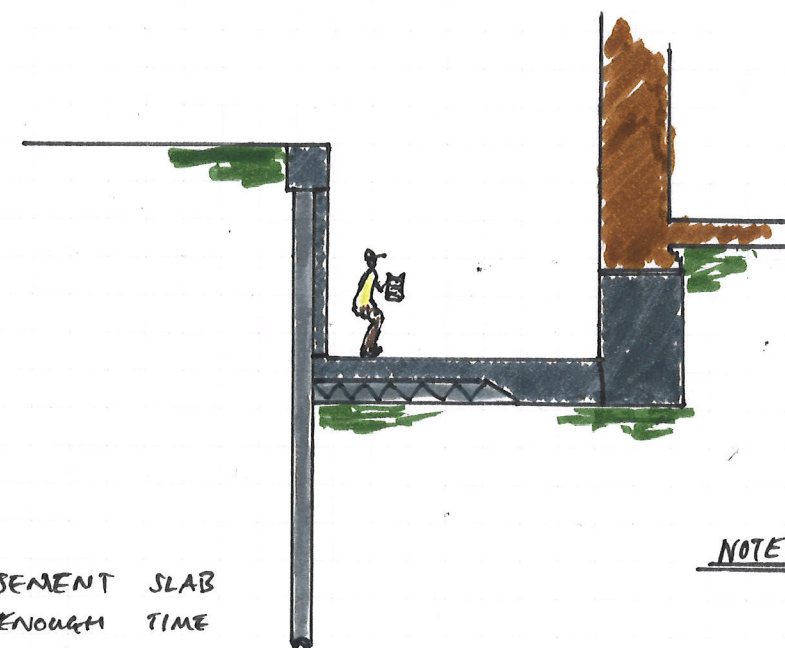
### PHASE 4 - CAST SLAB WALL

1. CAST BASEMENT SLAB
2. ALLOW ENOUGH TIME FOR SLAB TO GAIN SUFFICIENT STRENGTH
3. DEPROP UNDERPINS
4. CAST LINING WALL.

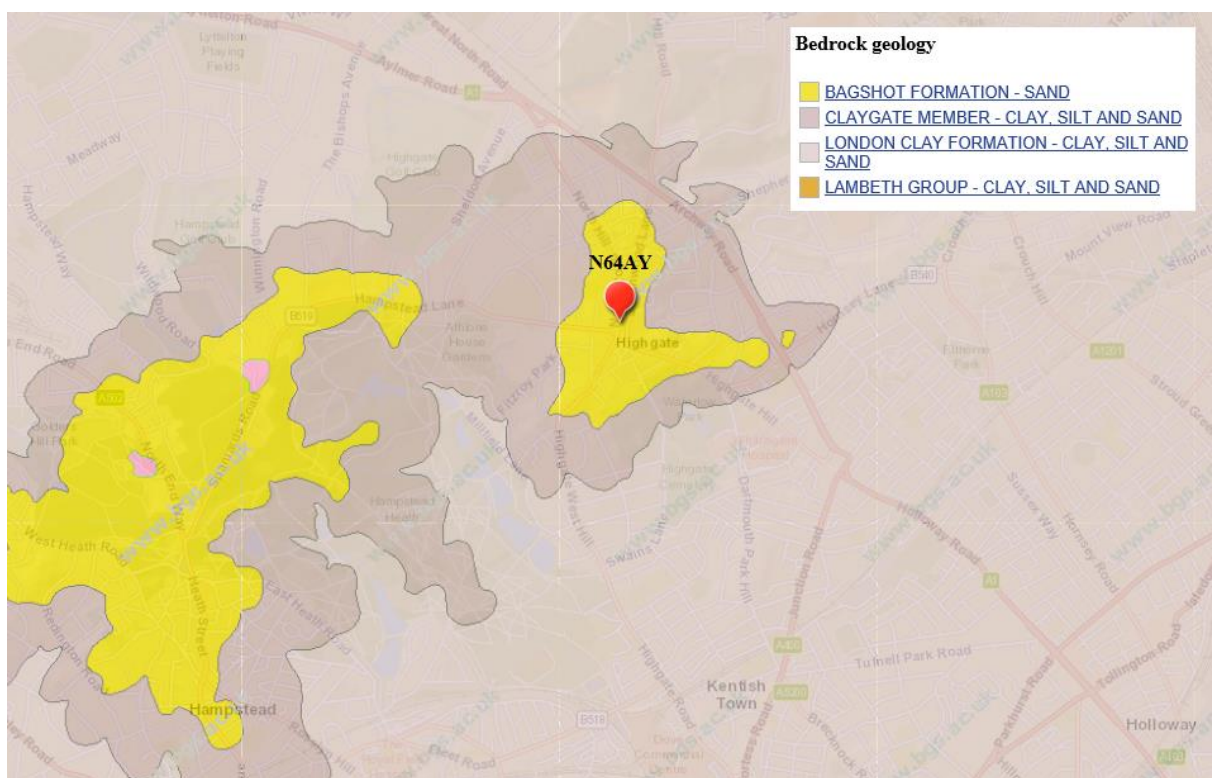
Figure 2.3: Local Geology (Map data British Geological Survey © NERC 2019)

The British Geological Survey (BGS) map for this area shows that the site is underlain by Bagshot Formation – Sand, as shown in Figure 2.3 below.

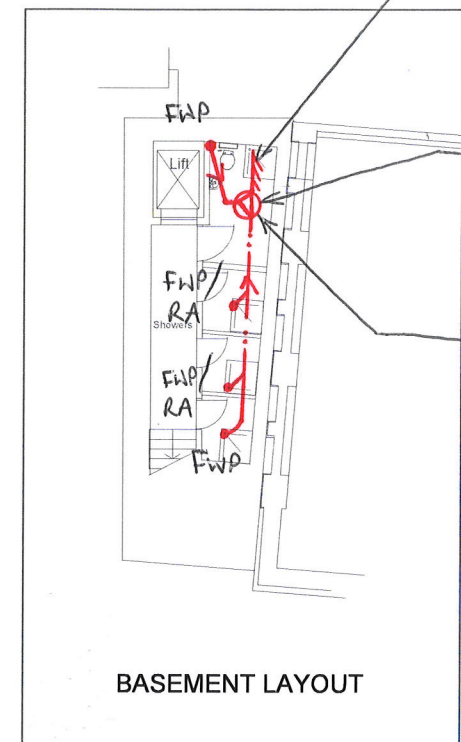
## Preliminary Below Ground Drainage Drawing

CAVITY DRAINAGE & PUMP  
SPECIFICATION/SIZE BY  
SPECIALIST.

RIISING MAIN TO  
HIGH-LEVEL BY  
M&E ENGINEER

VENT & DUCT WORK  
TO HIGH-LEVEL BY  
M&E ENGINEER

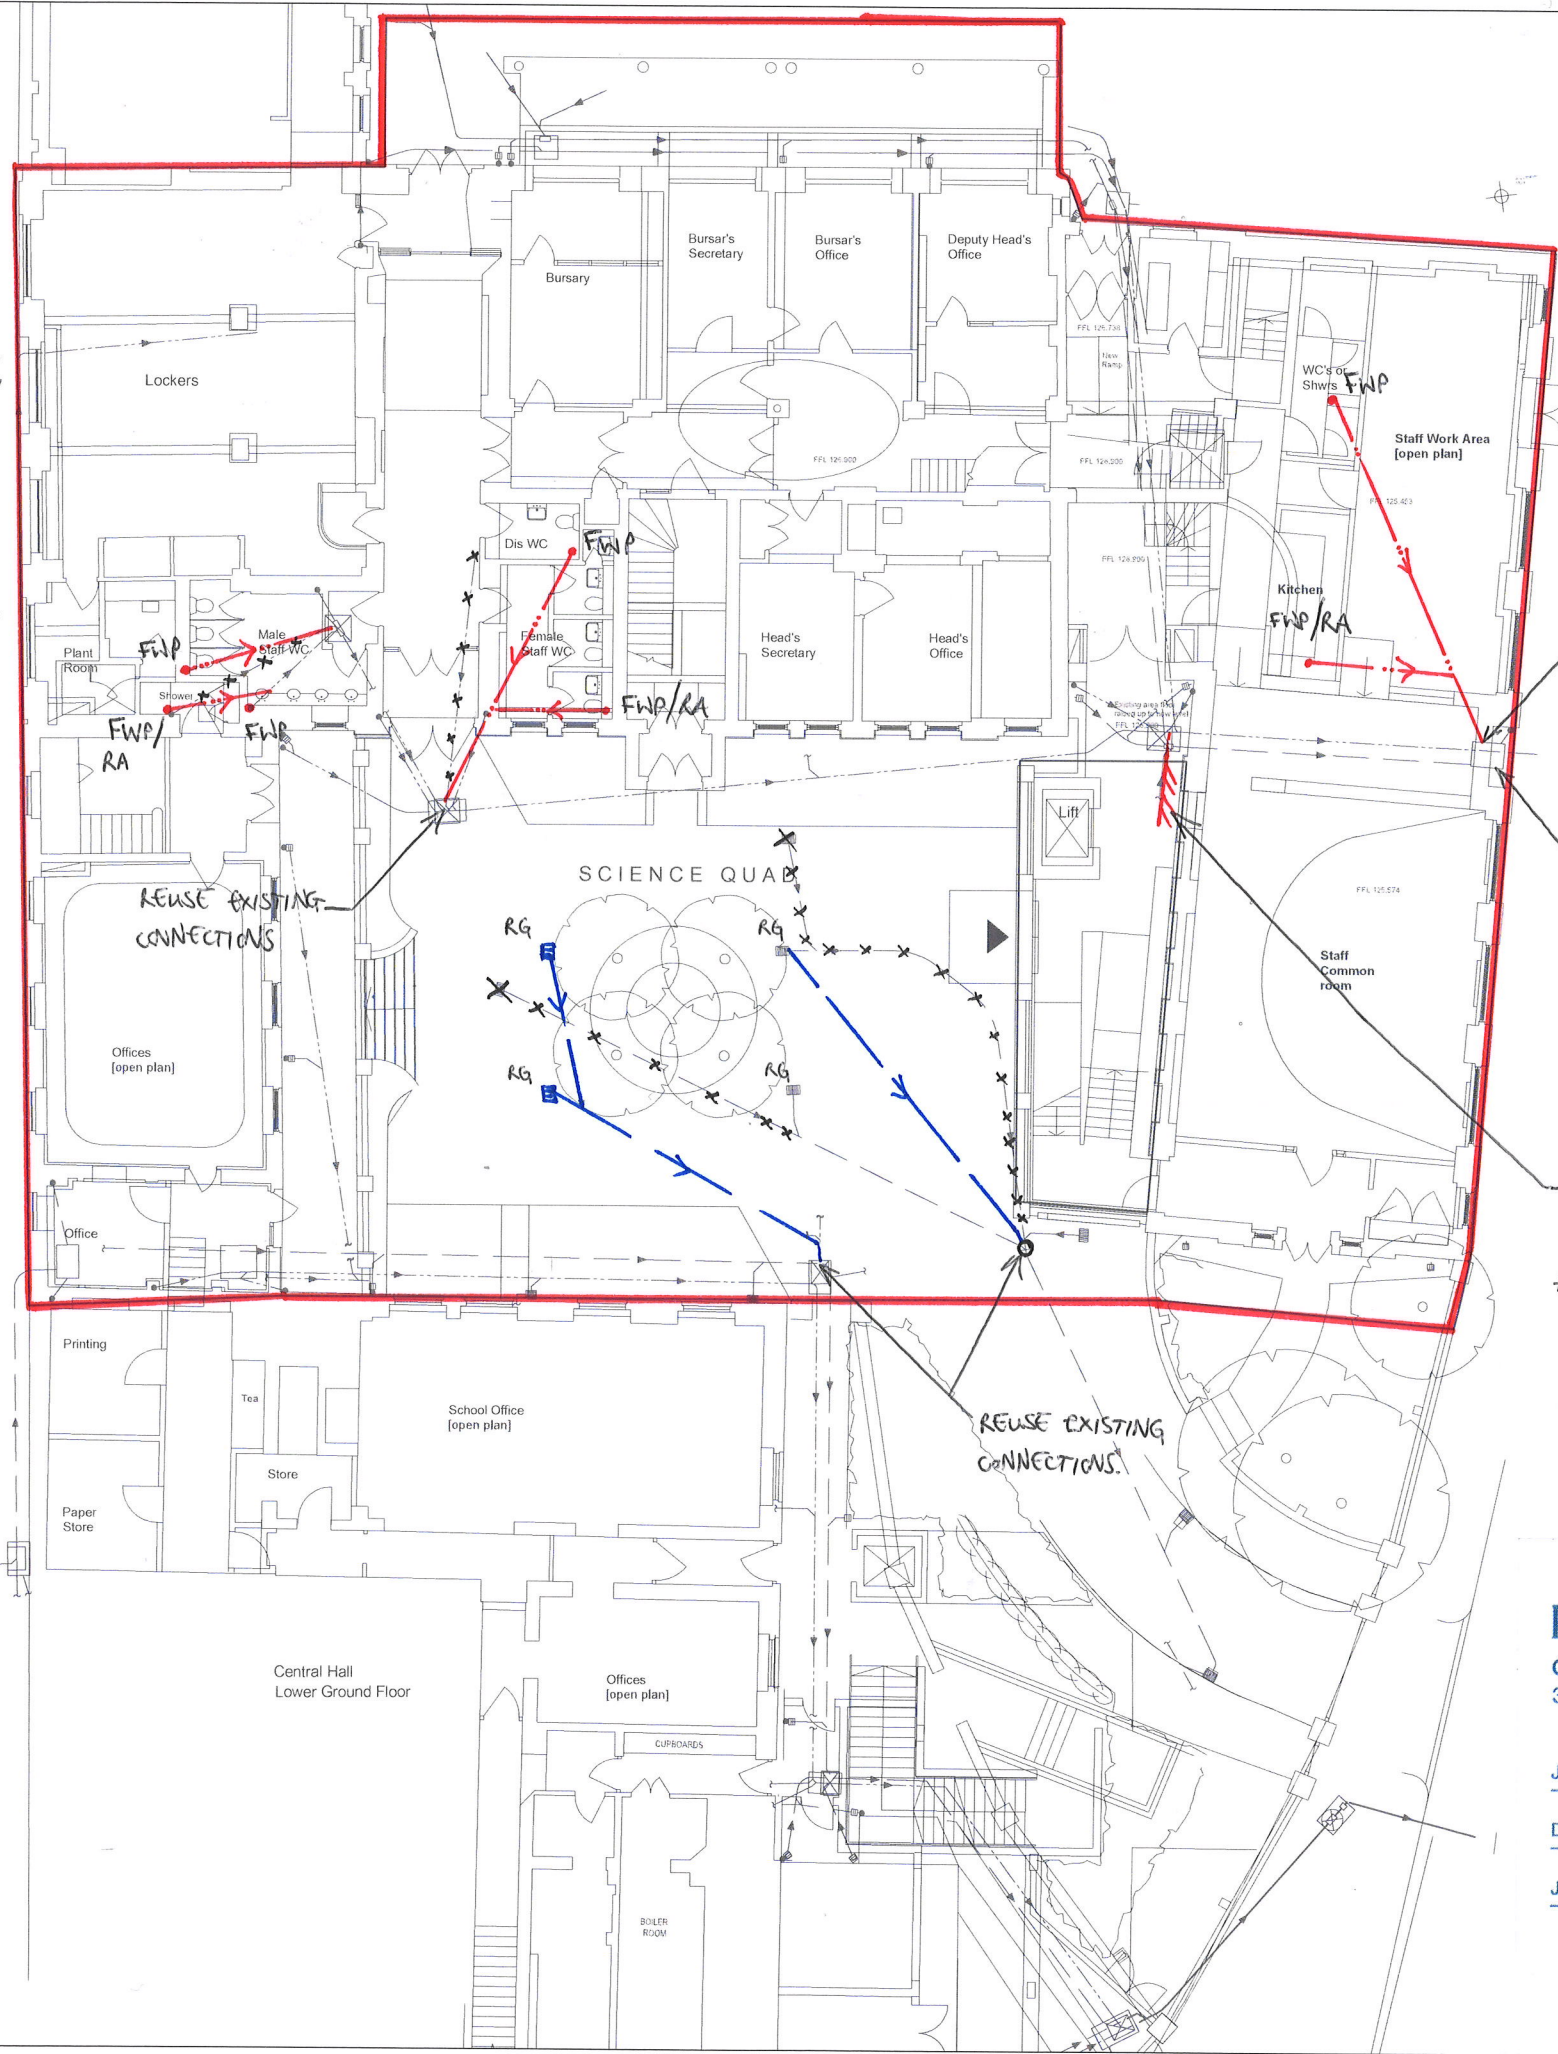
CONDITION OF ALL EXISTING DRAINAGE TO BE  
CONFIRMED. REMEDIAL WORKS OR REPLACEMENT  
AS REQUIRED.

MANHOLE REBENCHED  
TO SUIT ADDITIONAL  
CONNECTIONS.

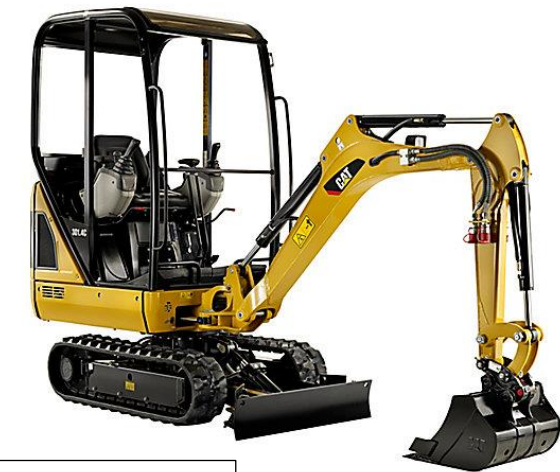
MINI-EXCAVATOR

The proposed strip foundation for the new extension could be small enough to be excavated entirely by hand. Alternatively the mini excavator shown here retracts to under 1m wide and weighs around 1.5 tonne. It could be delivered through the building with only minor temporary works to accommodate it.

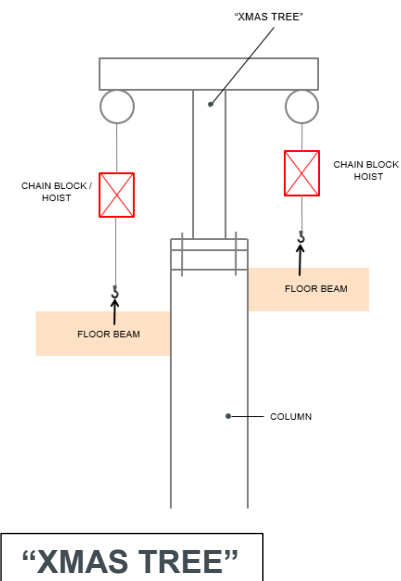
Other methods of manual erection could be employed including the “Xmas Tree” system where the new permanent columns are adapted to lift the beams into place:

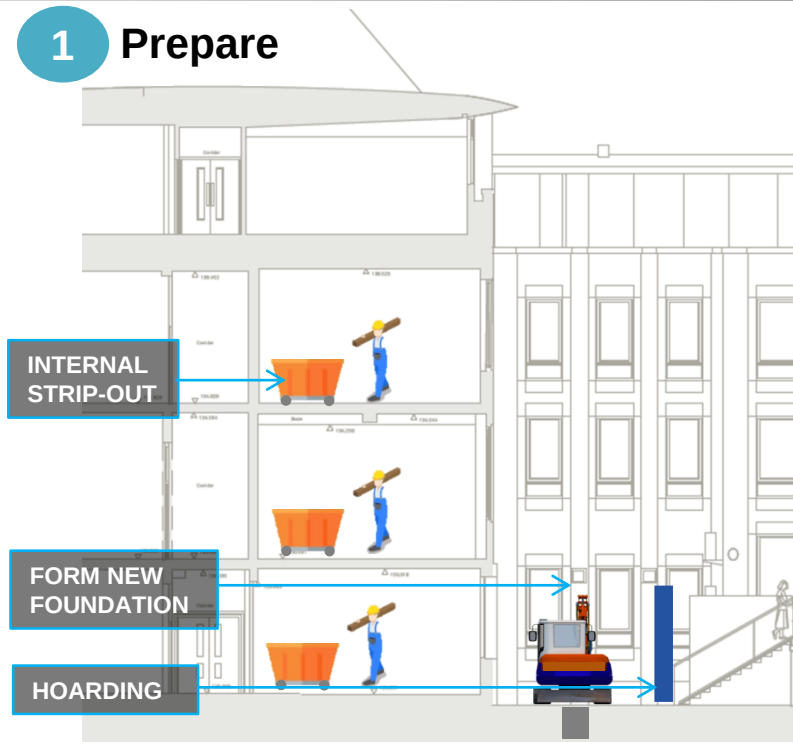
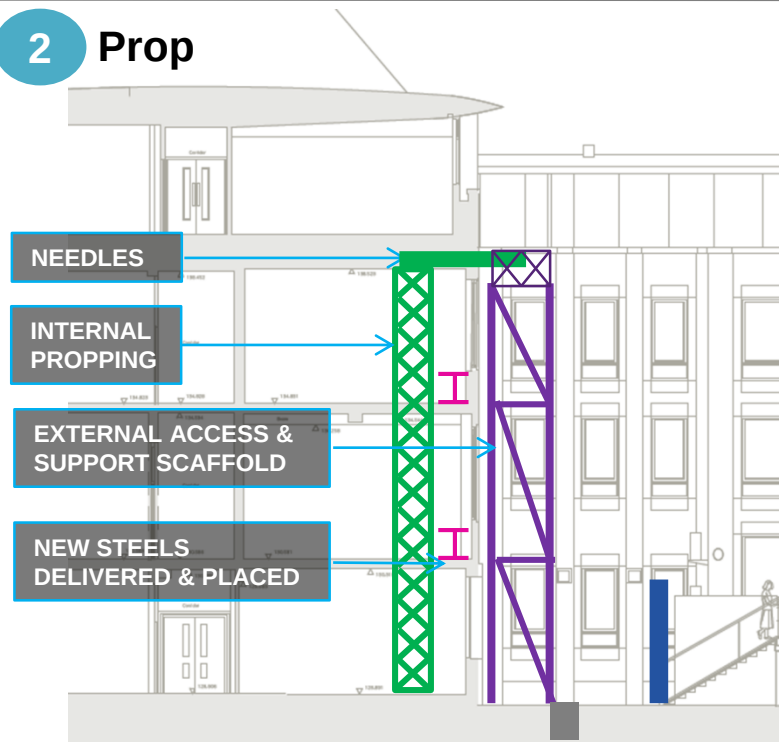
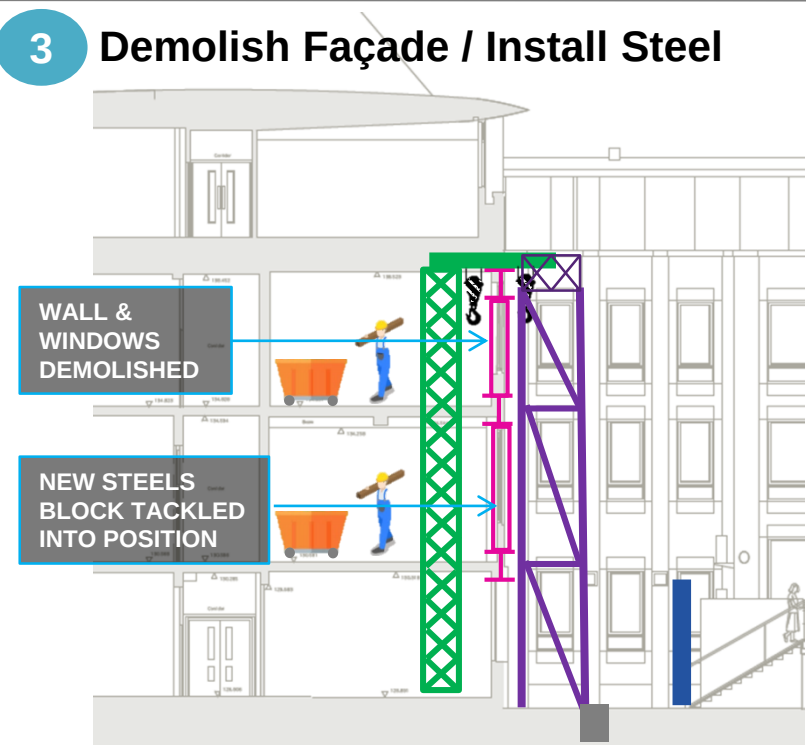
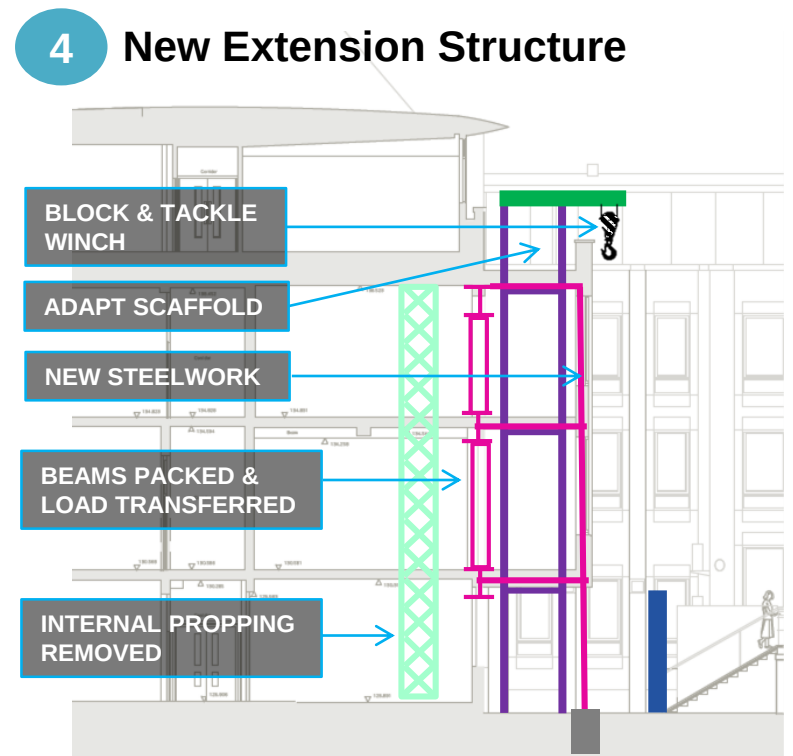
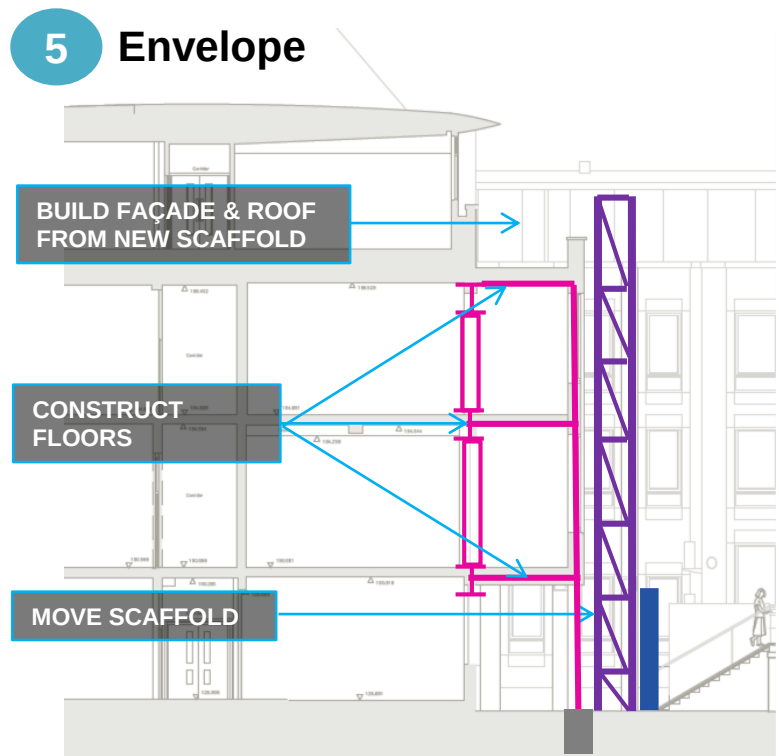
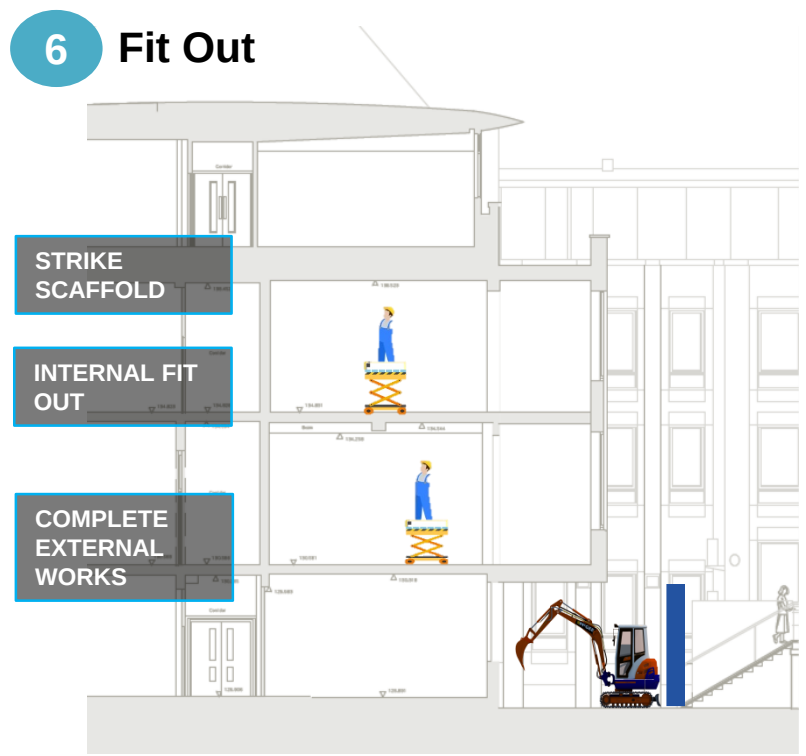
**DRAWING NO.:** BSB-HS-002  
**REVISION NO. & DATE:** Rev 0 – 11/07/2018  
Copyright © 2018 Blue Sky Building

Please refer to drawing BSB-HS-002 – Rear Extension Sequence.

1 Prepare

2 Prop

3 Demolish Façade / Install Steel

4 New Extension Structure

5 Envelope

Once the inside is stripped and the foundation in place internal propping and external scaffold can be erected. We envisage that the external scaffold can be adapted to serve as access as well as support for temporary needles, as shown on our sequence diagram overleaf. The contractor should consider bringing in new permanent steel for the wall support *before* the propping is erected – to ensure it can be manoeuvred into place.

Once supported the old façade wall can be demolished in to the building and debris removed in bins to the front quad. New supporting steel is then lifted by block and tackle using the scaffold and temporary works for support.

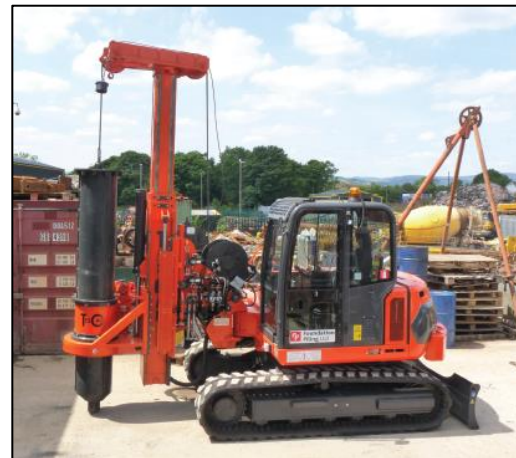
**CF3 RIG,  
2.2M WIDE, 11 TONNES**

Piling would be undertaken from ground level using a small rig that can be driven through the entrance gate, similar to the rig in the photograph here. We estimate that 4-5 piles per day would be achievable. Arisings would be stock piled for removal by skip or lorry. Concrete deliveries would be by ready mix truck to the quad and placed directly.

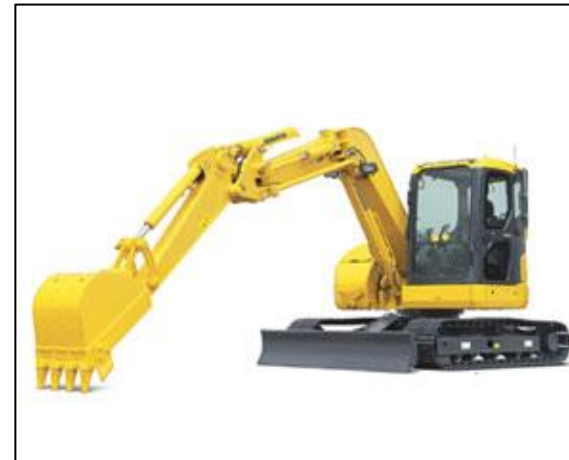
**KOMATSU EXCAVATOR,  
2.4M WIDE, 8 TONNES**

Machine selection for basement excavation should be the biggest machine that can be got in. Excavation to underside of raft will proceed when piling and underpinning are clear, with temporary propping as required.
