Address  
12 Wood Lane  
Highgate

Project  
EXISTING PLAN  
Ceiling Repairs

Drawing Title  
First Floor  
Reflected Ceiling Plan

Drawing Number  
255-12WL-FD02

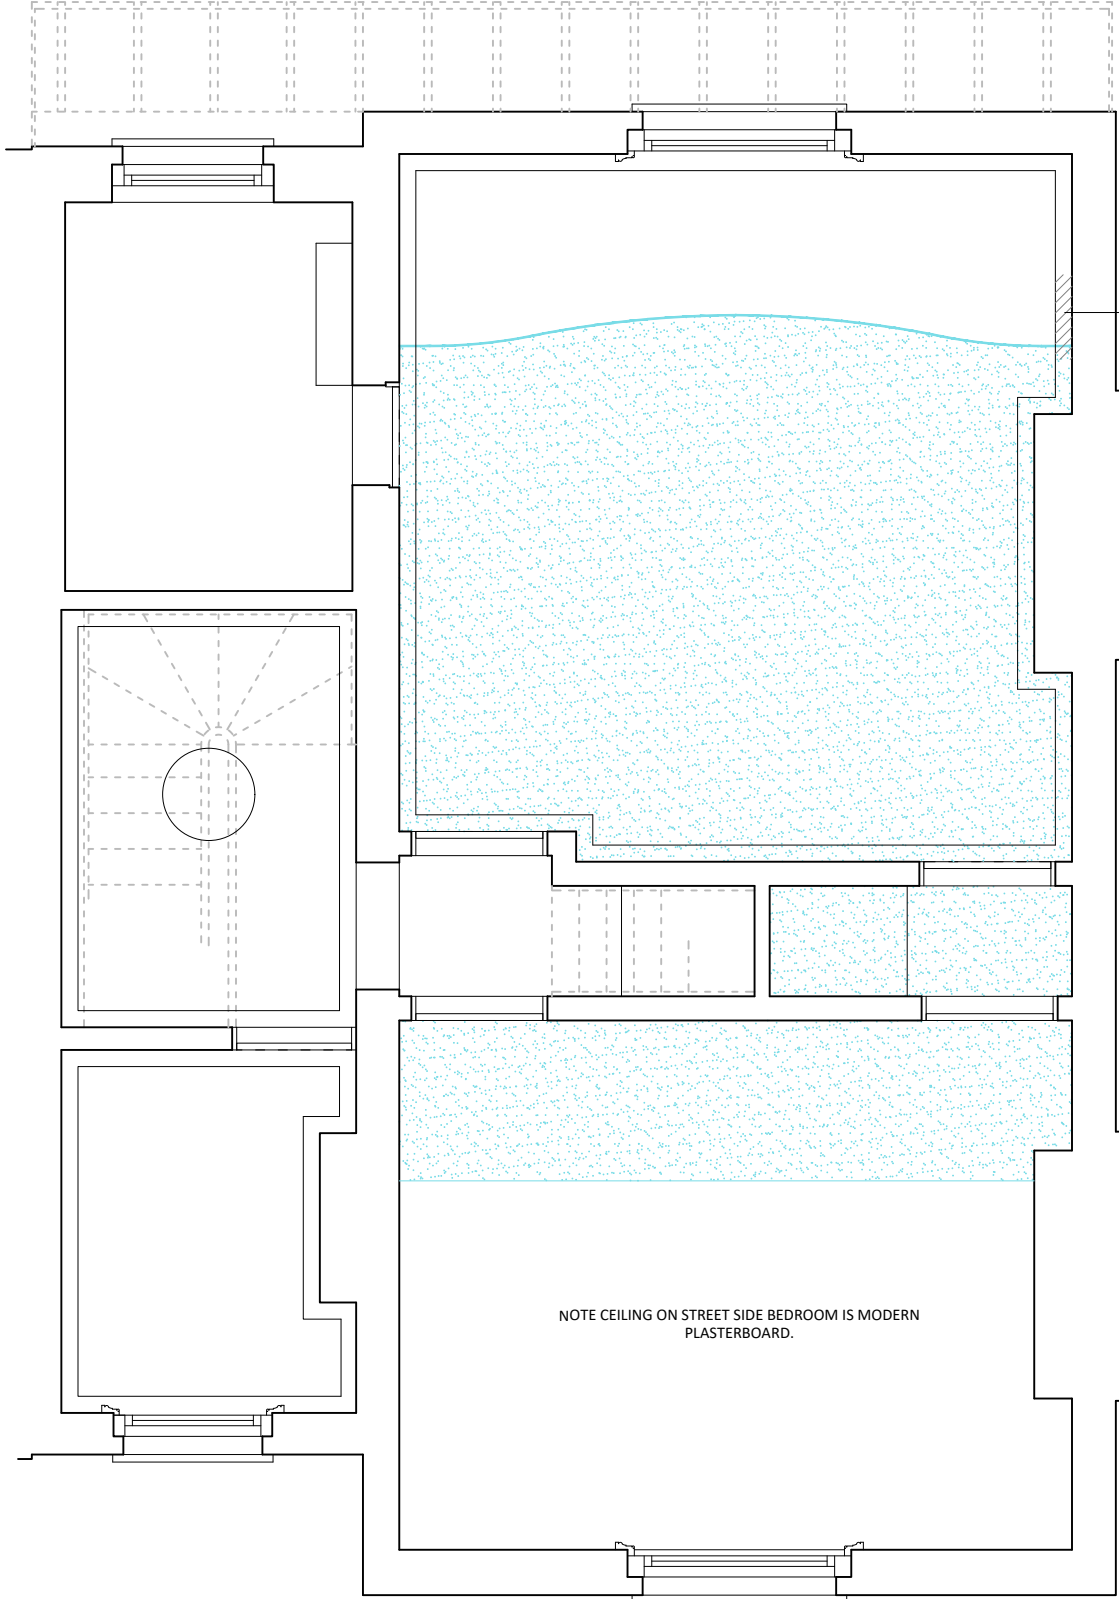
Area of ceiling damaged by water from the flood and determined to be unsound. Unsound section of ceiling to be replaced in lath and plaster. Mouldings of the existing cornice are to be taken and matching cornice to be formed as part of the repair work, note this detail is in part inset into the bed of the ceiling. This will preserve the character of the Listed Building, allow for curvatures in the ceiling structure and allow for flexibility in the structure.

Original, reeded perimeter cornice to be modelled from site, moulded cast and refixed where required.

NOTE CEILING ON STREET SIDE BEDROOM IS MODERN PLASTERBOARD.
