**Condition A25: HGY/2023/0747 – Responses to LBH 19.05.23**

## Appendix 1 – Photographic Evidence

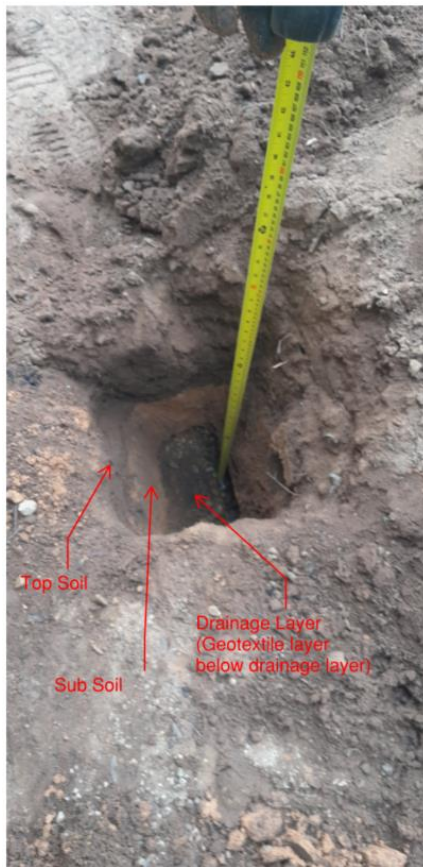
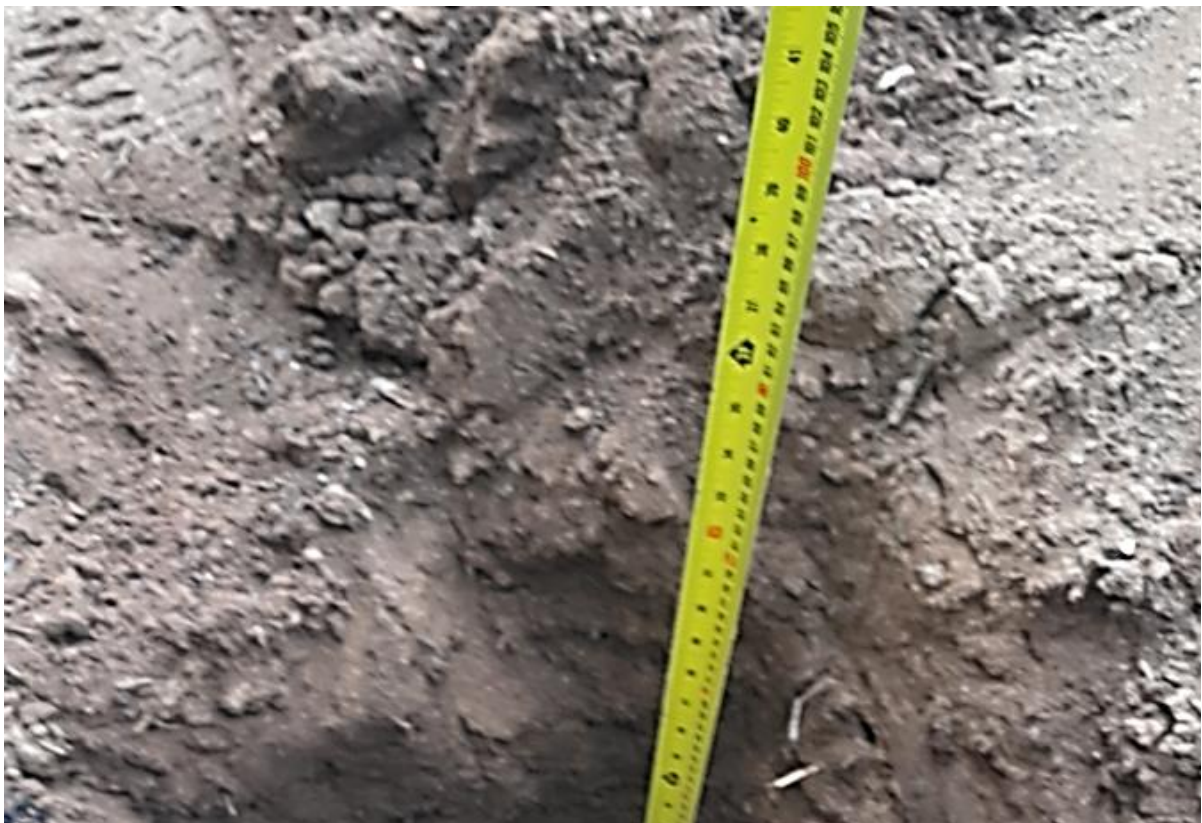
| LBH Comments 15.05.23 | Responses |
|---|---|
| <p>1. 1. Photographic evidence that the depth of the clean cover systems for areas of soft landscaping are no less than 600mm. While we take note of the photographs on page 2 of the applicant submitted document, we do not consider them sufficient to determine the depth of the cover system. We would require additional photographs with a method of establishing depth/scale (measuring staff or tape) to be able confirm the depth of the imported soils - rather than with annotated arrows/measurements as currently submitted in the submitted document "Condition A25: HGY/2023/0747 – Responses to LBH" dated 5th May 2023. Therefore, additional photographic evidence is required.</p> | <p>Please see further photographic evidence demonstrating clean cover of around 900mm over the minimum depth of 600mm in <b>Appendix 1</b>.</p> |
