**Refined CSM  
Phase 3 Options Appraisal (OA)  
Remediation Strategy (RS)  
and Verification Plan**

**Ashley Road Depot  
Ashley Road  
London  
N17 9AZ**

**(ref. TJ3952AR1v1.1)**

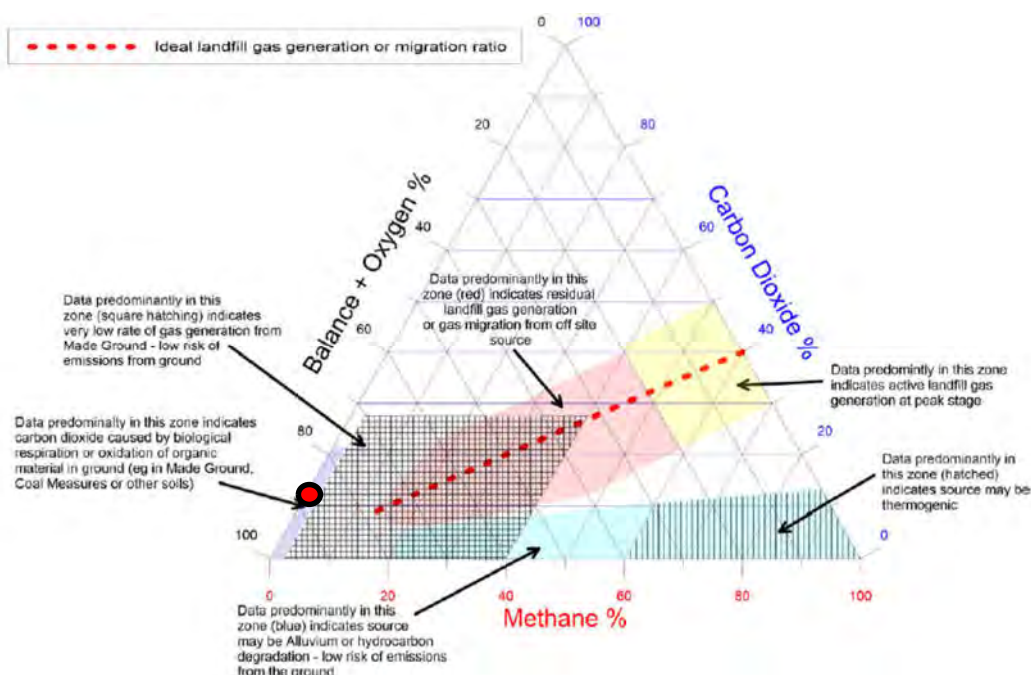
In accordance with NHBC (2023) Hazardous Ground Gas – An Essential Guide for Housebuilders, a ternary plot is useful for deciding whether to increase a site's classification from CS1 to CS2 where there are elevated concentrations but low flow rates.

As can be seen from the ternary plot above, the concentrations of carbon dioxide and balance + oxygen from BH12 would be in the purple zone, which indicates that the carbon dioxide is caused by biological respiration or the oxidation of organic material in the ground (e.g., made ground). As stated in NHBC (2023), concentrations from a single well or only occur occasionally that are in the purple, light blue, squared hatched and vertical hatched areas may indicate that there is no need to increase the classification.

In our experience, it is common for boreholes to return elevated pressure, flow, and gas concentrations during the first visit after installation. The elevated concentrations of carbon dioxide were only returned at one location, in each case coinciding with depleted oxygen, indicating that biological respiration is the most likely cause of the gas concentrations as shown on the ternary plot above. There was no significant pressure or flow recorded during the monitoring indicating that there is no significant gas generation potential within the made ground.

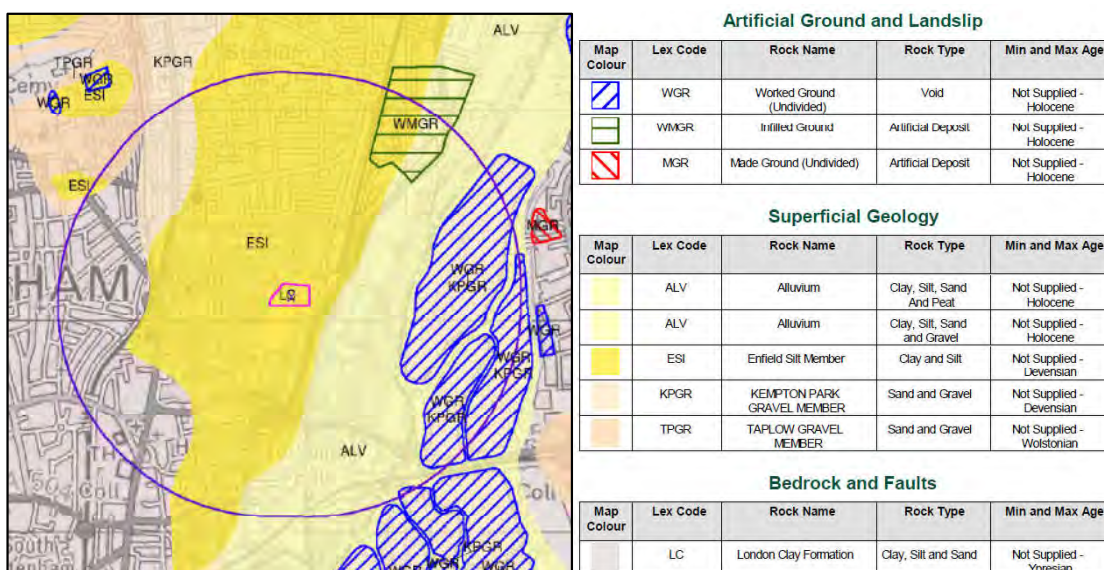
The British Geological Survey (BGS) viewer of the area (Sheet 256 as reproduced by Envirocheck below) indicates the site to be underlain by the Enfield Silt Member, overlying the Kempton Park Gravel over the London Clay Formation.
