HAYCOCK ENVIRONMENTAL CONSULTANTS LIMITED

# Highgate School - MSC - Phase 2a and 2b - HGY/2023/0338 - Review of BIA, FRA, SUDs and implications of the proposed development for the adjoining owners in Broadlands Road

15th June 2023

2.05

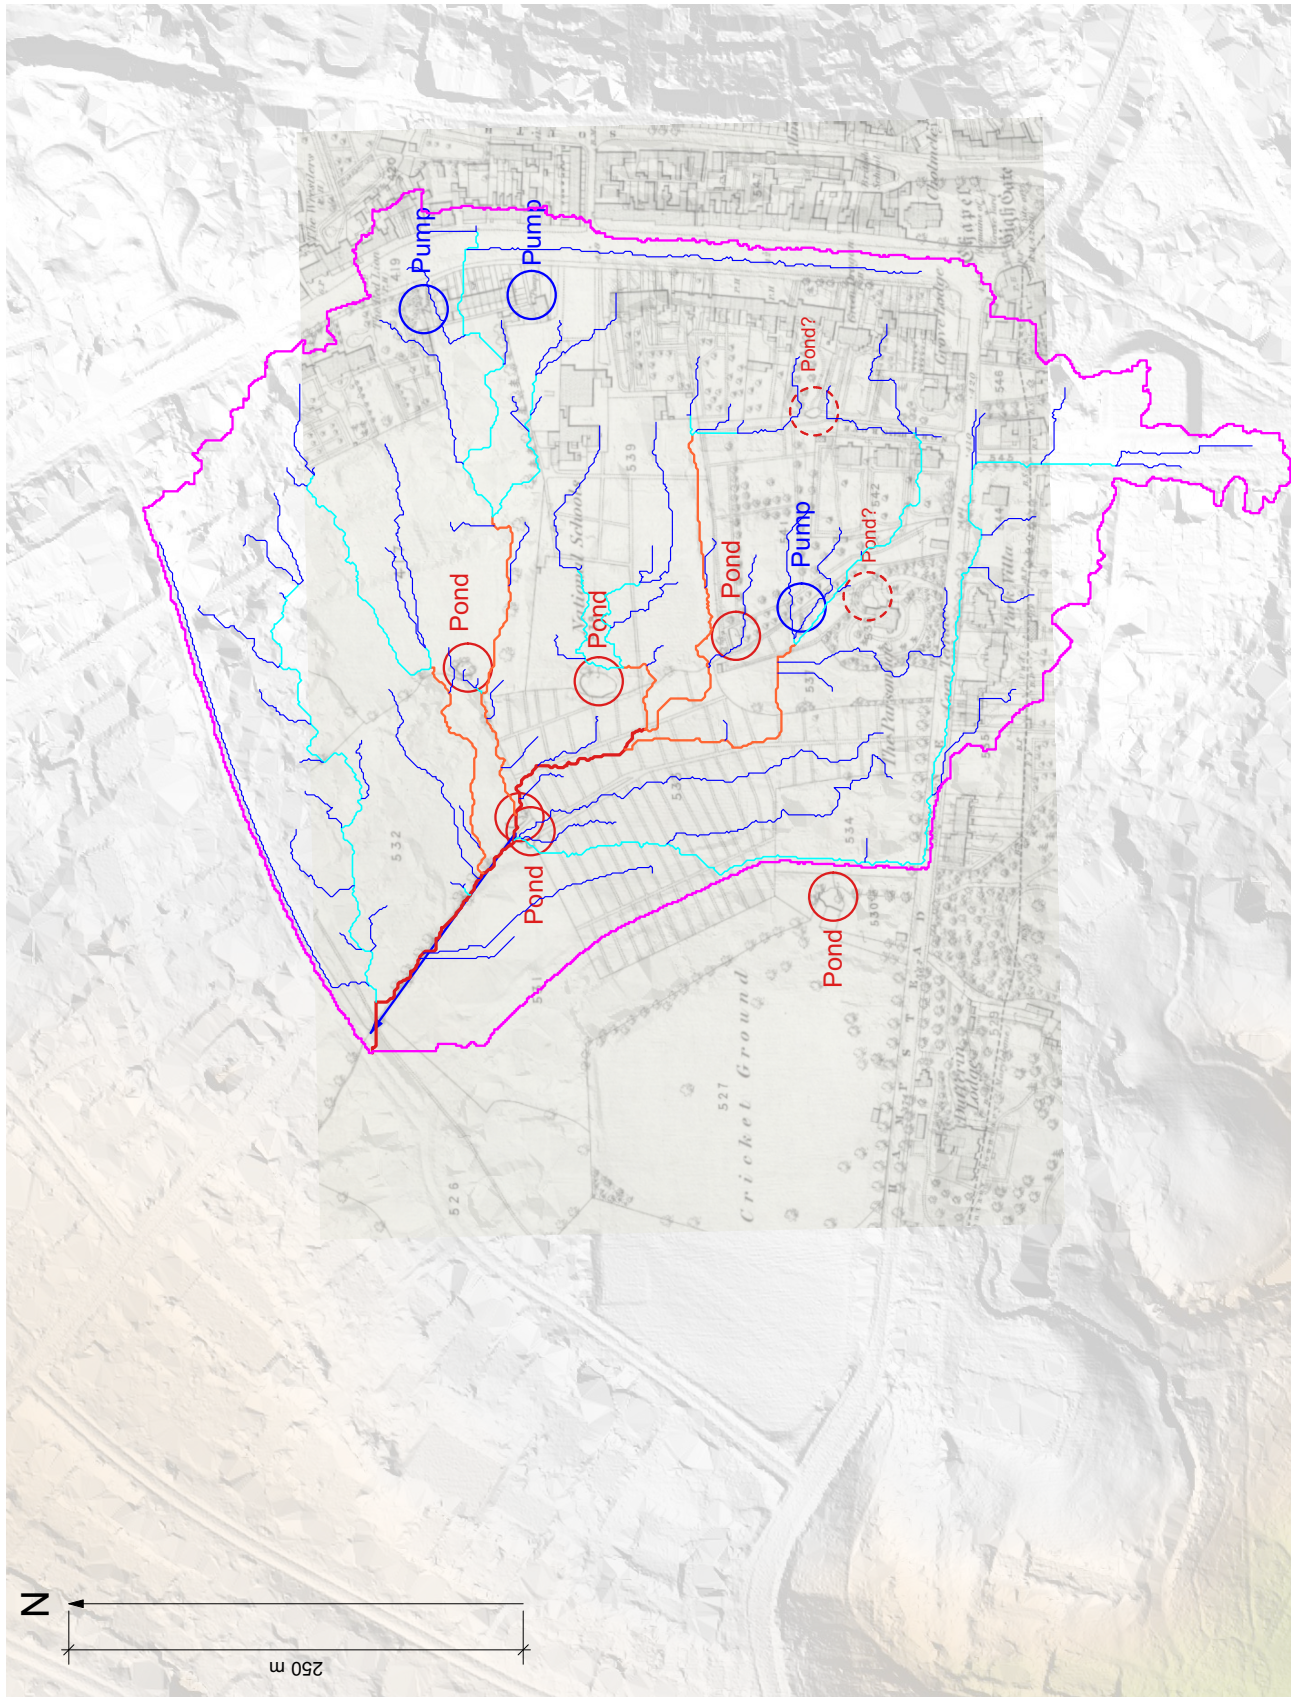
Appendix 2: MSC Drainage Basin (RT), Flow Lines (RT-D8) against the background 1st Series OS Map and Environment Agency LiDAR (DTM 1m).
