# Noel Park, London, N22

## Heritage Statement

### Baseline, Character & Significance Appraisal and Proposed Works

**Noel Park, N22 – Heritage Statement**

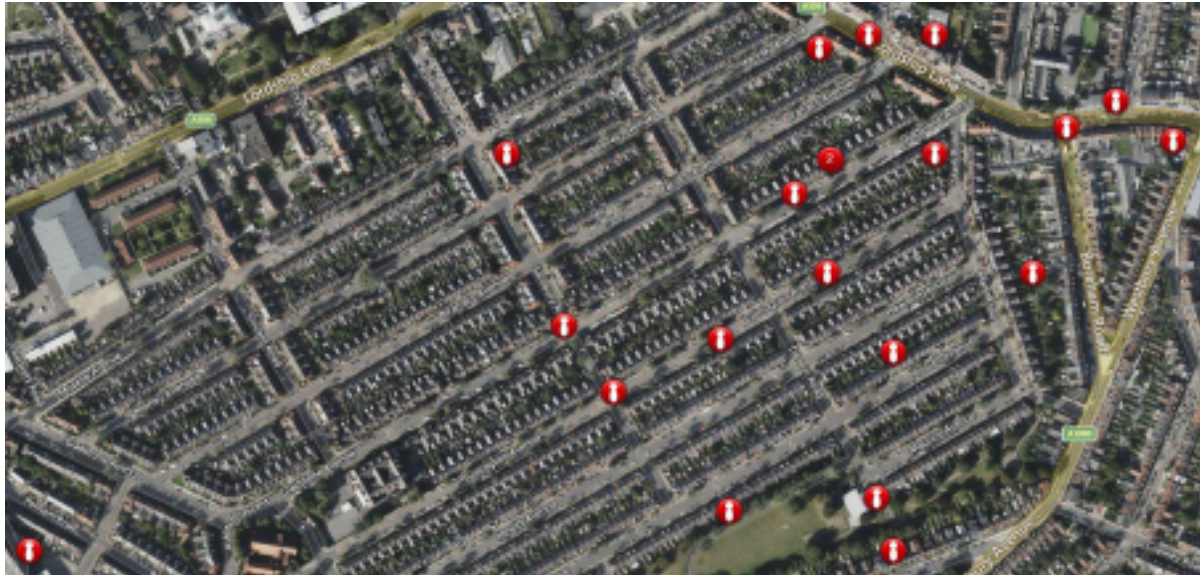
**Figure 9** A bomb damage map of the Estate. Source: Bomb Sight.

A decade after the Estate was completed, part of Noel Park was damaged during the air raids of World War II. Many lost their lives and flying bombs destroyed dozens of houses. Gladstone Avenue, Farrant Avenue, Pelham Road and Vincent Road were the worst hit (see Figure 9 & Figure 10).

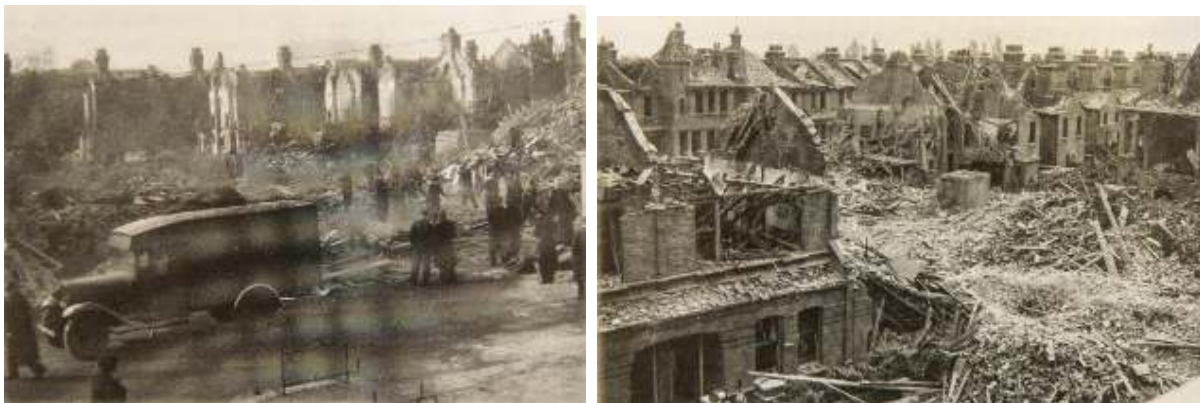
**Figure 10** Pictures of bomb damage on Gladstone Avenue, 1945.  
Source: Bruce Castle Museum.

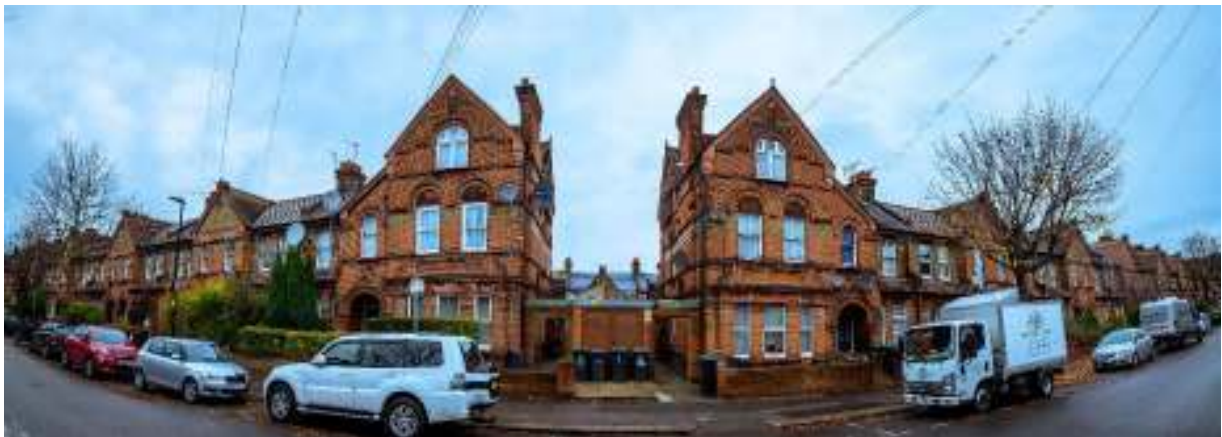
**Figure 15** The south façade of the terraces on the north side of Gladstone Avenue. (SLHA@Dec'21).

The Noel Park Estate has a number of distinct features. Firstly, the street profiles in the area are straight, forming a grid layout with extensively long terraced rows and trees along the streets (see Figure 15 & Figure 16). With a variety of high-quality housing and sufficient public facilities, including a school, church, shops, theatre (formerly on the site on Lymington Avenue now occupied by the shopping centre) and community hall; Noel Park set the standard for later suburban Council estates.

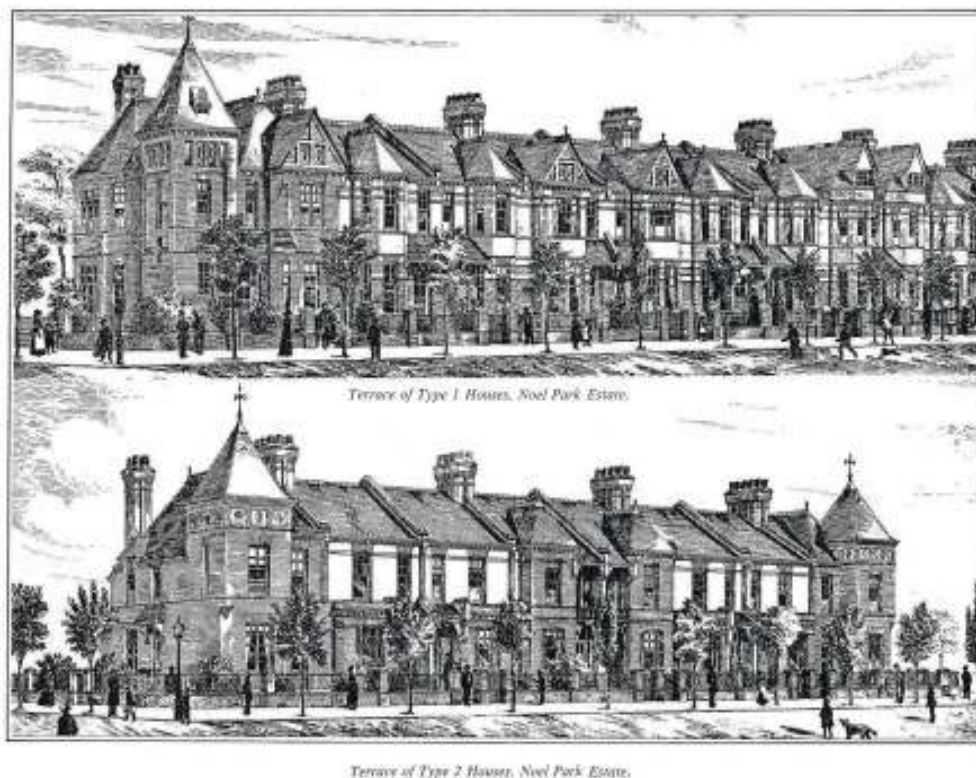
**Figure 17** The original design of the Noel Park from the Artizans Labour and General Dwellings Company.  
Source: Artizans Centenary: 1867-1967.

emphasise the horizontality and the general low-rise nature of the Estate, while the differentiated gables and corner houses with their fully hipped turrets give each composition rhythm and unity (see Figure 17). Although the front elevations of some houses have been altered and partly repainted, the overall streetscape has not changed considerably in the last several decades.

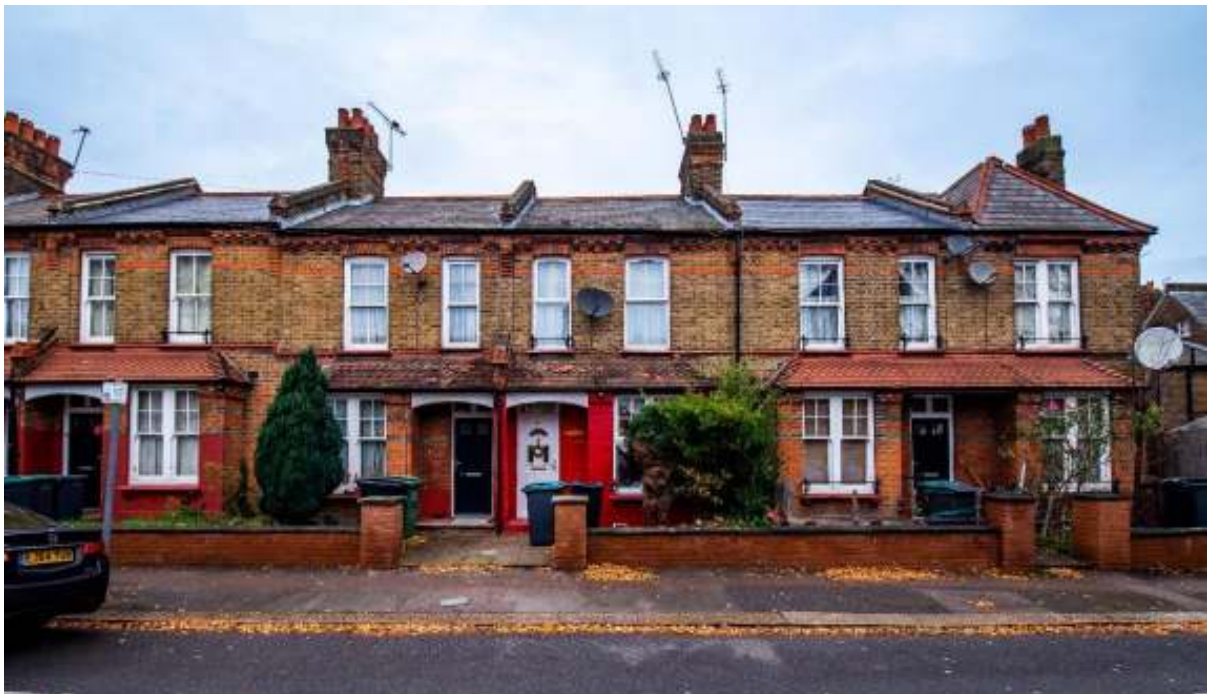
Throughout the estate, many properties have been either altered or repaired in a way that doesn't reflect the original design or materials. Examples include painting, pebble dashing or cladding of facades, replacing windows, and removing, enclosing or replacing porches. This has adversely impacted the original character of the Estate, as Figure 19 shows.

**Figure 19** Picture of the south elevation of the terrace on Moselle Avenue shows that many properties have been altered or repaired in an unsympathetic way. (SLHA@Dec'21).

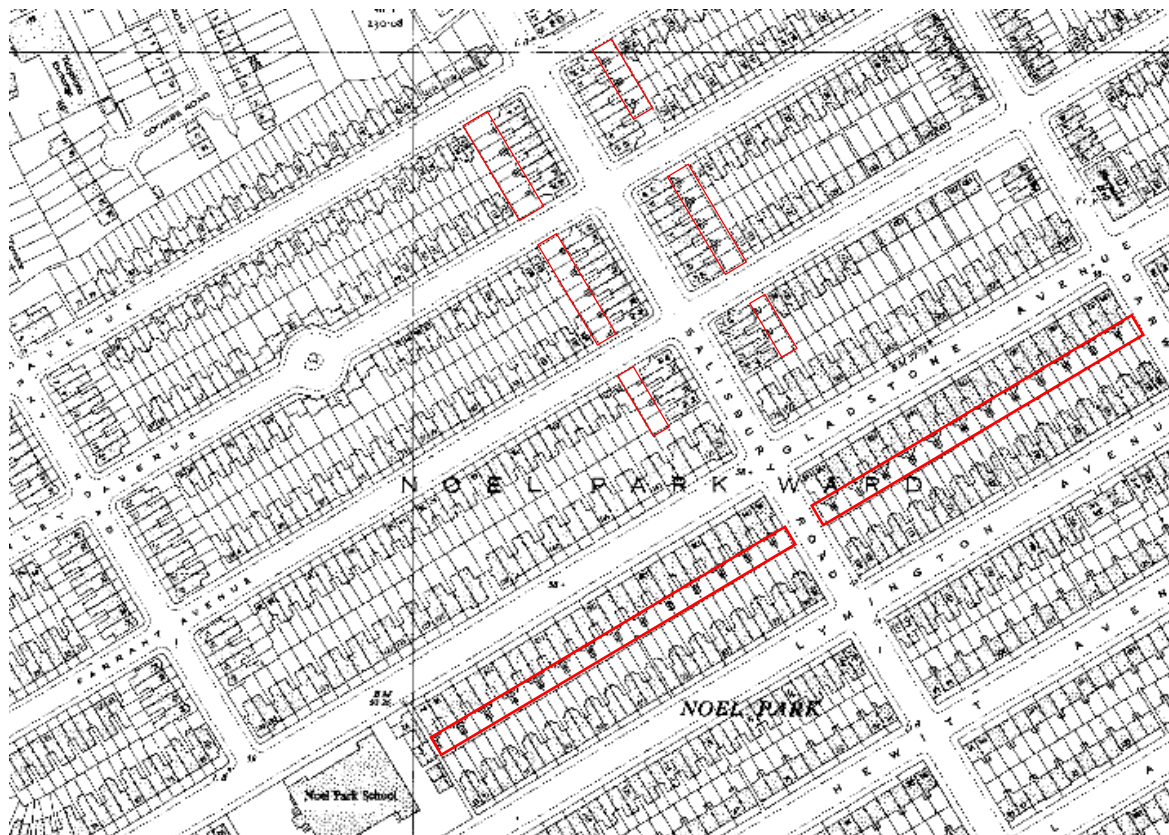
**Figure 23** OS Map of 1955. Highlighted areas show the development of new extensions to the original extensions. Source: National Library of Scotland.

These original extensions have been significantly altered over the last century, and importantly, further extensions have been added by individual households since 1950s. a comparison of the Ordnance Survey map of 1935 and 1955 reveals several later-built structures adjacent to the original extensions, especially south of Gladstone Avenue and those on Salisbury Road (see Figure 22 & Figure 23). Further developments of these extension could be seen in the OS map of 1970s. For example, in Gladstone Avenue, houses on the north side had new extensions built after 1950 and consequently rear gardens have lost their original consistency of design (see Figure 24 & Figure 25). In 1980, residents were given rights to purchase their houses, resulting a complicated pattern of ownership which resulted in piecemeal works, which impacted the street view and the rear gardens. As Figure 23 (1955 OS Map) and 24 (1974 OS Map) show, the number and scale of these extensions had been evolving throughout the Estate.

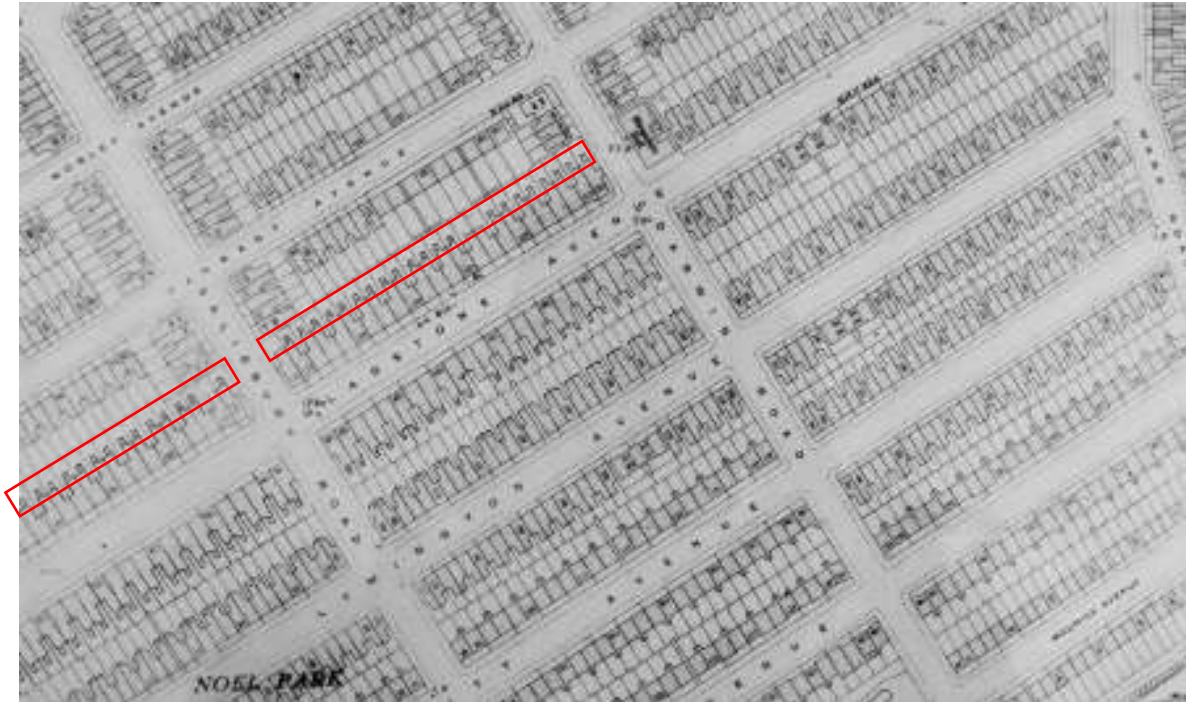
**Figure 24** OS Map of 1974. Highlighted areas show the new extensions to the original extensions in the rear gardens of the terraces on the north of Gladstone Avenue. Source: Bruce Castle Museum.

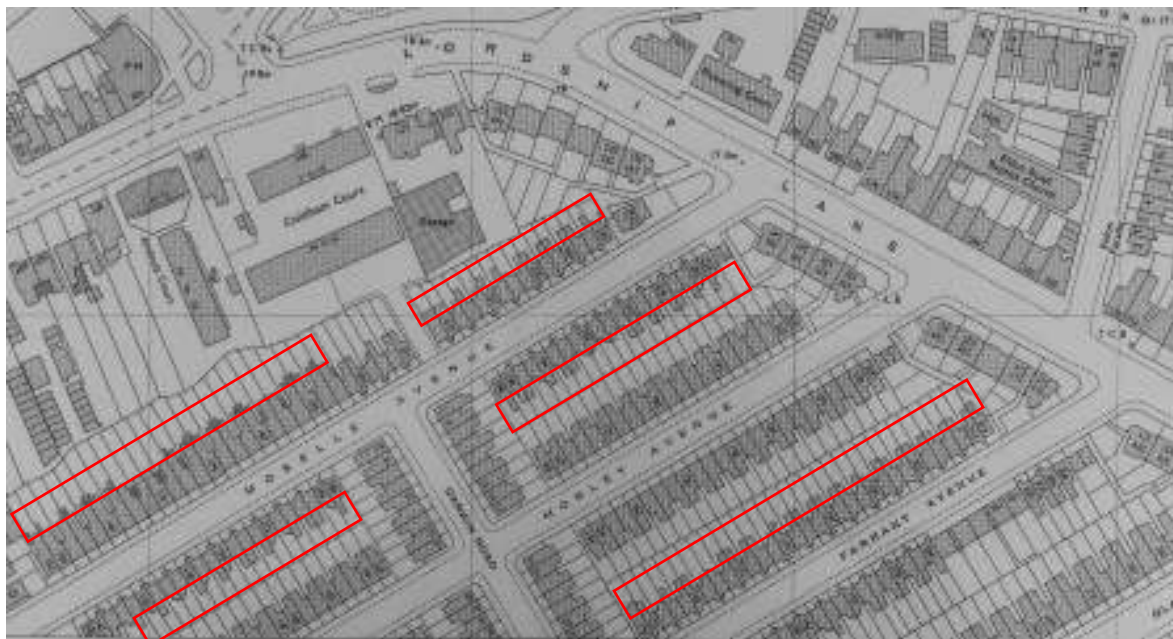
**Figure 25** OS Map of 1974. Highlighted areas show the developments in the rear gardens, where the original design of consistency has already lost. Source: Bruce Castle Museum.

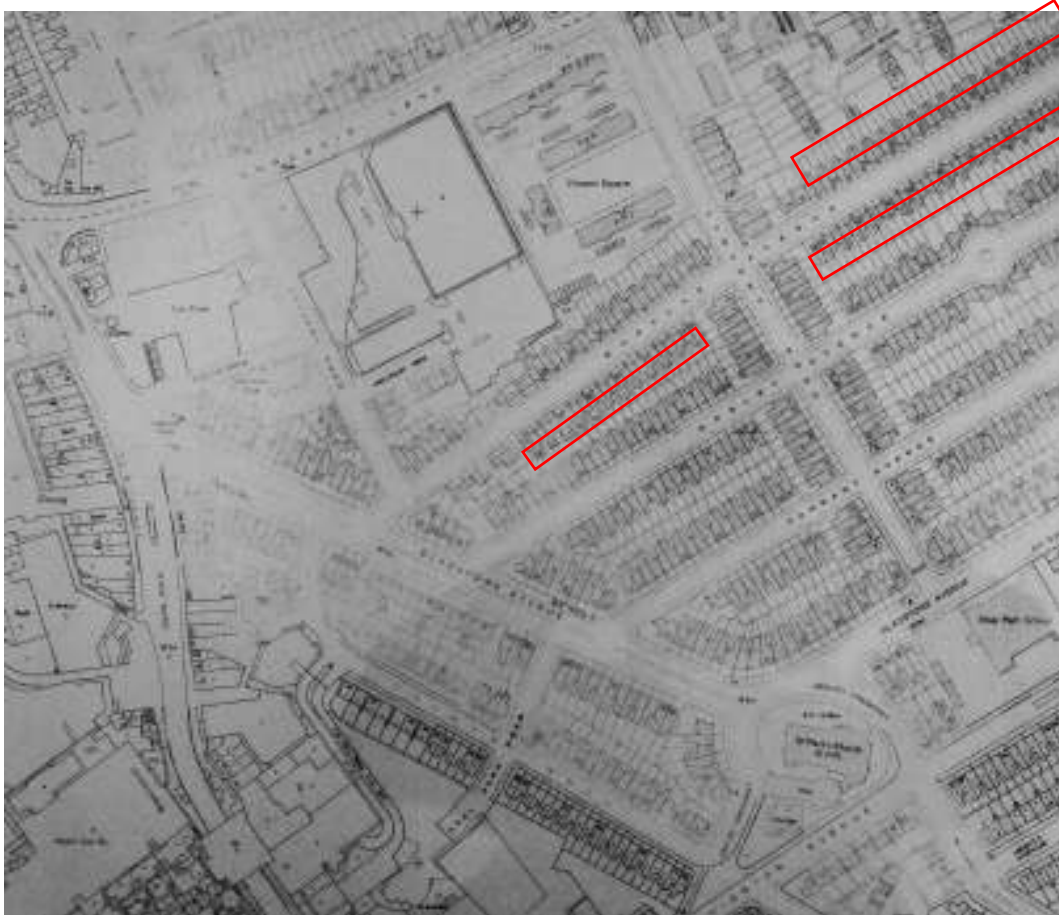
**Figure 26** OS map of 1983. Highlighted areas show the newly developed extensions in c.1970s. Source: Bruce Castle Museum.

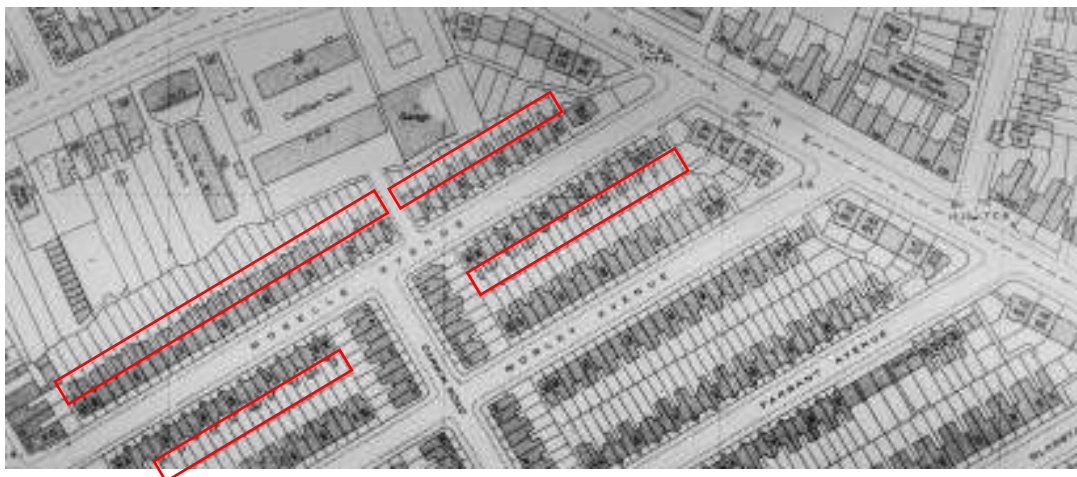
**Figure 27** OS map of 1983. Highlighted areas show the newly developed extensions in c.1970s. Source: Bruce Castle Museum.

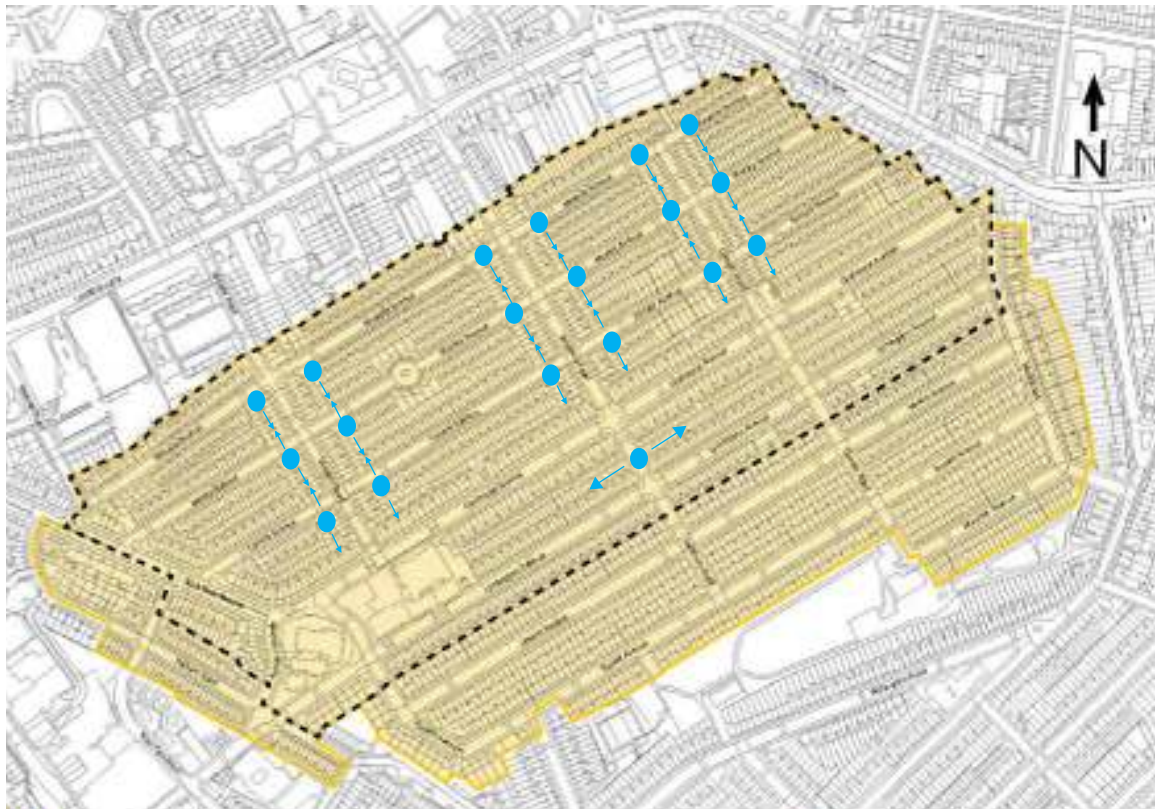
**Figure 31** Viewpoints (blue dots) where the rear extensions could be seen.

Although some parts of the Estate have terraces along the N-S running transverse streets, which screen the view towards rear gardens of properties, many of these later-extensions are still clearly visible from a pedestrian point of view and from key viewpoints (see Figure 31). As shown in Figure 32, some rear gardens are visible from the other side of the terrace when standing at the corners where terraces run in different directions met. The other places where one can see rear gardens are on roads between Gladstone Avenue and Lymington Avenue since there is no horizontal terraces at the junction areas, as Figure 33 demonstrates. These viewpoints highlight the visual significance that rear gardens could contribute to the landscape of the Estate, highlighting the poor designs of these later built extensions.

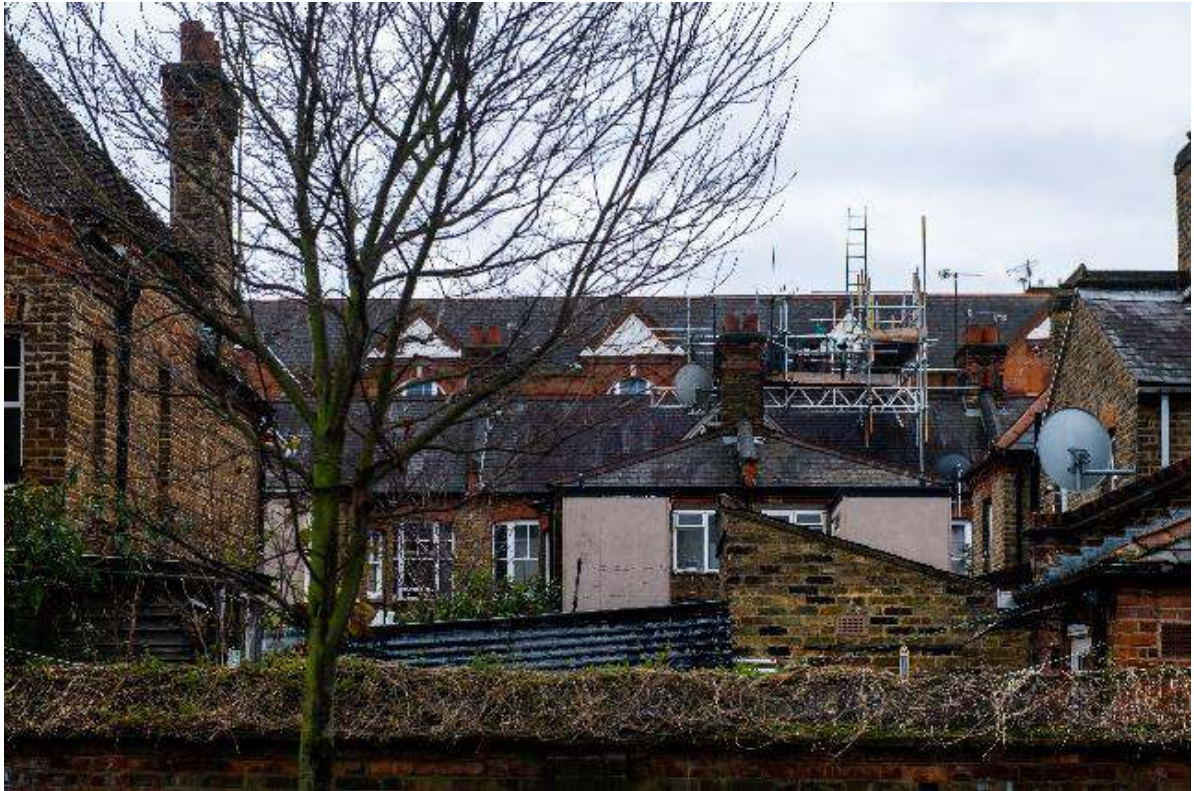
Architecturally, these extensions were built in different ways. The ones shown in Figure 32 and Figure 33 were the most common ones of Gladstone Avenue, which were of 2 storey with a PVC door or window on the first floor. Some of them have been repainted in white, while others retained its original colour. Smaller ones, which were single storey, could be found in the northern part of the Estate, as Figure 35 shows. Here one can also see different types of extensions with different materials, colours, and sizes, leaving the landscape of the rear side of the terraces complicated and inconsistent. In order to build and accommodate these later extensions, original extensions were altered accordingly. Considering the terraces on either side of Gladstone Avenue for example, as Figure 36 and Figure 37 show, some of the original sash windows were replaced by PVC French windows, which were the same material as the windows in the later extension. The decorative brick arches above the original windows were removed as the windows being replaced. These alterations have had a negative impact on the streetviews, creating chaotic elevations of buildings, damaging the character and appearance of the area.

**Figure 32** Looking south from Farrant Avenue, one could easily see the later extensions in the rear gardens of the terrace on Gladstone Avenue. (SLHA@Dec'21).

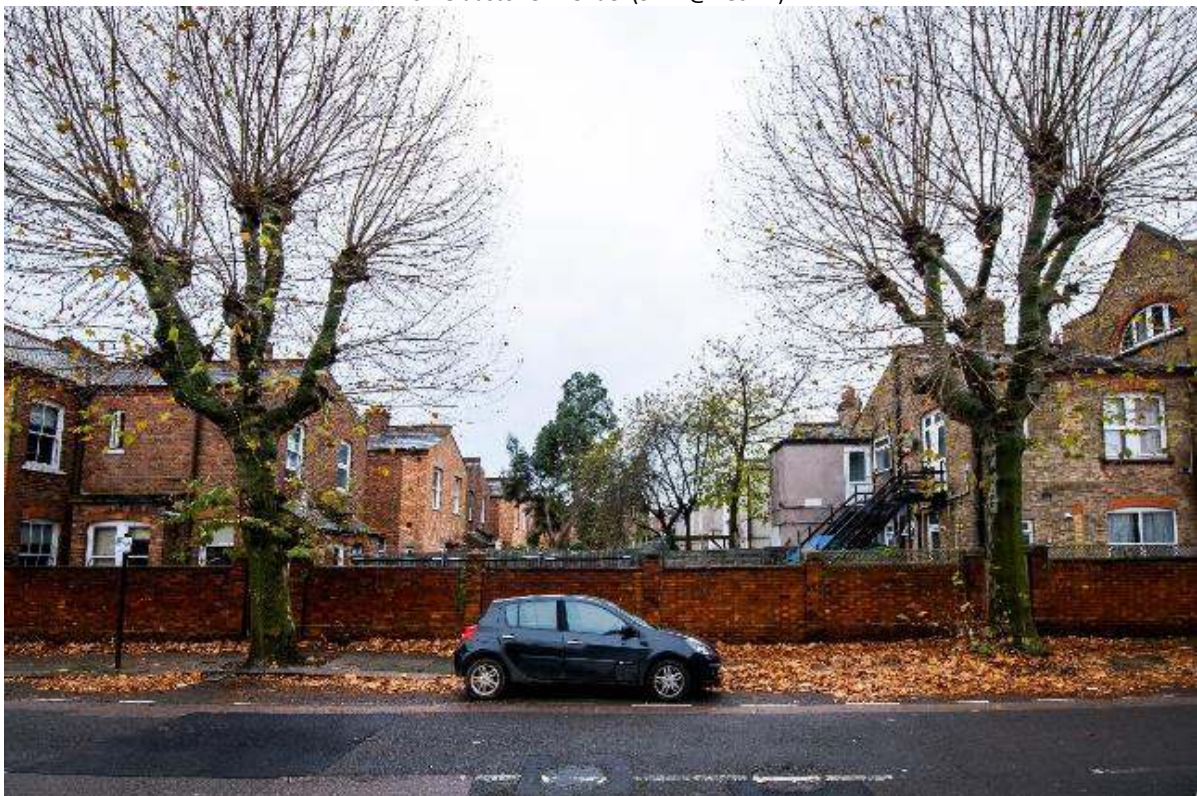
**Figure 33** Looking west from Salisbury Road, one can see the rear gardens of the terraces on Gladstone Avenue and Lymington Avenue. (SLHA@Dec'21).

32, Figure 33, Figure 34, and Figure 35; page 28 to 29), the size, colour, and layout of extant extensions are inconsistent, and such inconsistency has already had its negative impact on the character and appearance of the conservation area. Moreover, it has been identified that some of the existing extensions have asbestos contamination (refer to Design & Access Statement by Ridge; January 2022).

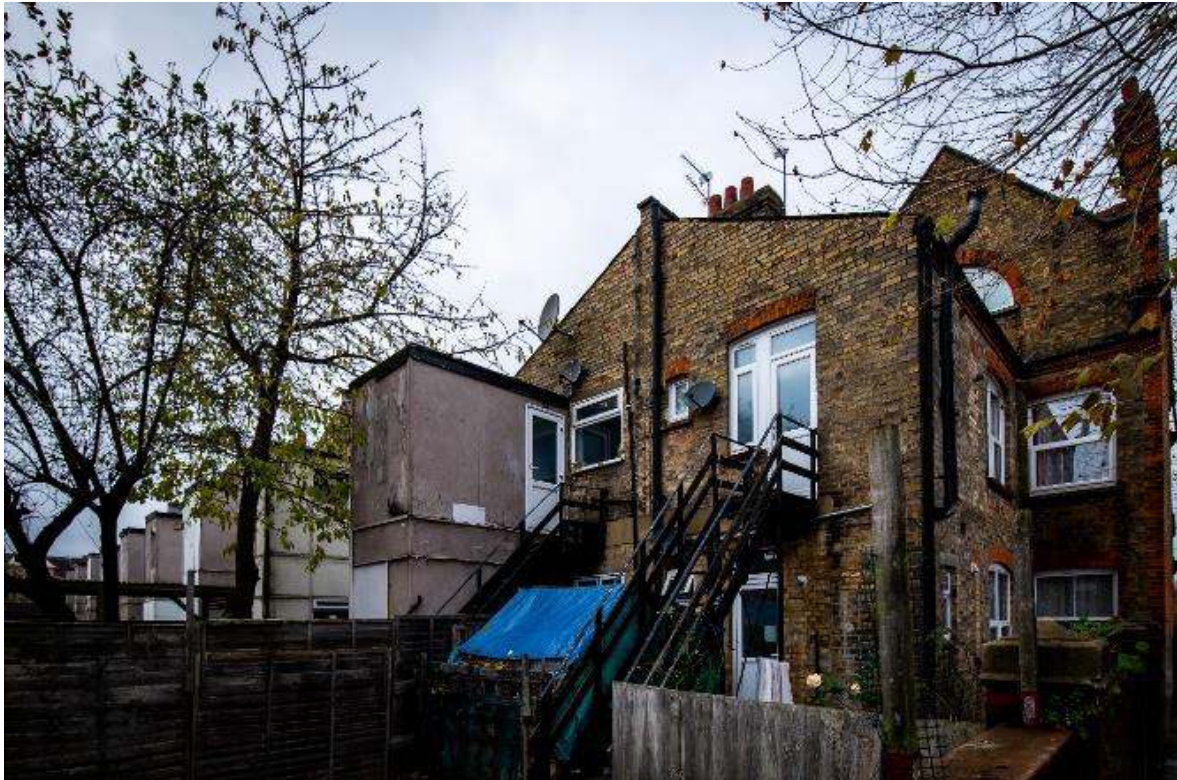
**Figure 34** Rear extensions of the terrace on south Gladstone Avenue, looking west from Salisbury Road. (SLHA@Dec'21).

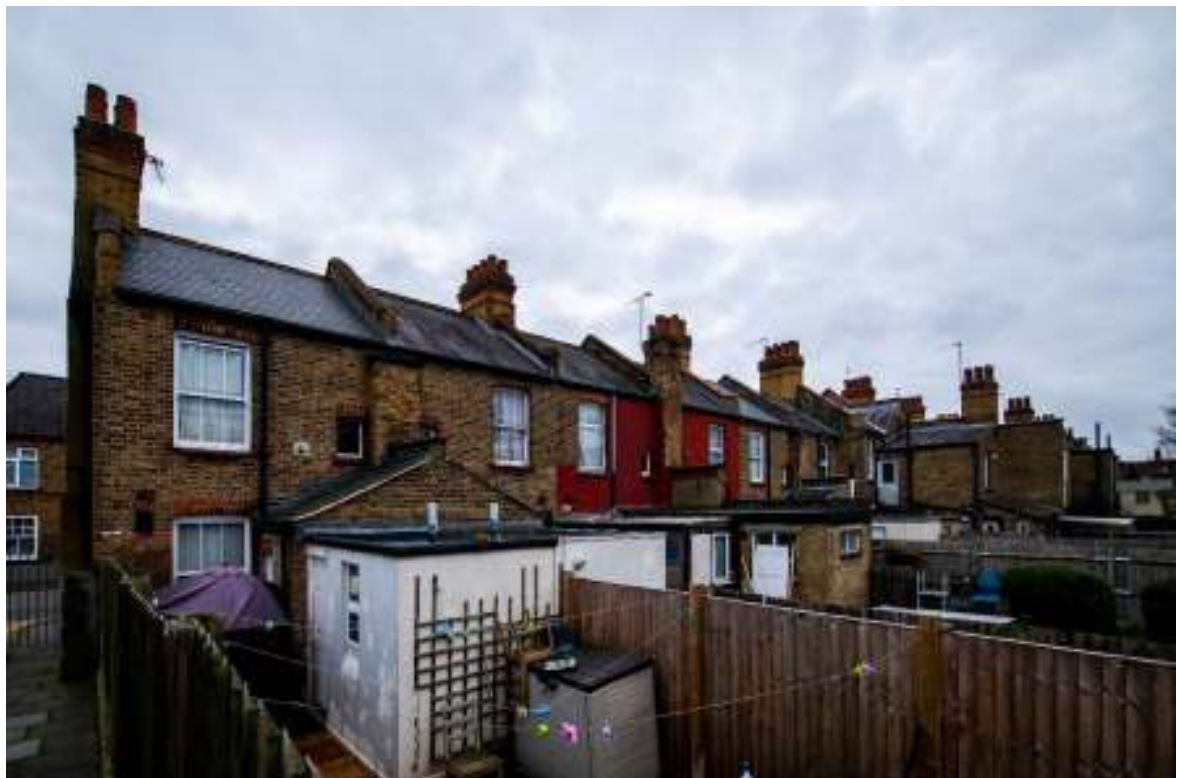
**Figure 35** Looking west from Coldham Ct at the terrace on the north side of Moselle Avenue. (SLHA@Dec'21).

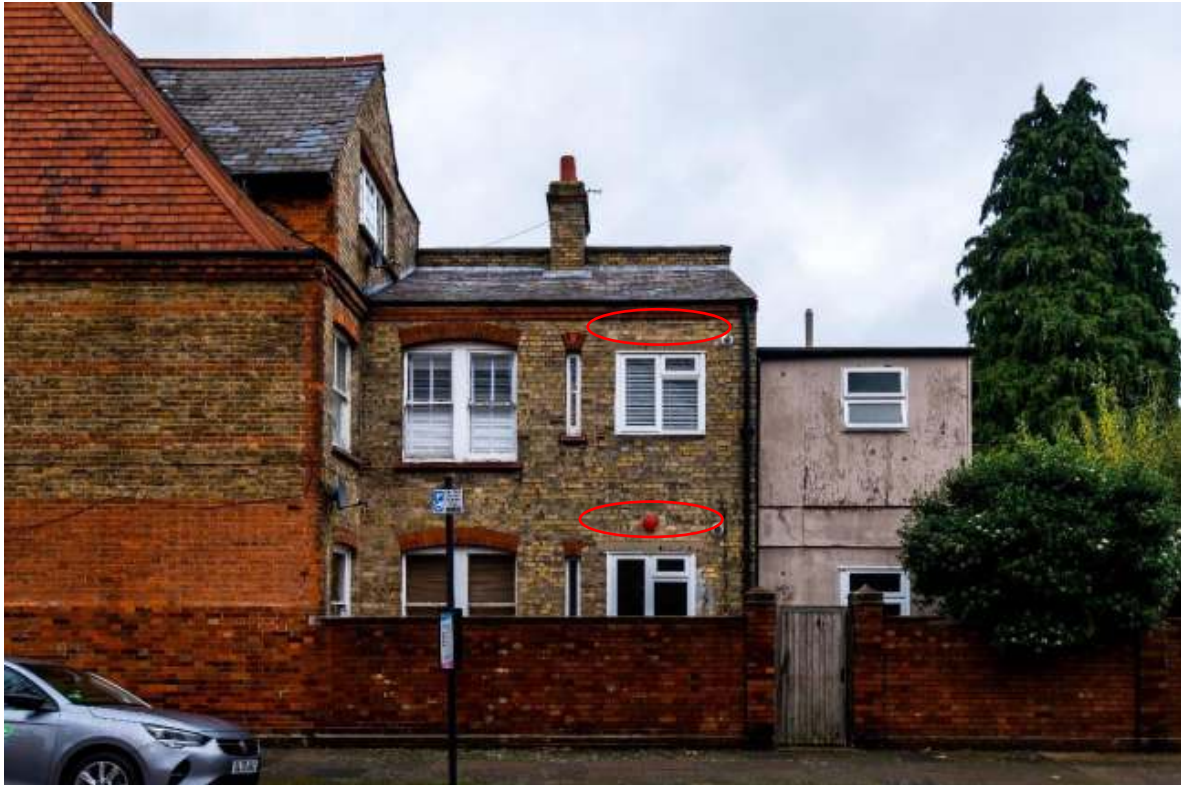
**Figure 36** Rear extensions of the terrace on south Gladstone Avenue, looking east from Salisbury Road. Red circled areas show the alterations made to the windows. (SLHA@Dec'21).

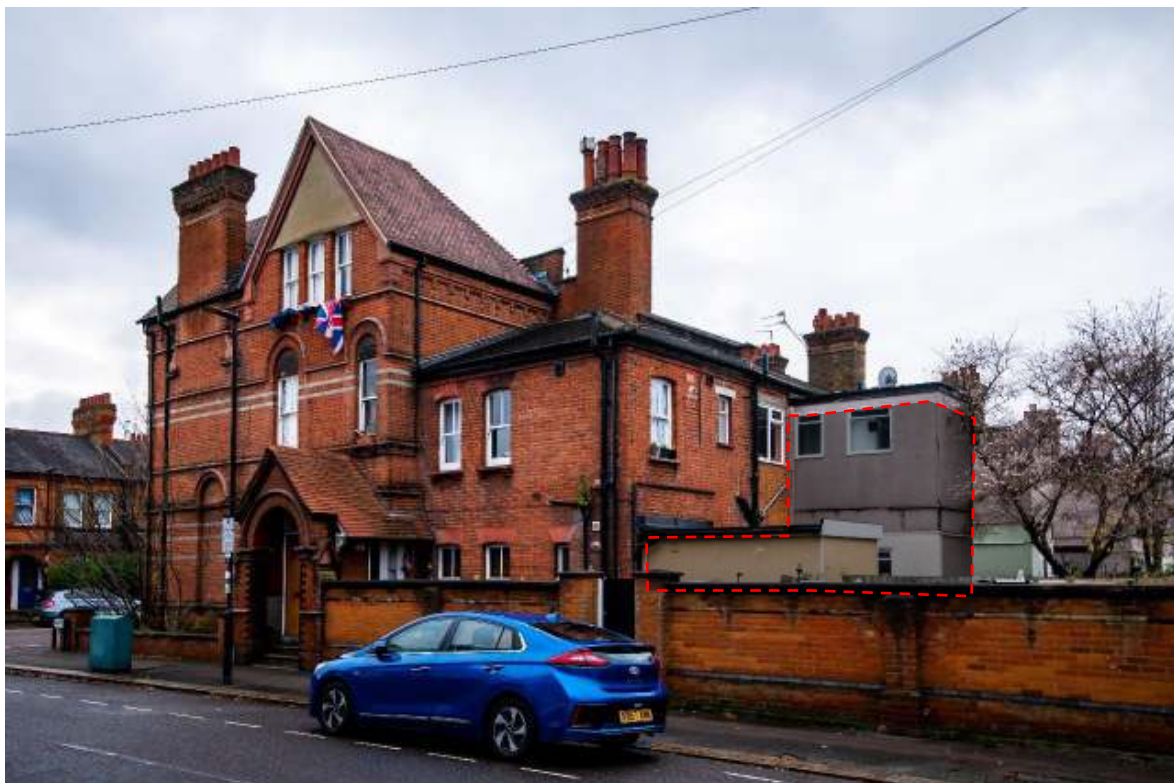
**Figure 37** Rear extensions of the terrace on north Gladstone Avenue, looking west from Darwin Road. Red dashed area shows the extension on the first two properties. Also note the alterations to the original closet wing windows (SLHA@Dec'21).

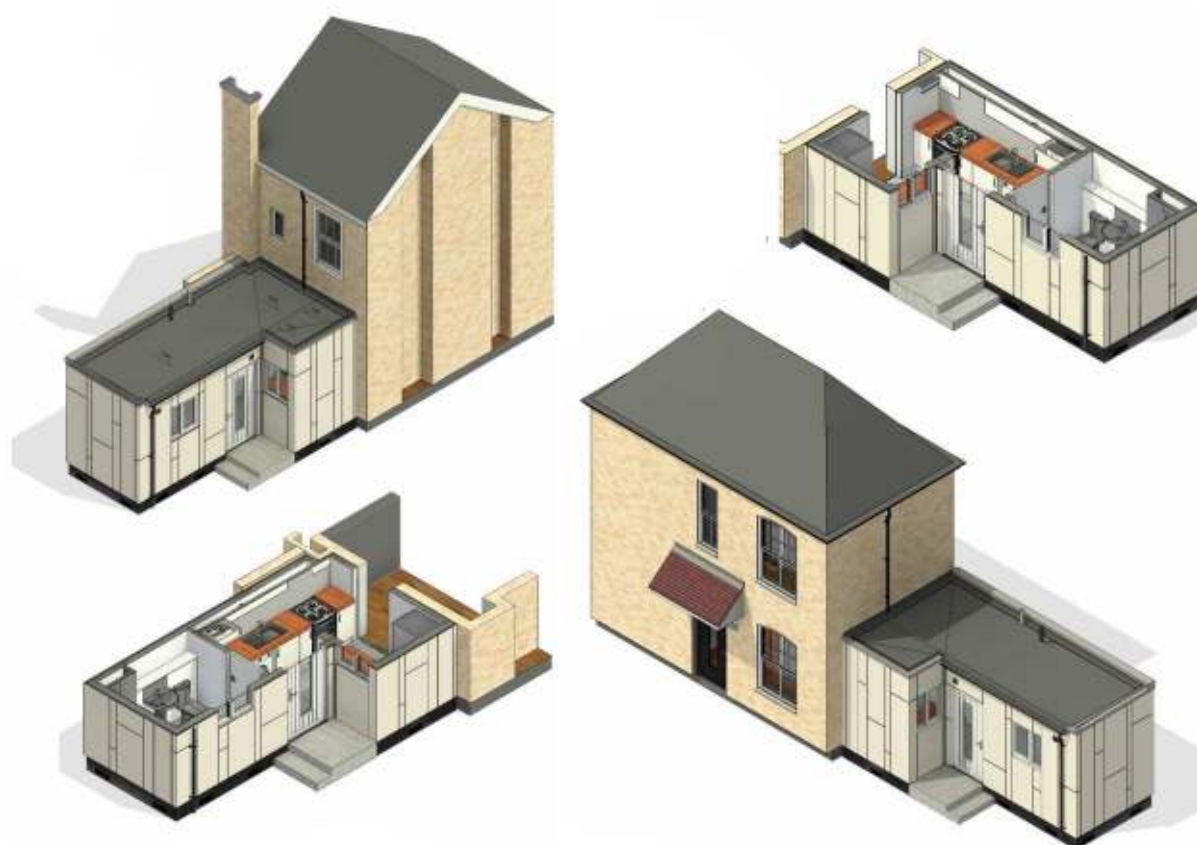
| Type H | Two storey houses with two bedrooms located on the first floor. The property has a modular pod bathroom abutting the rear elevation. | One single-storey extension with a hallway and a bathroom. (See Figure 38) |

**Figure 38:** Proposed rear extensions- Archetype A (left) and Archetype BH (right)

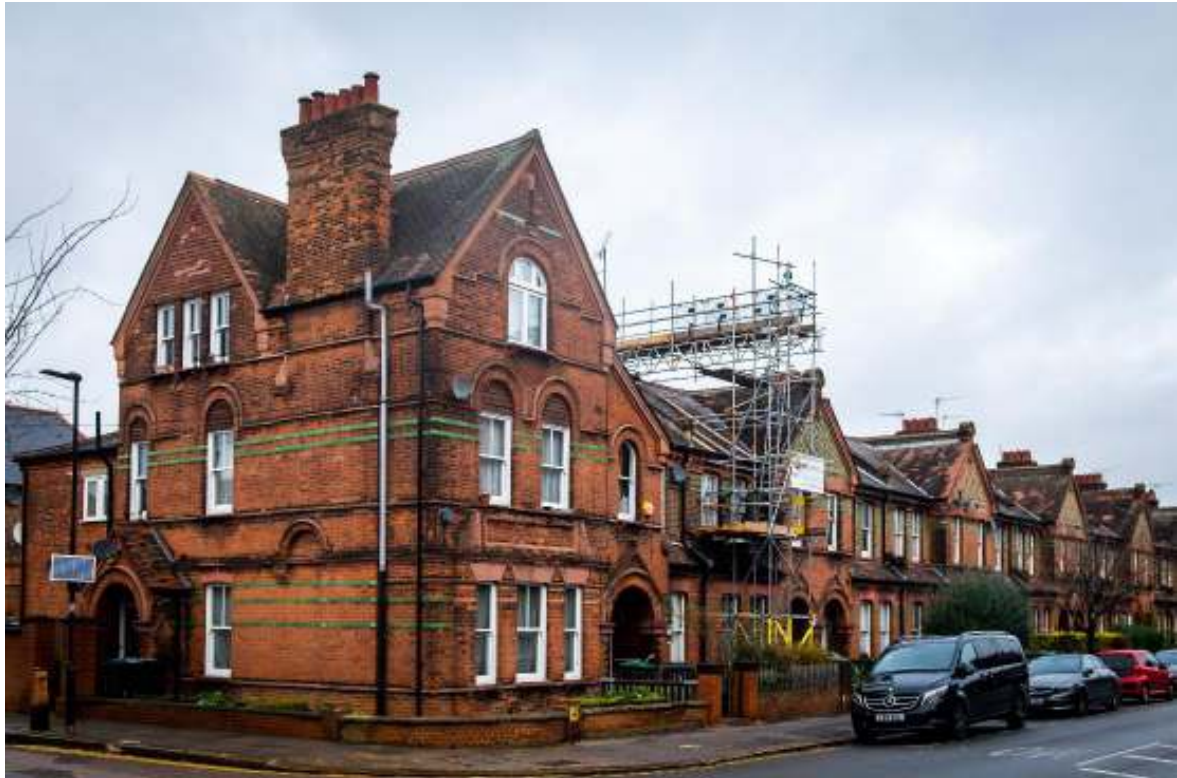
Overall, the properties on the Gladstone Avenue are in a fair-poor state of repair with several defects to the roofs, masonry, windows, and front doors. According to the condition survey reports, the properties' roofs have been repaired respectively, and many slates are in a poor condition with slipped and damaged of different degree, resulting in an inconsistency in the status of each roof (Figure 39). As for the external walls, the front elevations are of traditional construction and are formed from solid masonry. External walls are usually arranged in a Flemish Bond. Damages as well as eroded pointing could be easily observed, and there is water staining and organic growth beneath the leaking gutter joint on the elevations of several buildings. The rear elevations are even more inconsistent because of the different status of the pods and the quality of previous alteration works. While some of them are in a fair status of repair, many of them would need more repair works based on the existing conditions (Figure 40). For the windows, original windows should be timber-sash windows, although some of them have been changed into double-glazed or casement windows with very different status and quality. A few of windows have been repainted while many of them are in a poor condition with timber defects, peeling paint, and loose beads (Figure 41). The same situation could be applied to the front doors where many of them have been altered and repaired by individual owners respectively.

**Figure 39.** The inconsistent status of roofs of the houses on Gladstone Avenue are inconsistent with each other. Source: SLHA@Dec'21.

As a result, the proposed works are to repair the defects collectively to improve the appearance and character of Gladstone Avenue as the most significant street in the conservation area. Roofs, brickworks, and masonry would be repaired collectively to retain a sense of consistency, while windows and doors would be repaired to match existing styles. With improved materials and sympathetic design, the repair works are expected to enhance the Estate's historic character as well as its sustainability in terms of energy efficiency.

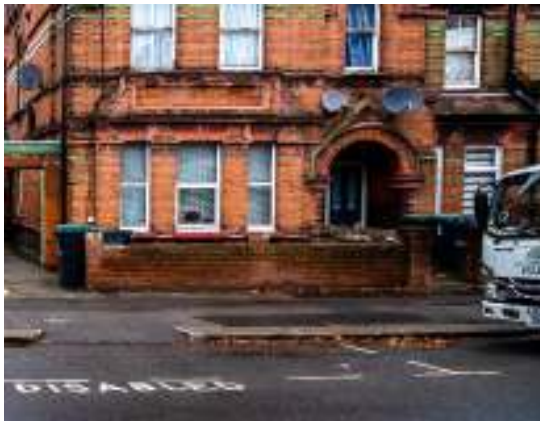
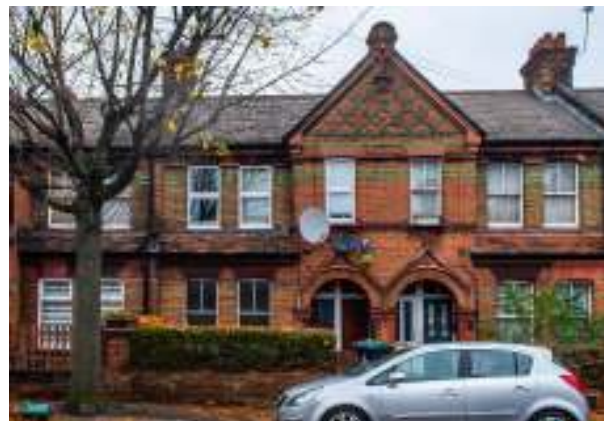
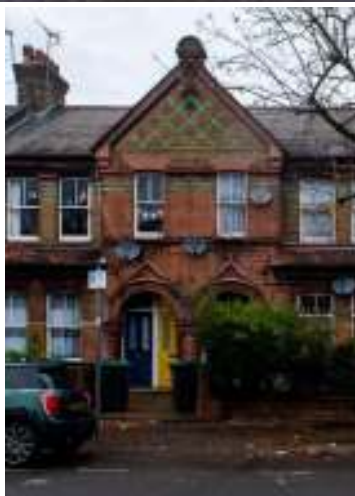
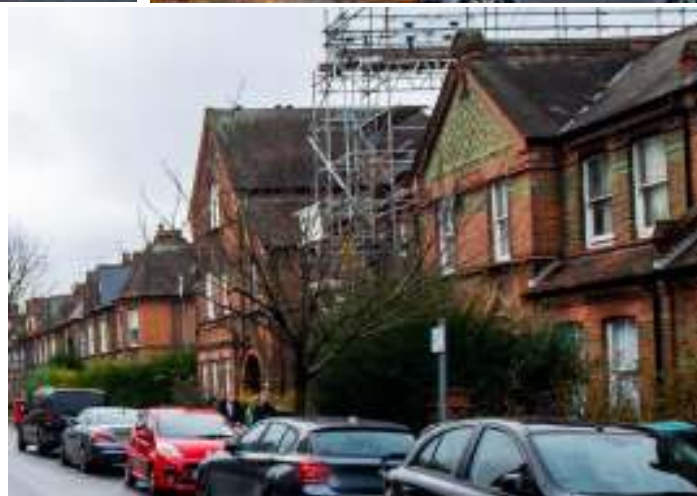
**Figure 40.** Examples of the status of external walls where damages could be easily observed. Source: SLHA@Dec'21.

Brick masonry which is the principal construction material in the estate, with an innovative use of red bricks and stock bricks contributing to the architectural interest and character of the conservation area as a whole. Patch repairs and re-pointing are required across the properties for repairs to masonry elevations, parapet walls, chimneys, etc. These are proposed to be undertaken using like for like materials to match the existing, in line with best conservation practice.

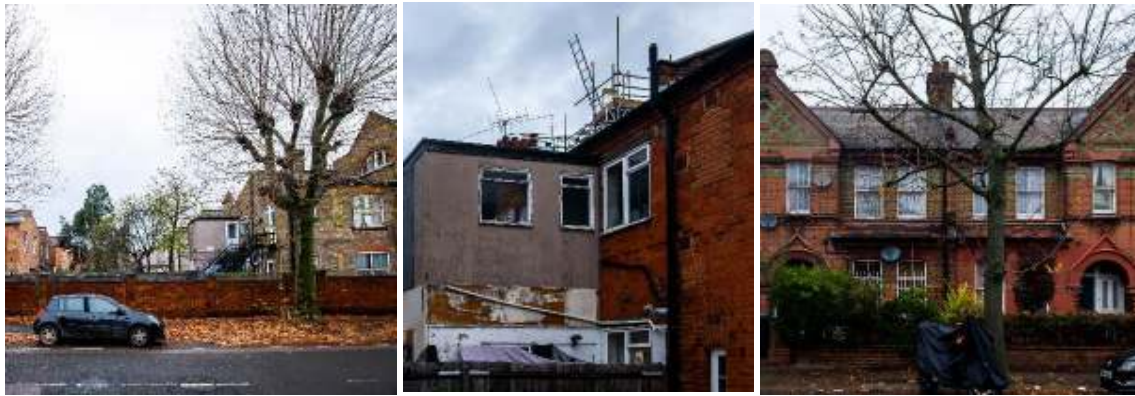
**Figure 41.** Several examples of the status of windows which need to be repaired. Source: SLHA@Dec'21.

The design and detailing of fenestration, their rhythmic arrangement and relationship with the façade/streetscape as a whole, are considered as a significant contribution to the streetscape. Originally, the estate was conceived with uniform door and window designs (respective to each type of house/street) with timber panelled (painted) front doors and traditionally designed timber sash windows. Due to the effects of weathering and owing to their considerable age, many window and door frames are effected by rot and beyond economical repair.

The proposed repair works to the windows would not change their design or detailing and will be like for like, aside from the introduction of double glazing. As for the front doors, those which have been significantly affected by rot would be replaced with painted timber doors of matching design and

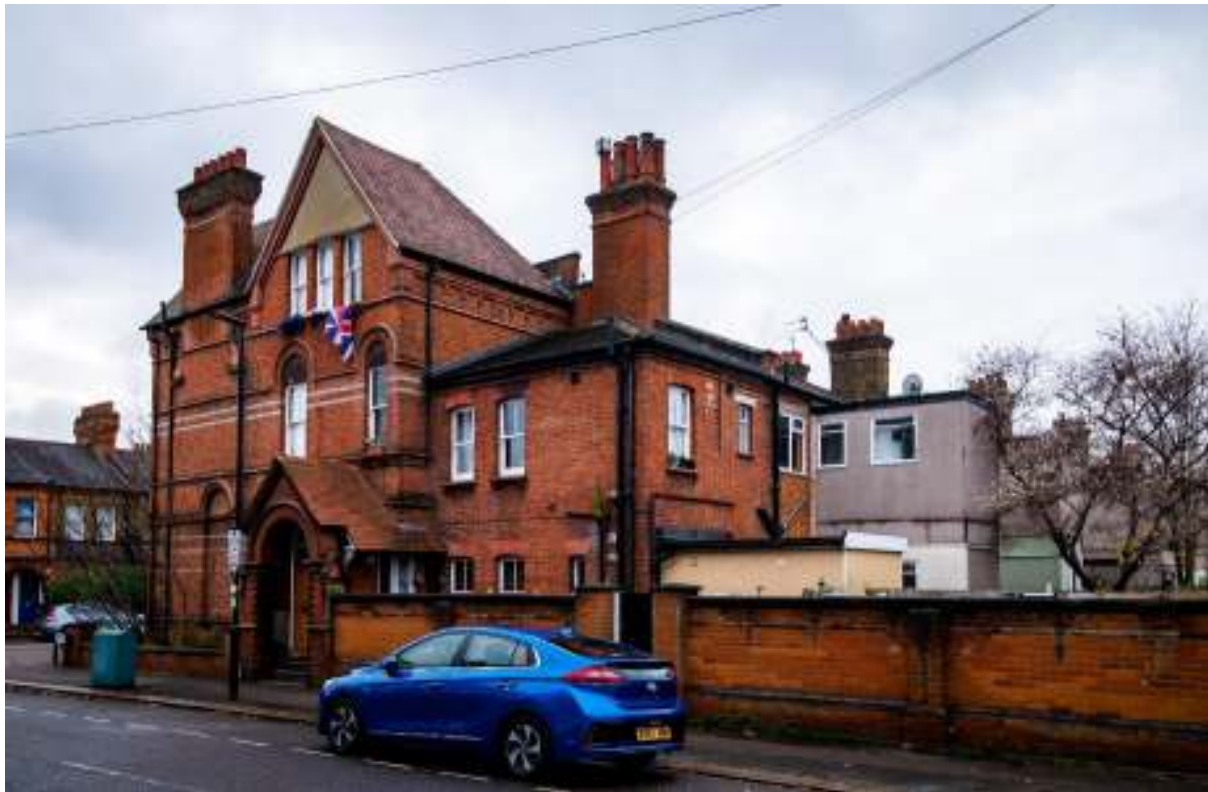
**Figure 43:** View of rear extensions along the north side of Gladstone Avenue. Their design and detailing is characteristically modern and in contrast with the architectural character of the host building. However, due to their uniformity and almost ubiquitous nature within the CA, they add another layer to the historic and architectural significance of the conservation area as a whole. However due to their age, weathering and relatively non-permanent construction, they appear to have served their lifespan and are in need of replacement.

Considering the existing pods in a poor state of repair and design, these proposals are an opportunity not only to improve the character and appearance of the conservation area but also the sustainability of the historic environment. The proposed extensions have been designed to be low maintenance and utilise materials that do not require the protection of paints/coatings to prevent deterioration. This reduces both the public cost and inconvenience to residents through the life of the installed modular pods.

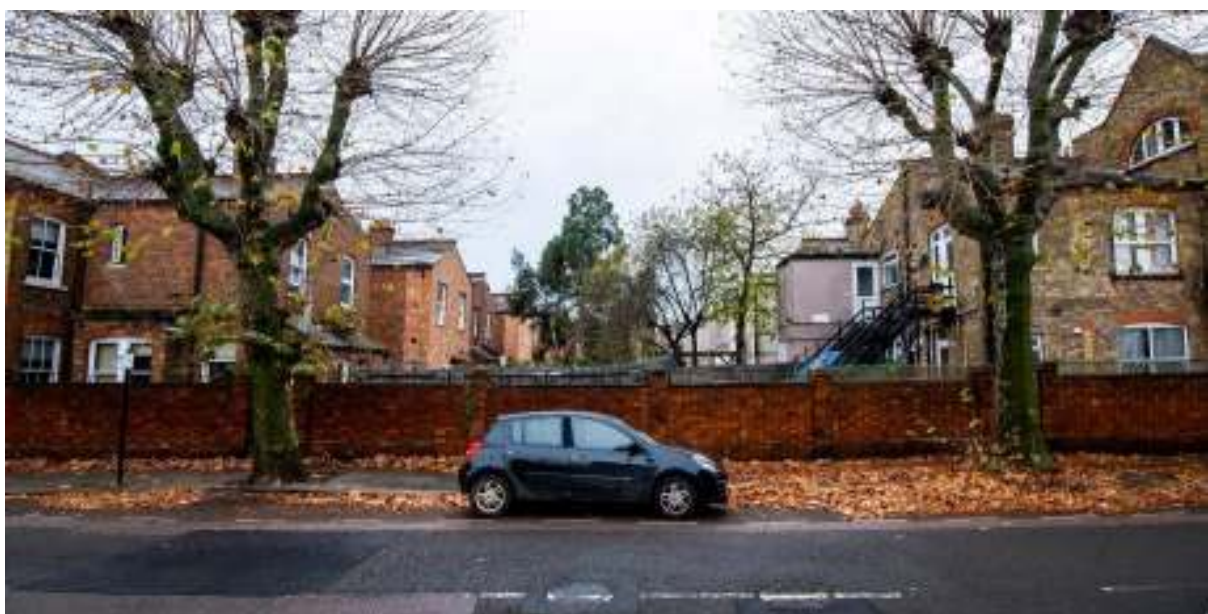
**Figure 44:** View of the rear extensions along the south side of Gladstone Avenue taken from Salisbury Road.
