# Noel Park, London, N22

## Heritage Statement

### Baseline, Character & Significance Appraisal and Proposed Works

**Noel Park, N22 – Heritage Statement**

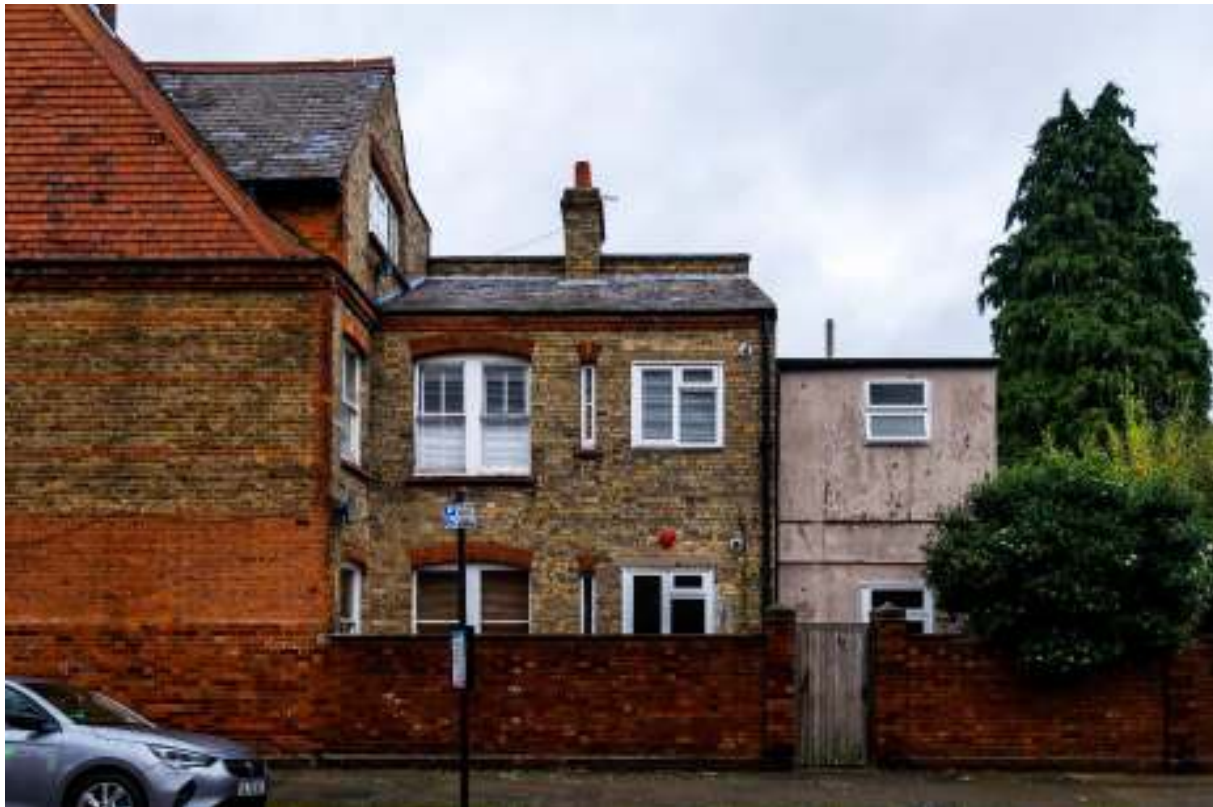
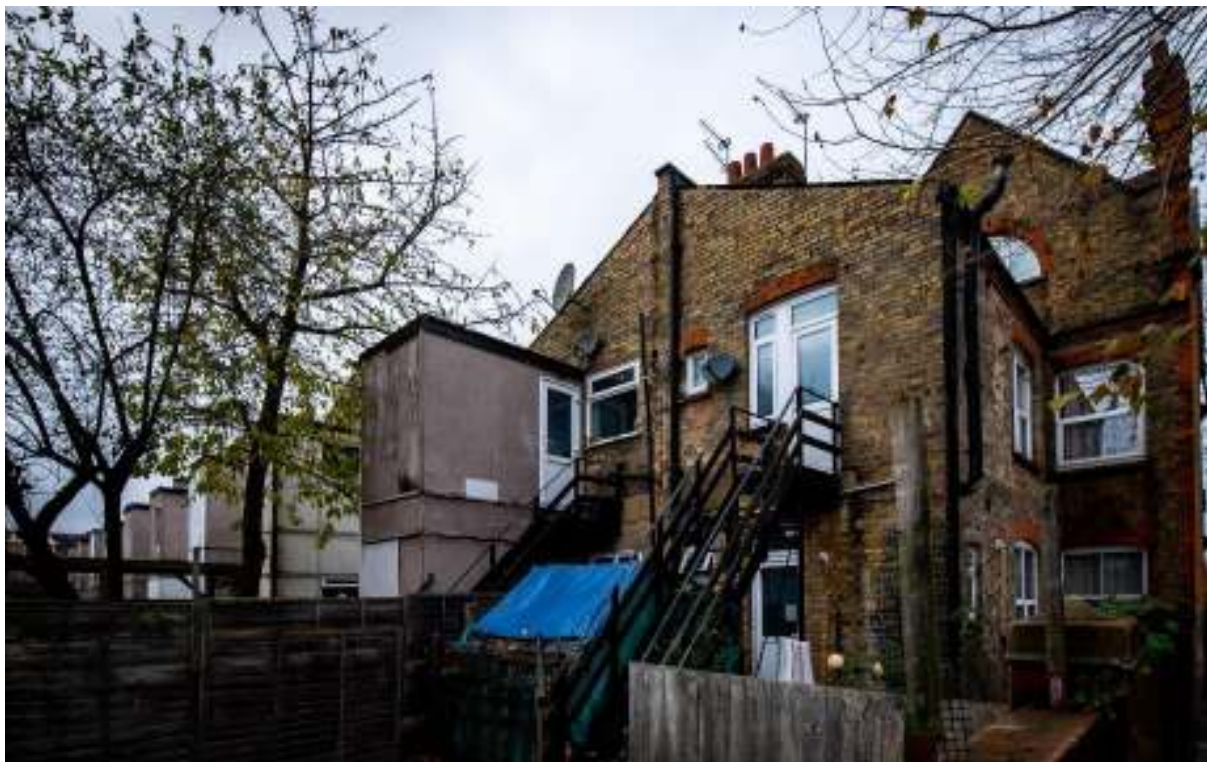
**Figure 45:** (top and above) Rear extensions seen in the context of the host house. Note how the existing extensions are not in keeping with the architectural character, design or materiality of the host house; however due to their age (most extensions date from the 1950s-60s) and uniformity (almost identical extensions with minor permutations are seen in the CA), they represent another distinct layer of architectural activity within the CA. However due to their relatively poor construction and materials, they have reached their end of life and require to be replaced.

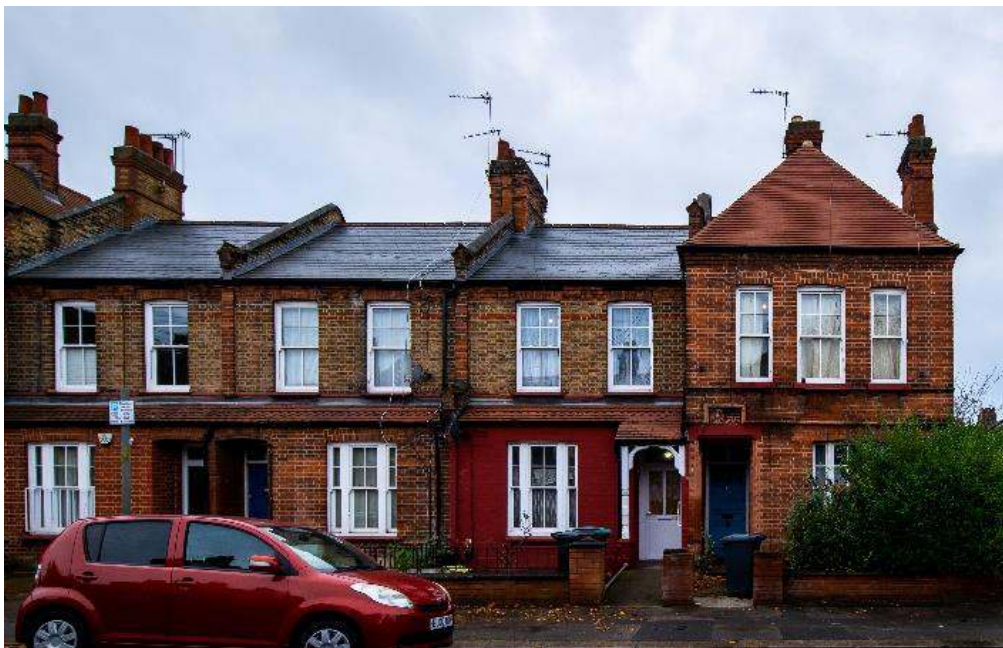
**Figure 46** A picture of the south elevation of the terrace on Moselle Avenue. (SLHA@Dec'21).

Throughout the estate, many properties have been either altered or repaired in a way that doesn't reflect the original design or materials, including painting, pebble dashing or cladding of facades, replacing windows, and removing, enclosing or replacing porches (see Figure 19, Figure 46, and Figure 47). These works have had adversely impacted the original character of the Estate.

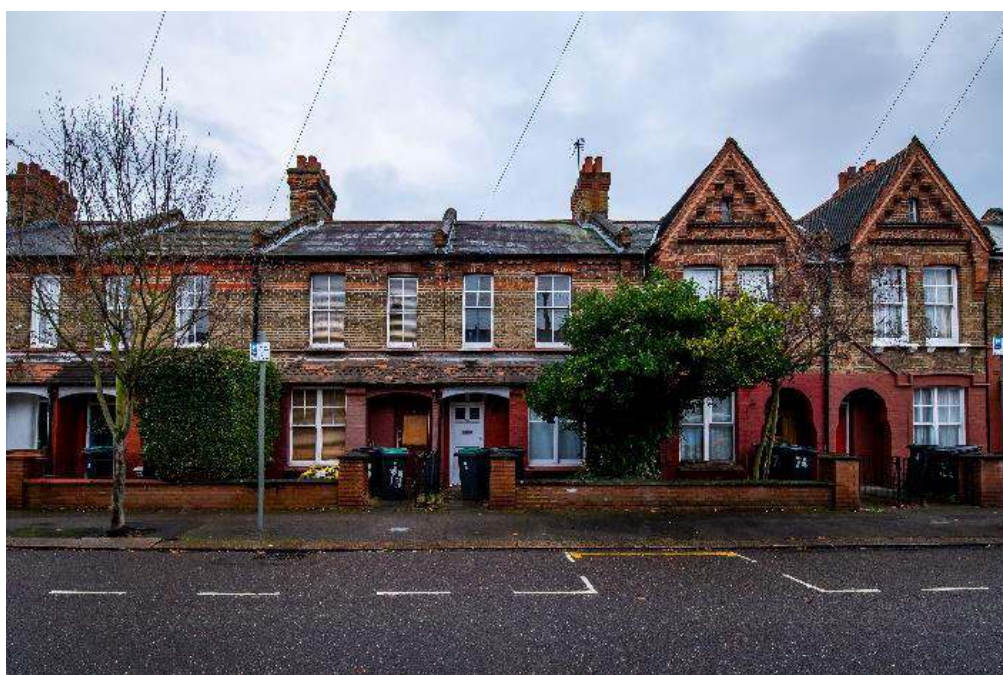
**Figure 47** Another picture of the south elevation of the terrace on Moselle Avenue. (SLHA@Dec'21).

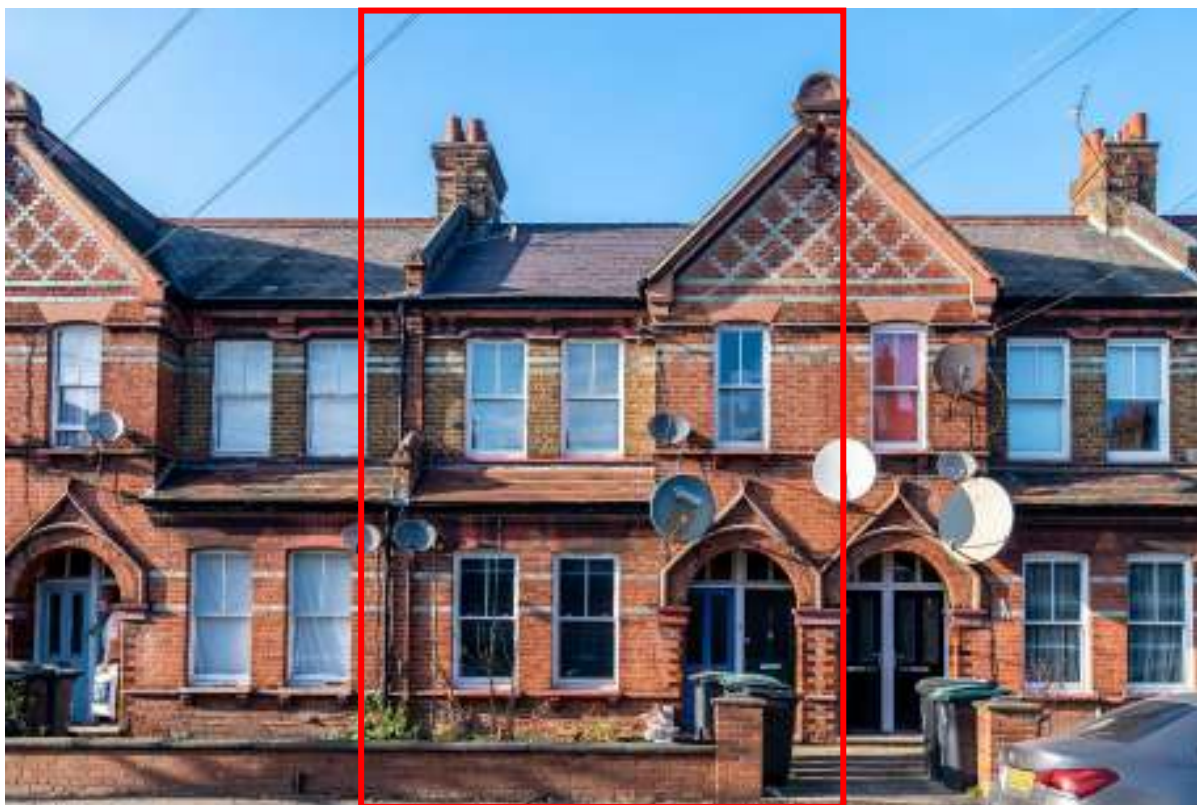
**Figure 49** The existing appearance of nos. 183 & 183A (highlighted in red).

The current state of nos.183 & 183 A is fairly depicted in Figure 49. The roof slates appear to have been replaced in the past. The brickwork on the facade has weathered and requires cleaning. Although the windows are in fair condition, some frame components require repainting. The doors exhibit varying colours and designs due to unsuitable replacements. It is important to note that the rainwater gutter above the ground floor has defects due to wear and tear, and poor maintenance, and this may be the cause of the dampness observed in the window lintels (brick) and the decorative brick cornice beneath the gutter.

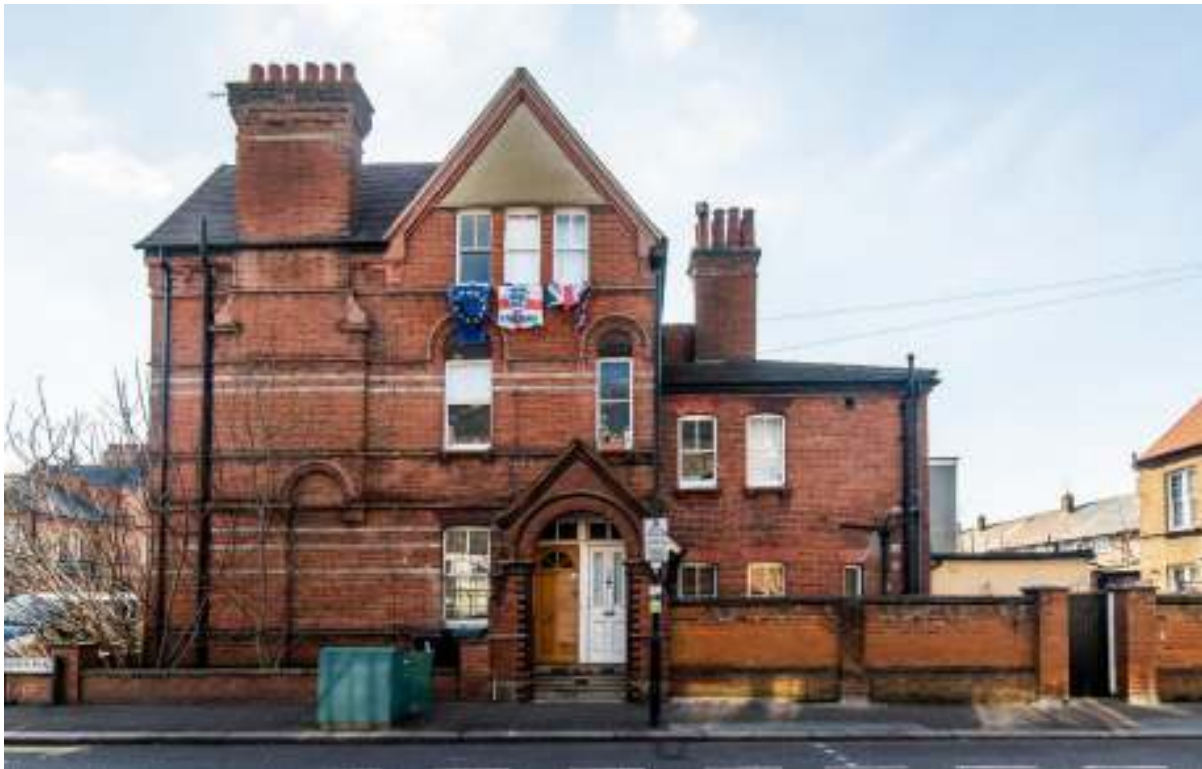
**Figure 50** The east elevation of nos. 221 & 221A (highlighted in red).

Although the property boasts significant architectural details and is prominently visible, it is in poor condition and requires extensive repairs. The roof, comprised of both Welsh and clay slates, has

incurred damage to some of its slates. The brickworks on the façade has been affected by weathering and require cleaning and repointing. The windows exhibit an inconsistent style, with some appearing original while others have been replaced with unsuitable designs. Additionally, the doors display varying designs and colours due to previous replacements.

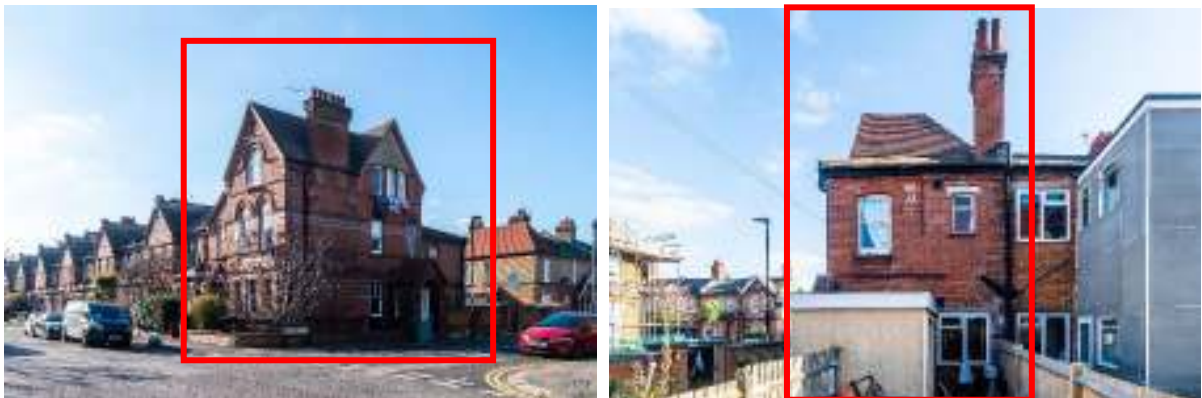
**Figure 51** The photos showing the south elevation(left) and the north elevation(right) of nos. 221 & 221A (highlighted in red).

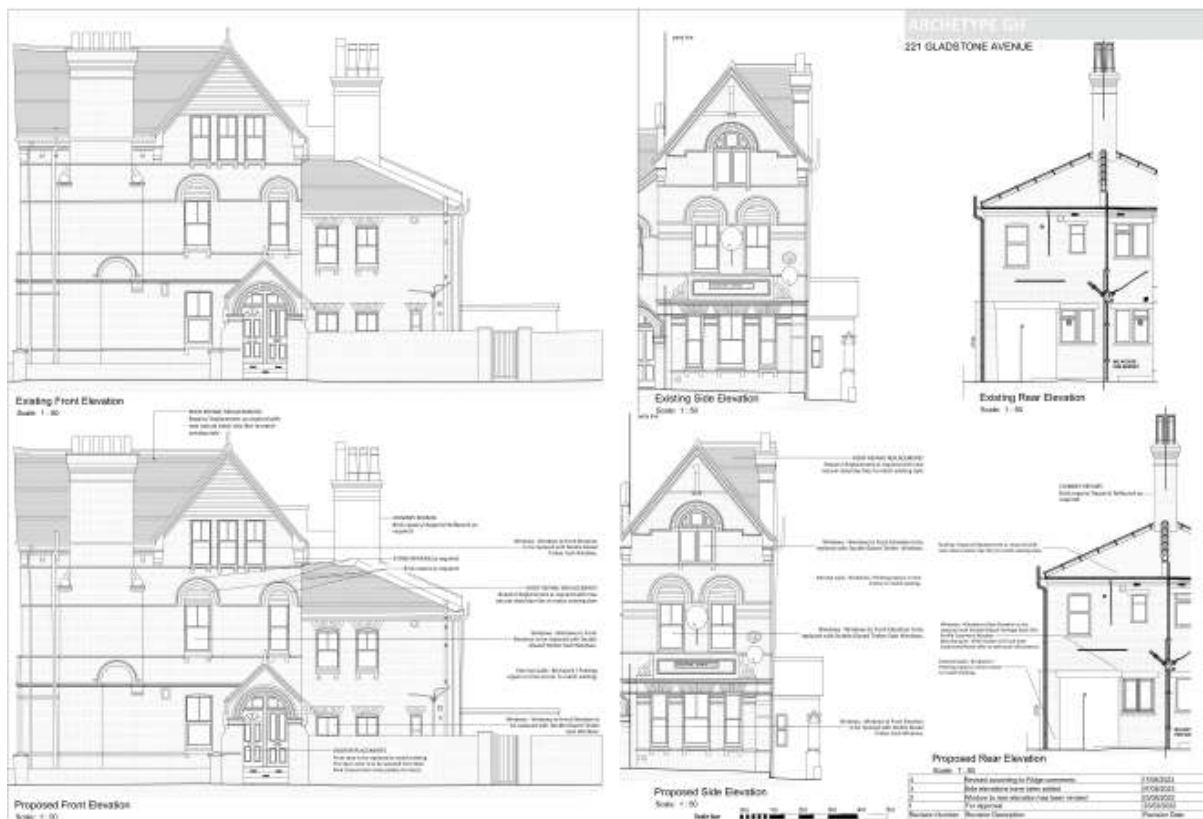
While the mentioned buildings differ in their appearance, the underlying principle of repair remains consistent to address the similar defects they are facing. As evident in Figure 52 and Figure 53, the proposed works encompass various elements, encompassing the repair of the roof, external brickwork, and the replacement of windows and the entrance door. The deteriorated roof/clay slates will be replaced with new appropriate ones to match the existing material. Comprehensive cleaning, repair, and re-pointing will be conducted on all elevations' brickwork wherever necessary. Regarding the windows, most of the units will be replaced with double-glazed counterparts designed to harmonise with the present form. Similarly, the entrance doors will undergo an enhancement aimed at bolstering energy efficiency, incorporating double-glazing and adopting a historically appropriate colour. These revisions align with the recommendations set forth in the Noel Park Conservation Area Appraisal and Management Plan, ensuring the proposed modifications uphold the heritage and aesthetic integrity of the area.

**Figure 53** The drawing showing the proposed works for nos.221 & 221A, Gladstone Avenue.
