PROJECT  
Braemar Avenue, Wood Green

DRAWING TITLE  
Proposed Elevation A

STATUS  
Planning Application

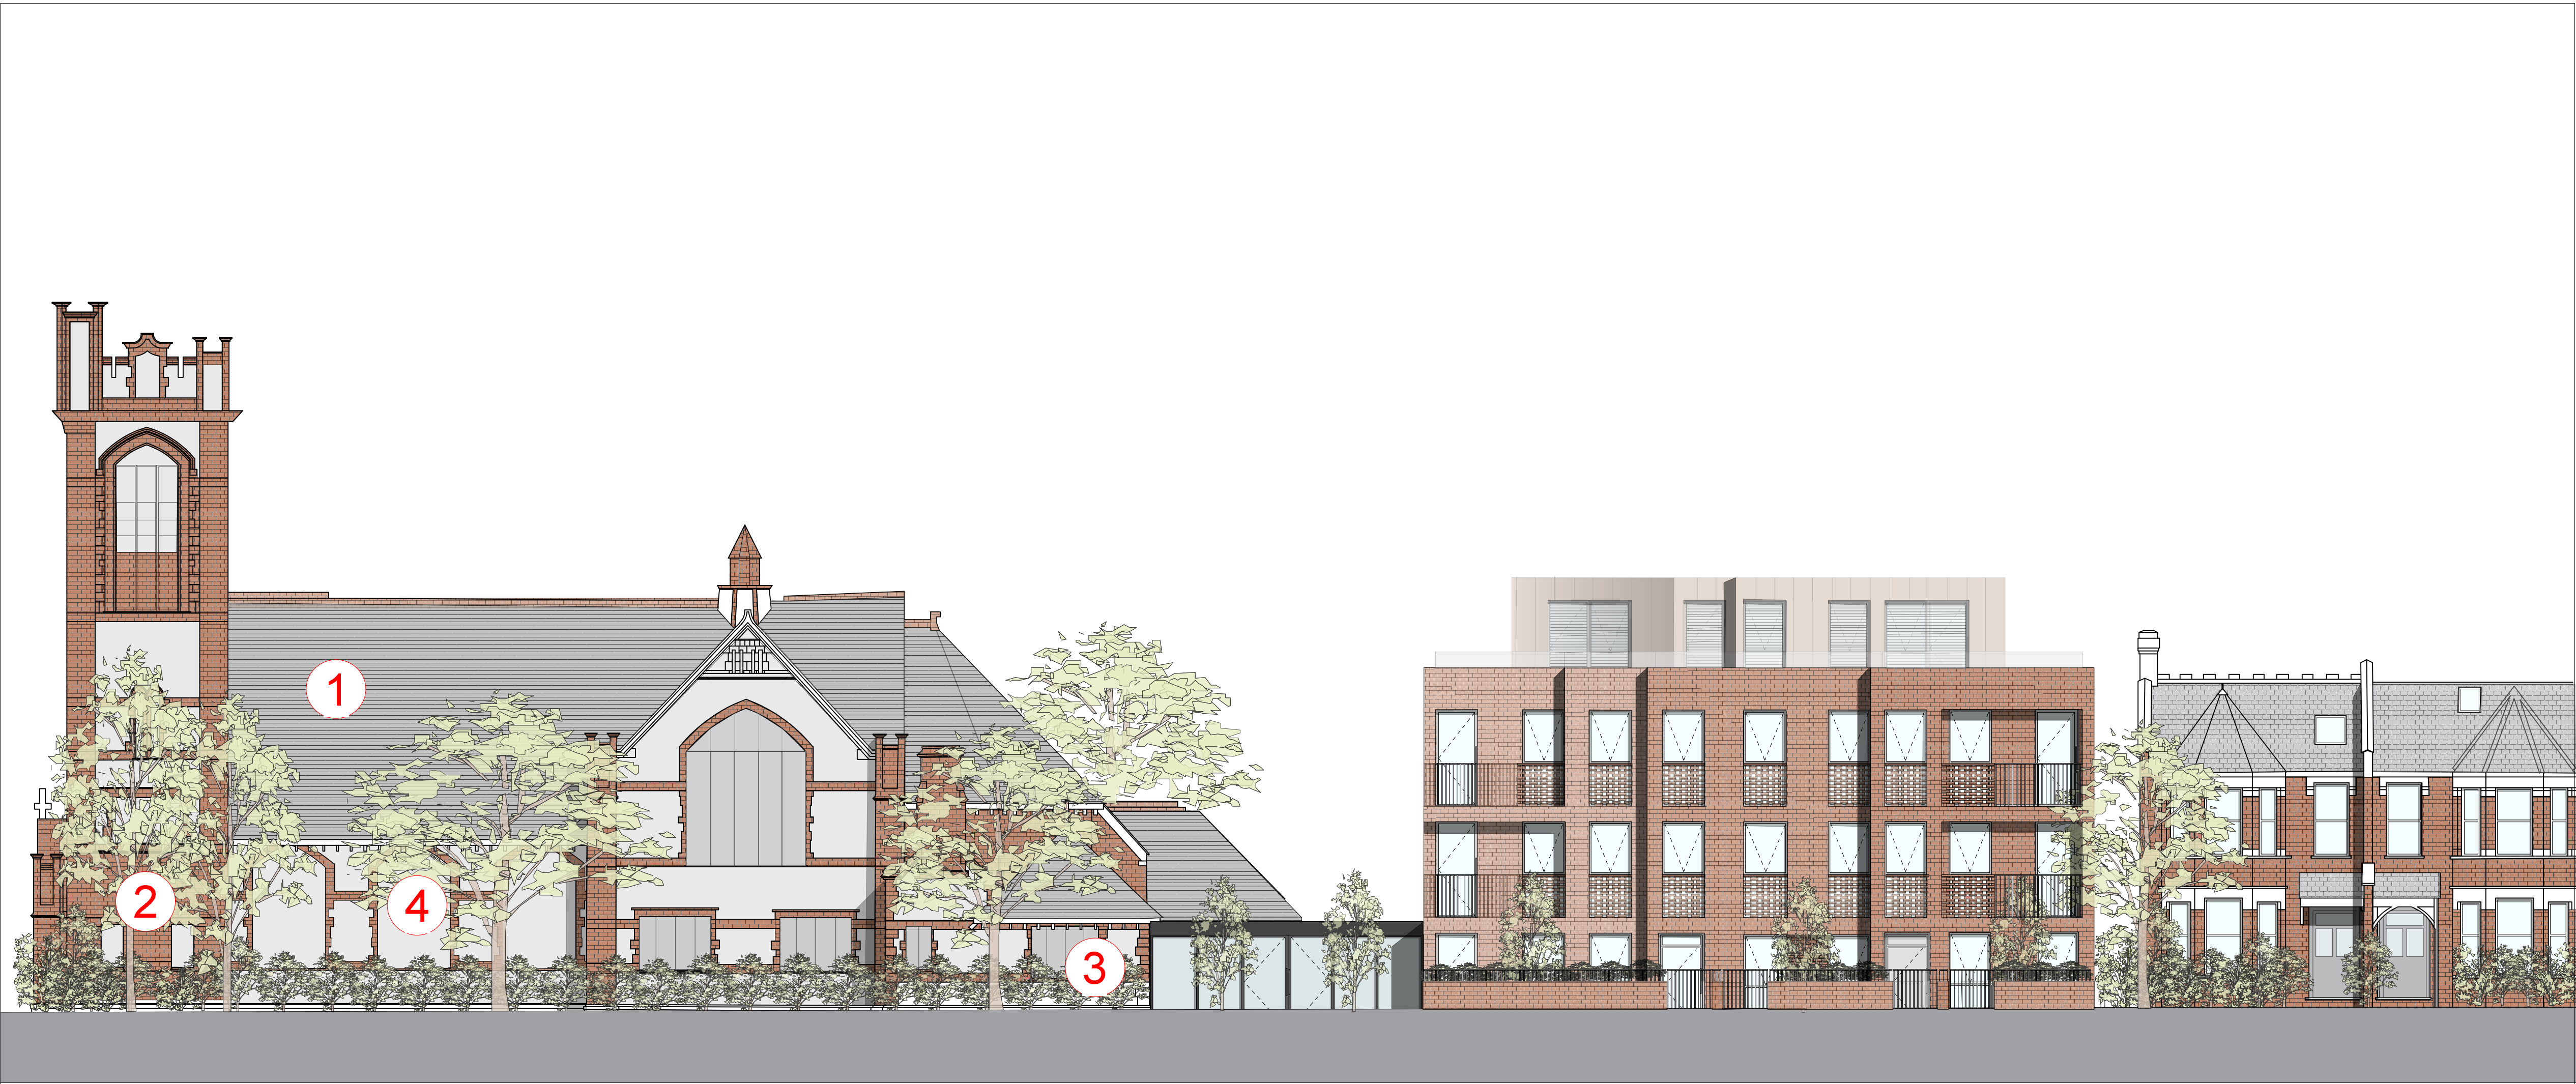
Church Works

- 1. Repairs to the existing roof where required including leak repairs and replacing missing terracota crestings
- 2. Cleaning of external elevations
- 3. Hard and soft landscaping
- 4. Stone/ Brickwork restoration where required. Like for like brickwork would be laid to match the surrounding bond, using mortar with flush joints
