# LEVEL MONITORING

## for SMS (AVI, PRE)

**27 Waltheof Avenue, London, N17 7PL**

| Our Ref: | M25919 |

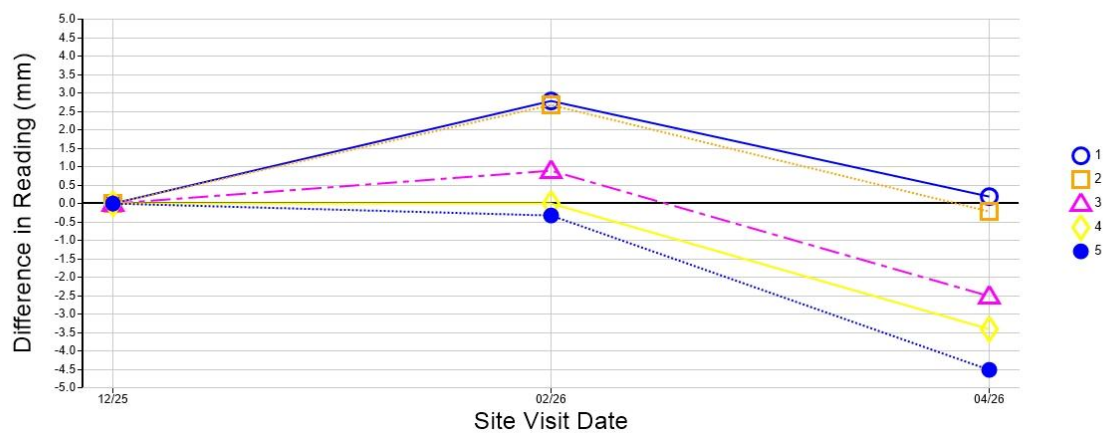
## Level Monitoring Difference Graphs

The following graphs display the progressive movement that each Level Monitoring Station recorded at each separate site visit date to give an overall look at how much the property is moving.

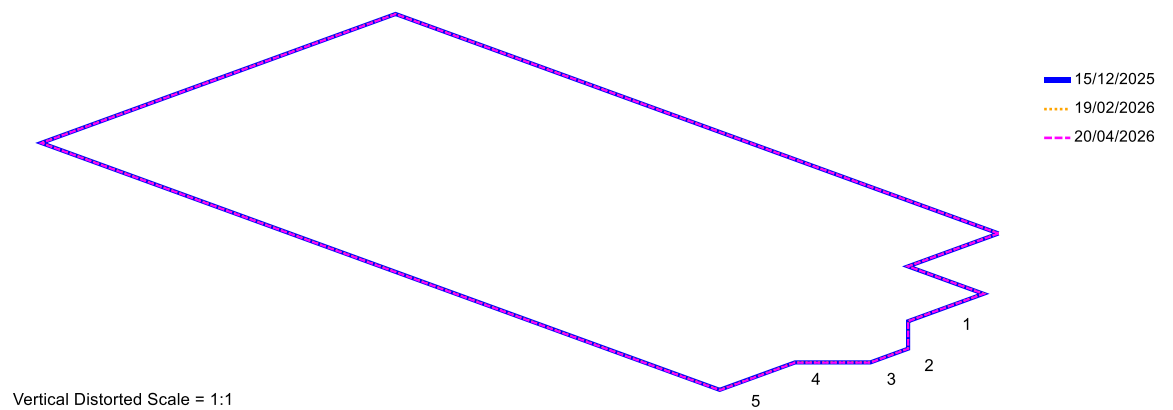
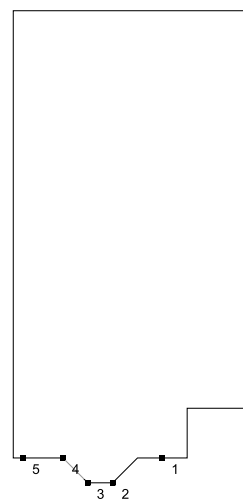
## Level Monitoring Displacement Map

The following image shows an isometric representation of the movement of the property, based on the Level Monitoring Stations that were installed.

FRONT
