Project Name: NGET Tottenham

Client: National Grid Property Holdings Limited

## Appendix B. Site photographs

## Appendix C. NET recovery and dip data

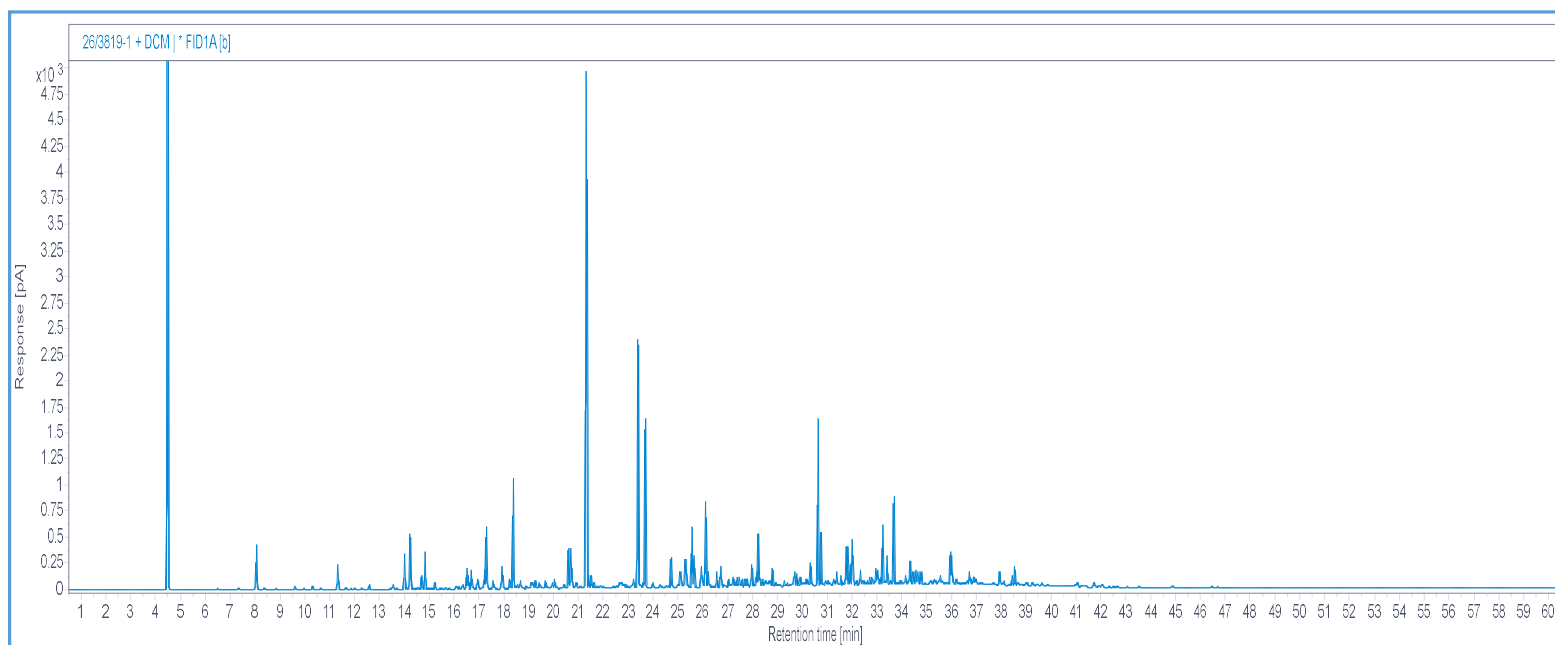
#### Chromatogram:

**Interpretation:** Coal Tar

\*The age of release estimated in this report is based on the nC<sub>17</sub>/pristane ratio only as prescribed by Christensen and Larsen (1993) and Kaplan, Galperin, Alimi et al., (1996). Age estimation should be treated with caution as it can be influenced by site specific factors of which the laboratory is not aware.

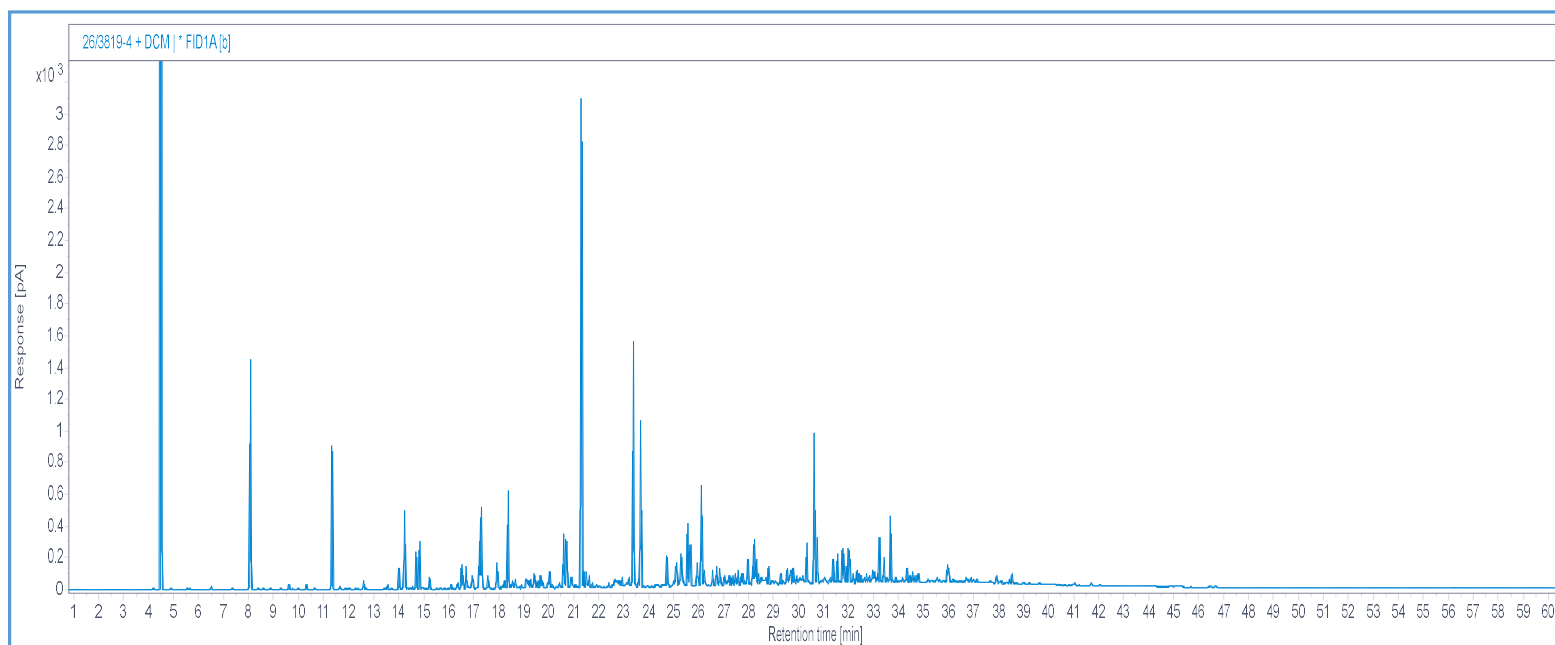
#### Chromatogram:

**Interpretation:** Coal Tar

\*The age of release estimated in this report is based on the nC<sub>17</sub>/pristane ratio only as prescribed by Christensen and Larsen (1993) and Kaplan, Galperin, Alimi et al., (1996). Age estimation should be treated with caution as it can be influenced by site specific factors of which the laboratory is not aware.
