# LEVEL MONITORING

## for SMS (AVI, PRE)

**123 Morley Avenue, London, N22 6NP**

## Level Monitoring Readings

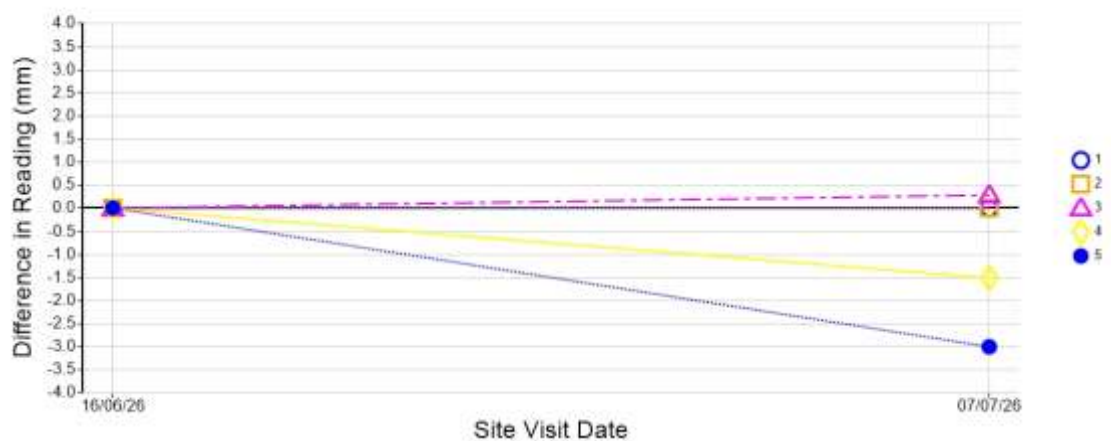
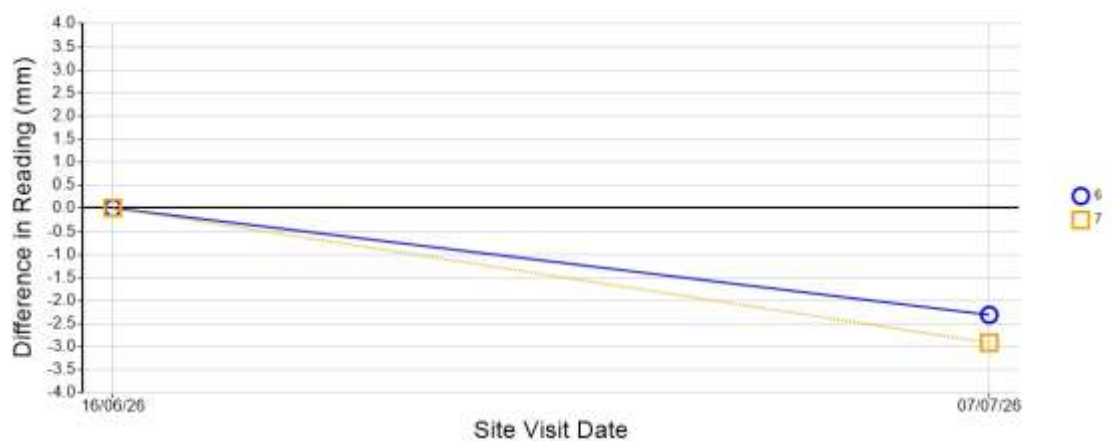
## Level Monitoring Difference Graphs

The following graphs display the progressive movement that each Level Monitoring Station recorded at each separate site visit date to give an overall look at how much the property is moving.

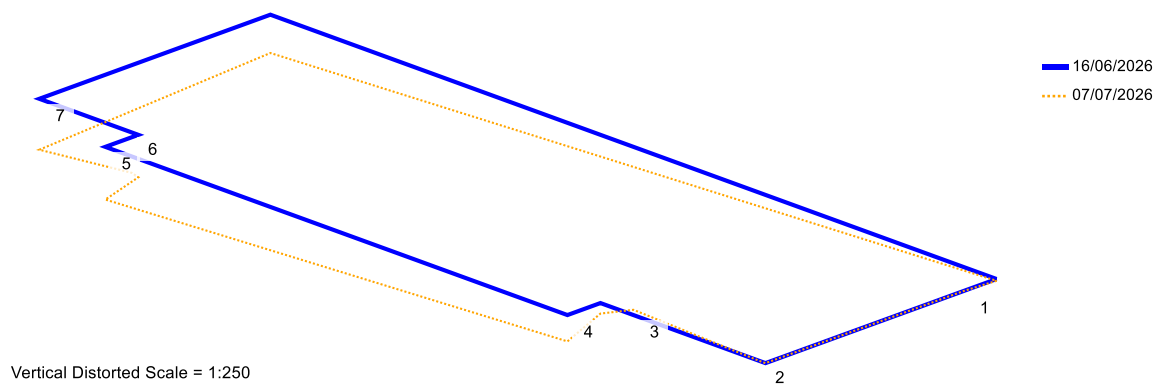
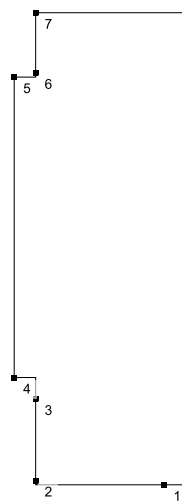
## Level Monitoring Displacement Map

The following image shows an isometric representation of the movement of the property, based on the Level Monitoring Stations that were installed.

FRONT
