1 **Second Floor**  
Scale: 1:50

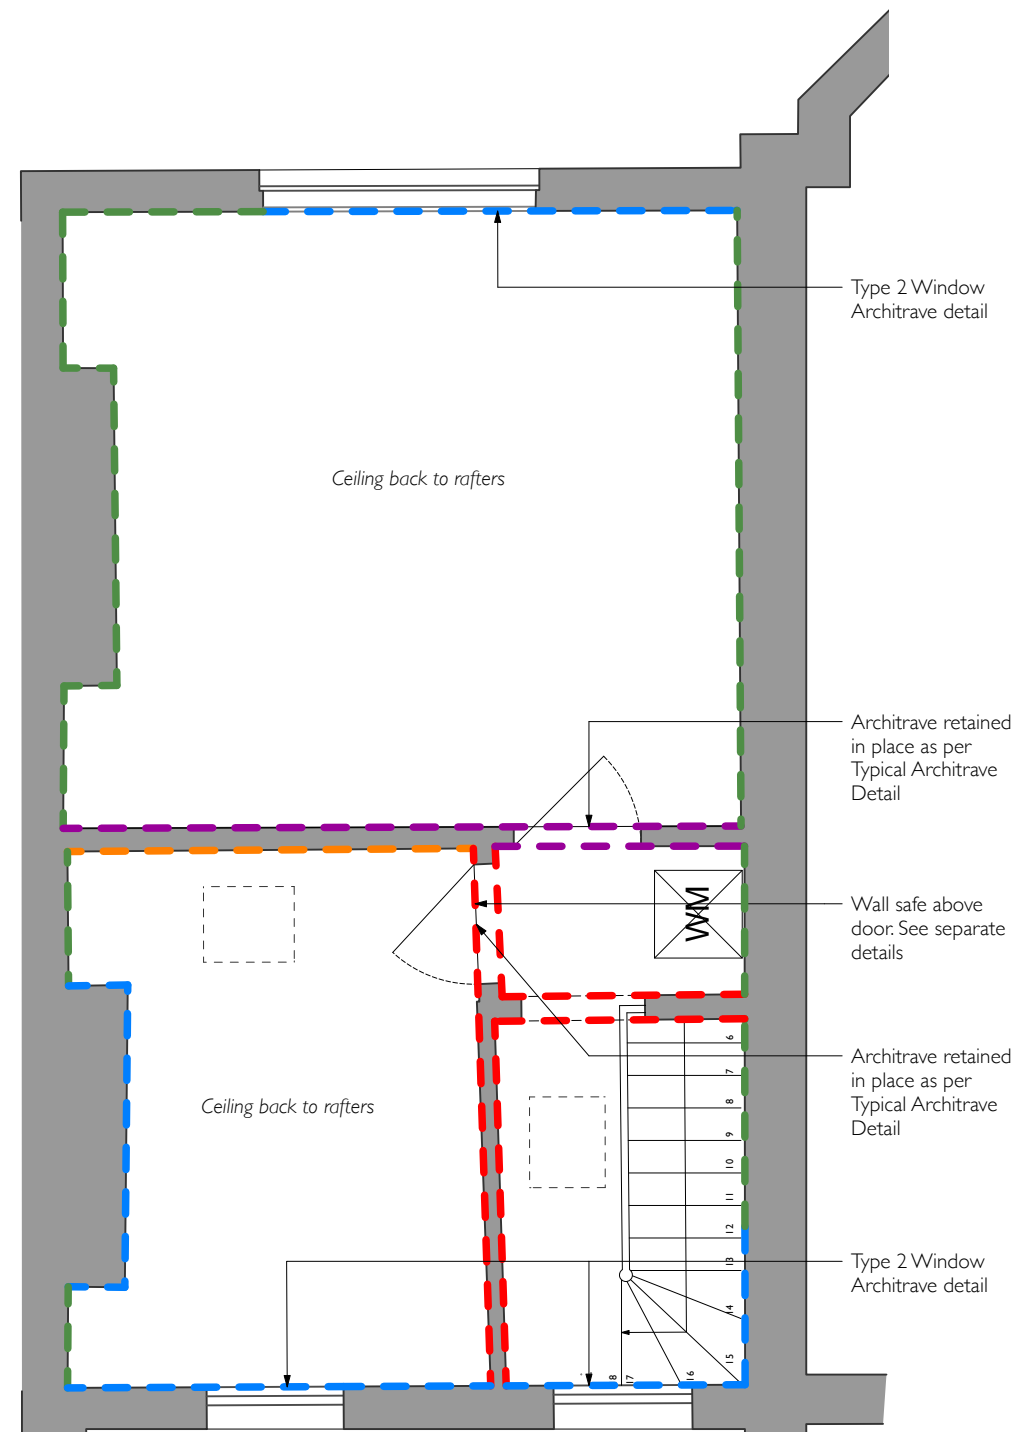
- Masonry: taken back to brick
- Masonry: lime plaster retained - re-skim
- Stud wall: taken back to stud
- Stud wall: laths retained
- Stud wall: lime plaster retained - re-skim

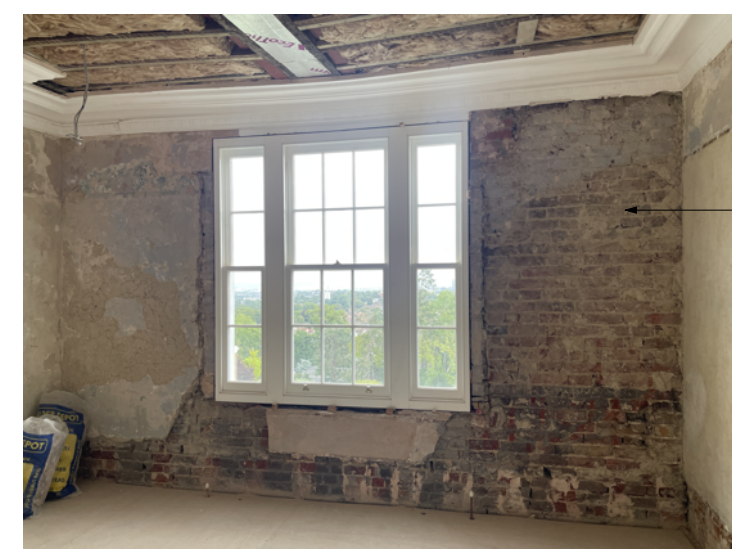
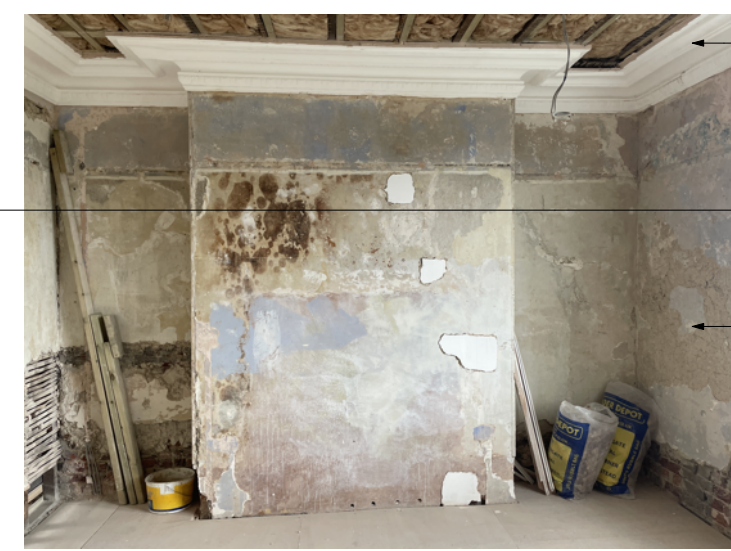
Second Floor Rear Room

- Cornice retained in place for specialist to confirm historic sections to be retained and reproduced as per previously agreed methodology statement
- Rear masonry wall with areas taken back to brick where plaster blown or crumbling to be infilled with lime plaster
- Masonry wall with retained areas of lime plaster to have new lime plaster finish coat

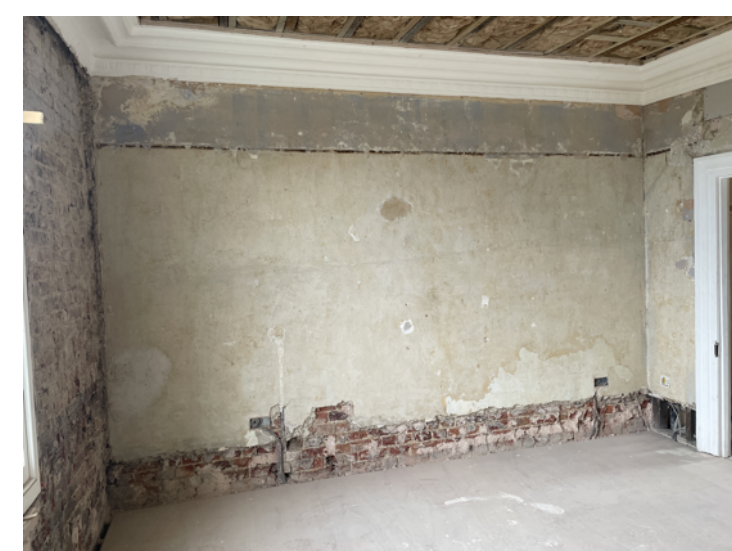
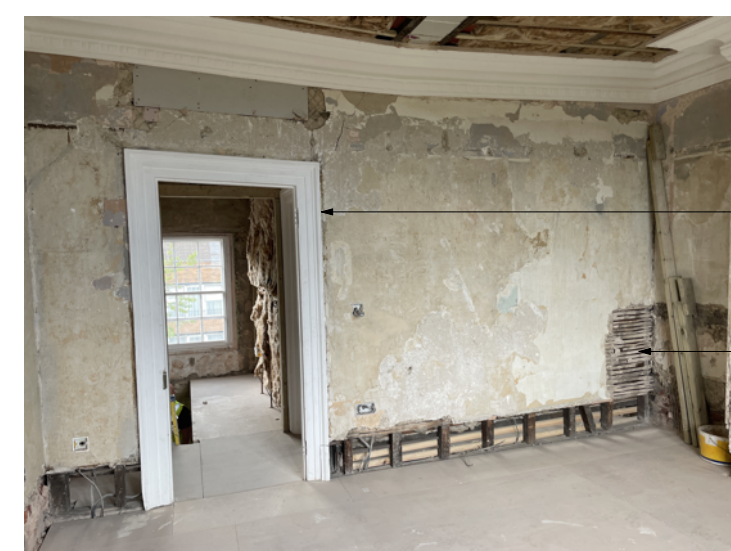
Second Floor Rear Room

- Existing architrave retained in place as per Typical Internal Door Architrave detail
- Area of damaged lime plaster removed to be patched in using existing laths

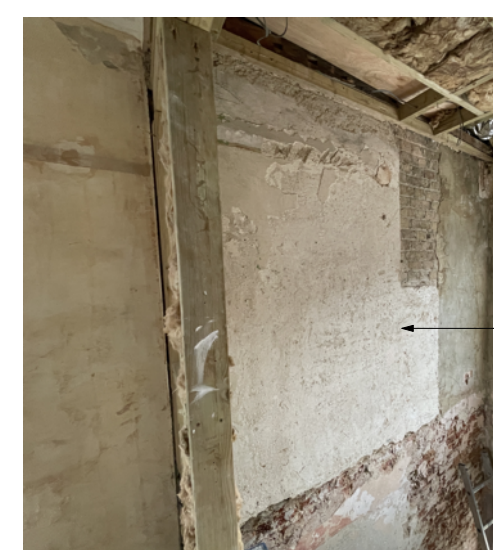
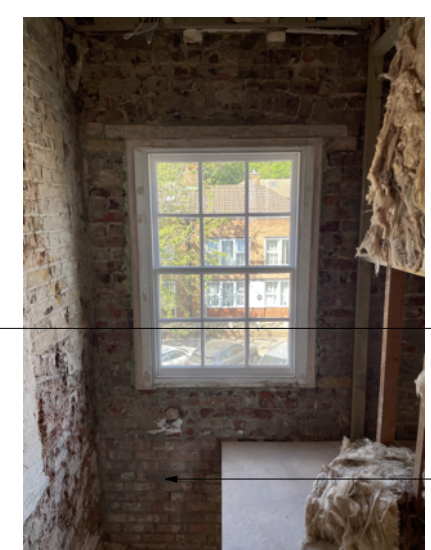
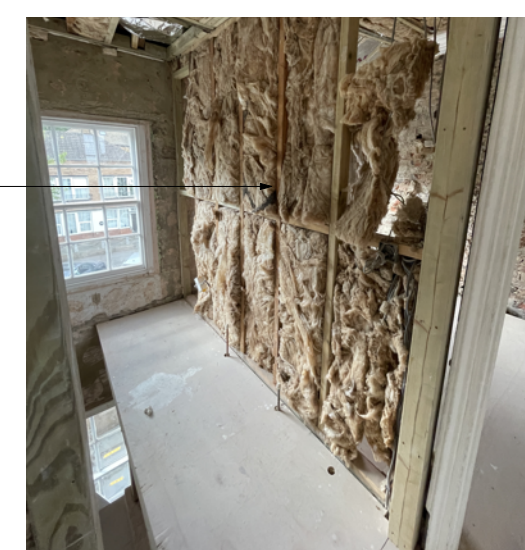
Second Floor Hallway

- Plasterboarded walls stripped back to stud (no existing lath and plaster behind)
- Area of lime plaster to party wall retained with new lime plaster finish coat
- Areas of old gypsum plaster taken back to brick to be finished with new lime plaster
