## Heritage, Design & Access Statement Summary

This document of drawings and images supports the application submitted by Proctor & Shaw on behalf of Mr Morten Helliesen and Ms Madina Howard, 24 Wellfield Avenue, London, N10 2EA.

Planning is sought for:  
'Replacement of two first floor rear windows including modifications to cill heights, and replacement of ground floor rear door and window with single glazed door including modifications to opening.'

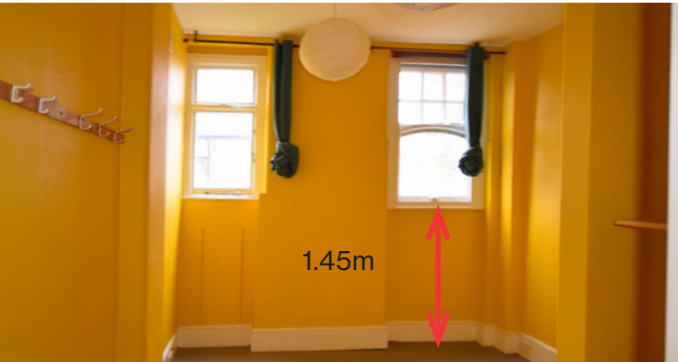
Internal View - 1F rear bedroom

A recent structural survey undertaken for the property at number 24 identified that the lintels of two first floor rear elevation windows showed severe deterioration and sagging of the right hand window lintel, and some visible cracking to the left hand window lintel, requiring their removal for re-mediation works.

In addition to this, the cill height of those two existing windows are unusually and unnecessarily high at circa 1.45m above floor level and awkwardly misaligned.

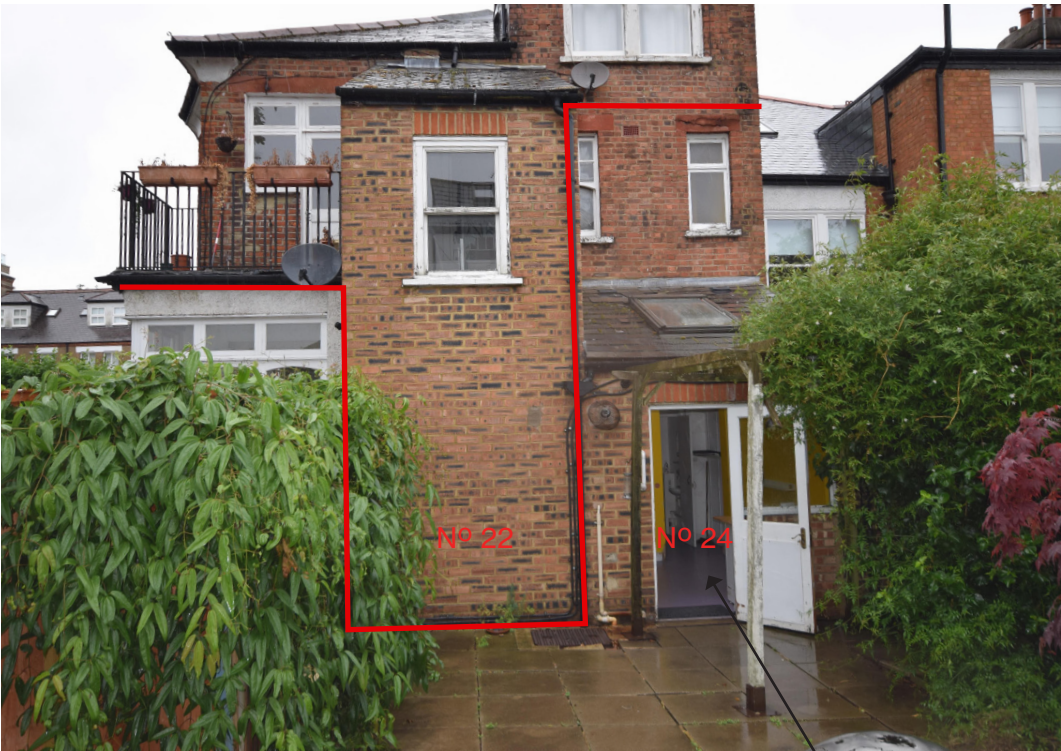
Rear View - Stepped rear elevation

existing GF rear door & window.

The existing ground floor rear access to outdoor amenity is currently limited to a single narrow doorway.

- At ground floor, the poorly performing heavy framed single glazed rear door and window are to be replaced with a more elegant high performance thin framed double glazed single wide pivoting door, improving rear garden accessibility.
- The rear kitchen existing Velux roof window is proposed to be replaced like for like, with an electrically opening device to provide better natural purge ventilation to internal space.

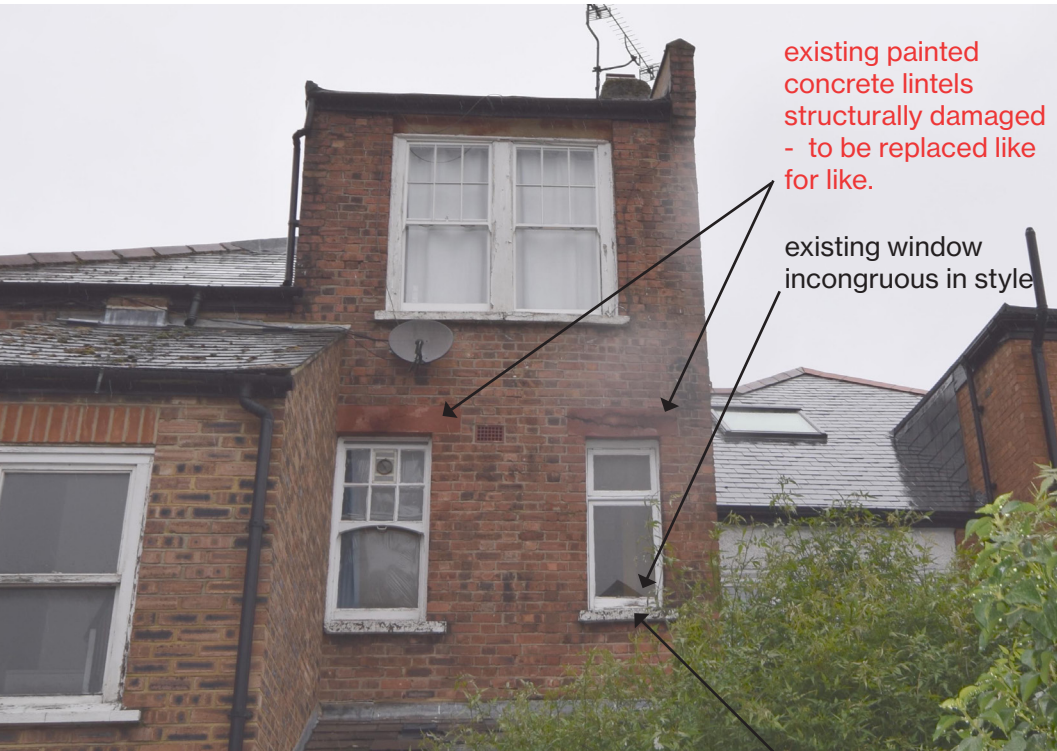
Side passage (similar down both sides of property).

overly high and misaligned window cills

- The 2 replaced 1F rear windows are proposed to be reinstated with a lowered cill height to make them compliant with building regulations for safe egress in the event of a fire.
- The existing lintels are structurally damaged, and in need of replacement like for like.
- The amenity of the rooms will be improved due to the lowered cill height, both by enhancing views to the garden (currently highly compromised), and allowing safe and fully accessible opening for access to air and natural ventilation of the room.

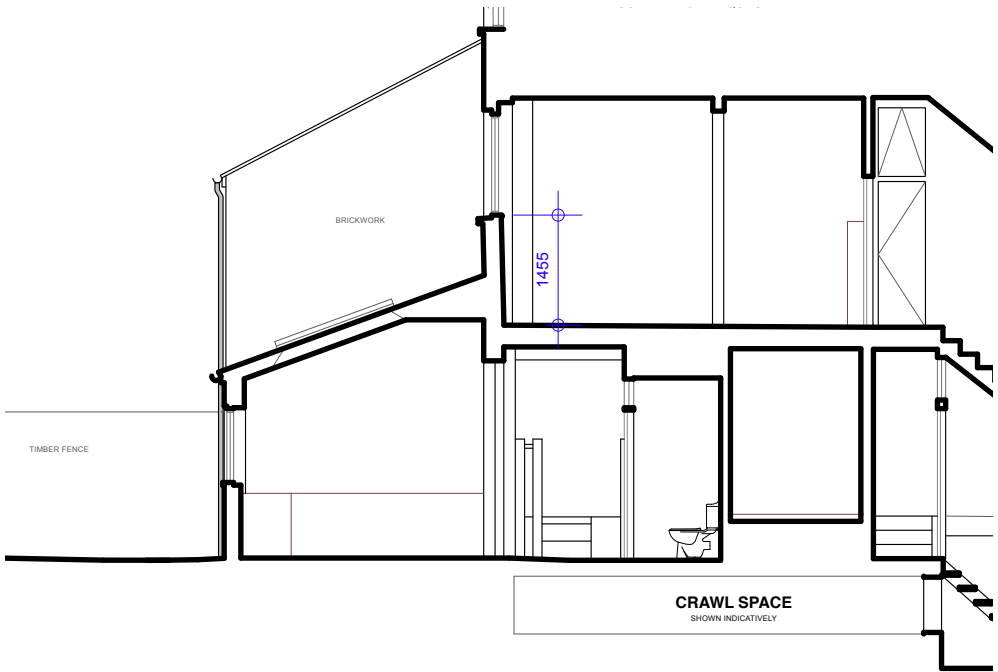
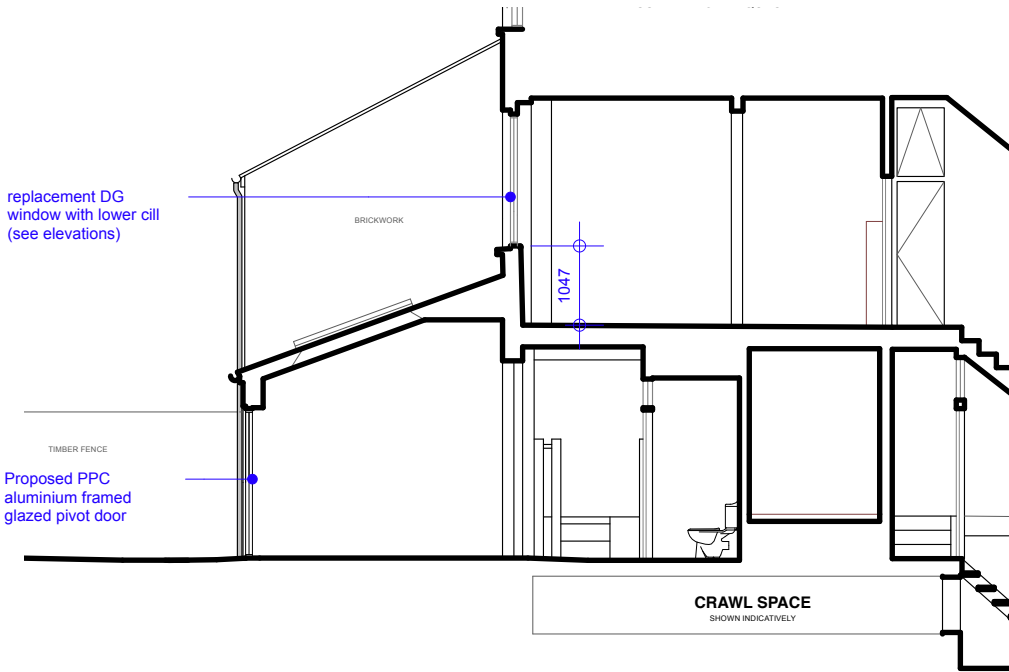
- Accessibility will be enhanced by better access to garden views and improved window opening heights for access to natural ventilation.
- The replacement GF roof window is to be like for like visually, but with enhanced electrical opening function for improved views out and access to natural ventilation.
- The replacement kitchen door and revised opening will improve rear garden access will dramatically improved clear opening and visual connection to a currently limited garden amenity access.

- making sympathetic 'like for like' replacement of the structural supports for the 2 rear 1F windows.
- with high quality replacement sash windows to a matching design, the left hand sash window is to be replaced with a matching sympathetic sash design, with improved thermal performance but retained fenestration design and frame widths. The existing narrower right hand window is to be replaced with a matching sash design, replacing the existing incongruous casement arrangement.
- realigning the window cills (currently mismatched) for a more balanced composition.
- improving the overall proportions of the windows, enhanced to an elegant vertical format.

At ground floor, the double glazed single door is proposed in a realigned opening, to give a more balanced, symmetrical organisation of the rear facade.
