Project title 112 Mount View Road, Hornsey

Drawing title Rear Elevation as Existing and as Proposed

Number 254\_EL\_12 Date August 2026 Scale 1:50 @ A3

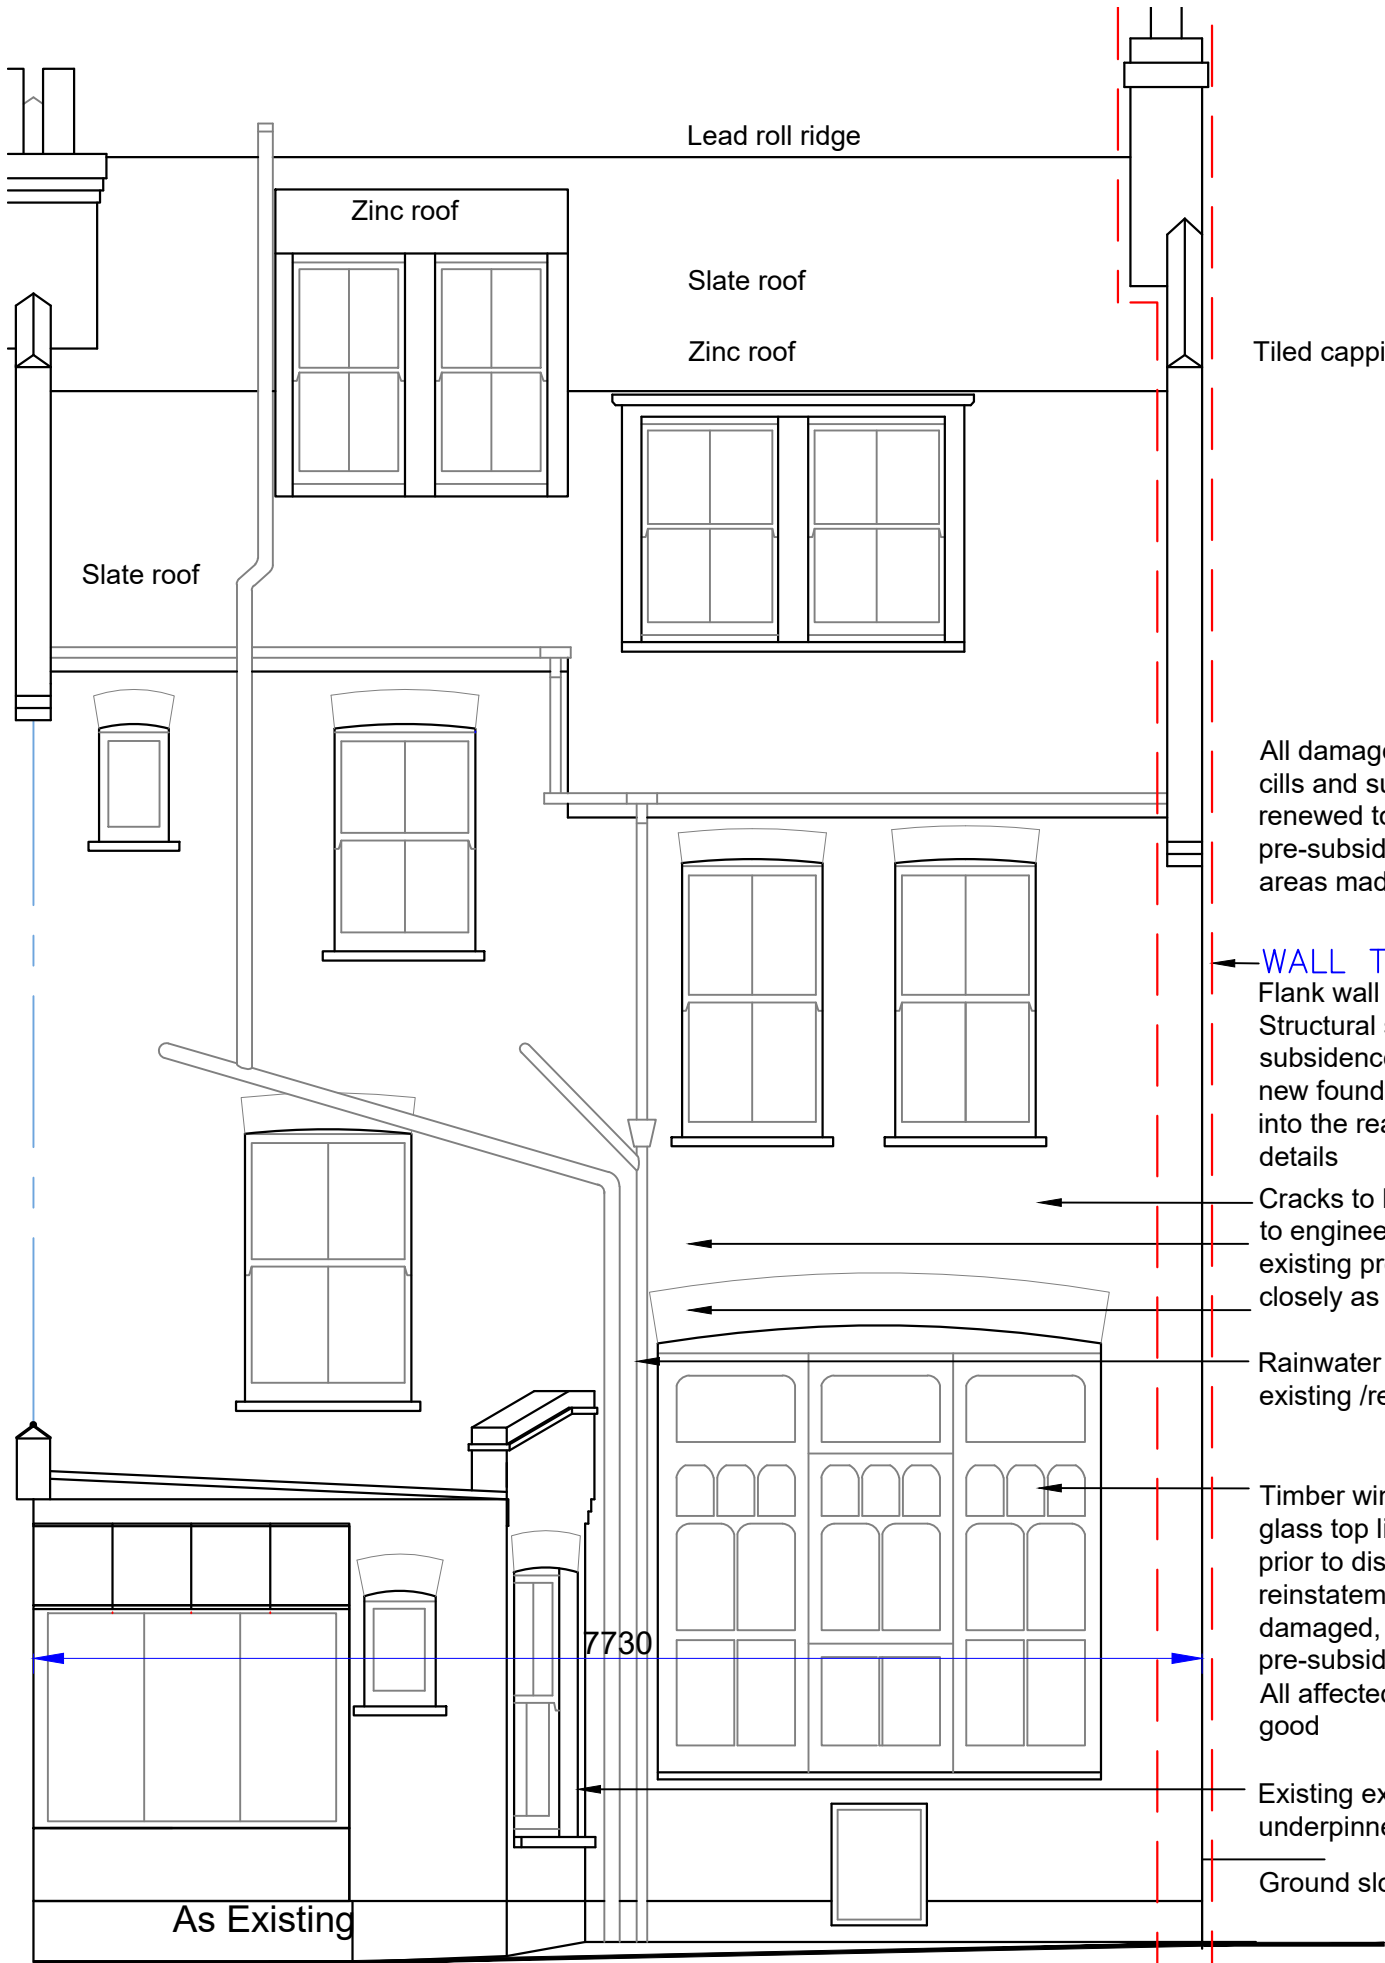
As Existing

← **WALL TO BE REBUILT**  
Flank wall London stock bricks  
Structural stability affected by subsidence, to be rebuilt on new foundations and stitched into the rear wall to engineer's details

← Cracks to be repaired or rebuilt to engineer's detail to match existing pre-subsidence as closely as possible

← Timber window with stained glass top lights to be protected prior to dismantling and reinstatement. Renew/repair if damaged, to match the original pre-subsidence  
All affected areas to be made good

← Existing extension. All walls to be underpinned and made good

All damaged timber windows, cills and surrounds to be renewed to match the original pre-subsidence and all affected areas made good

← Rainwater goods to match existing /reinstated if sound
