As Proposed

As Existing

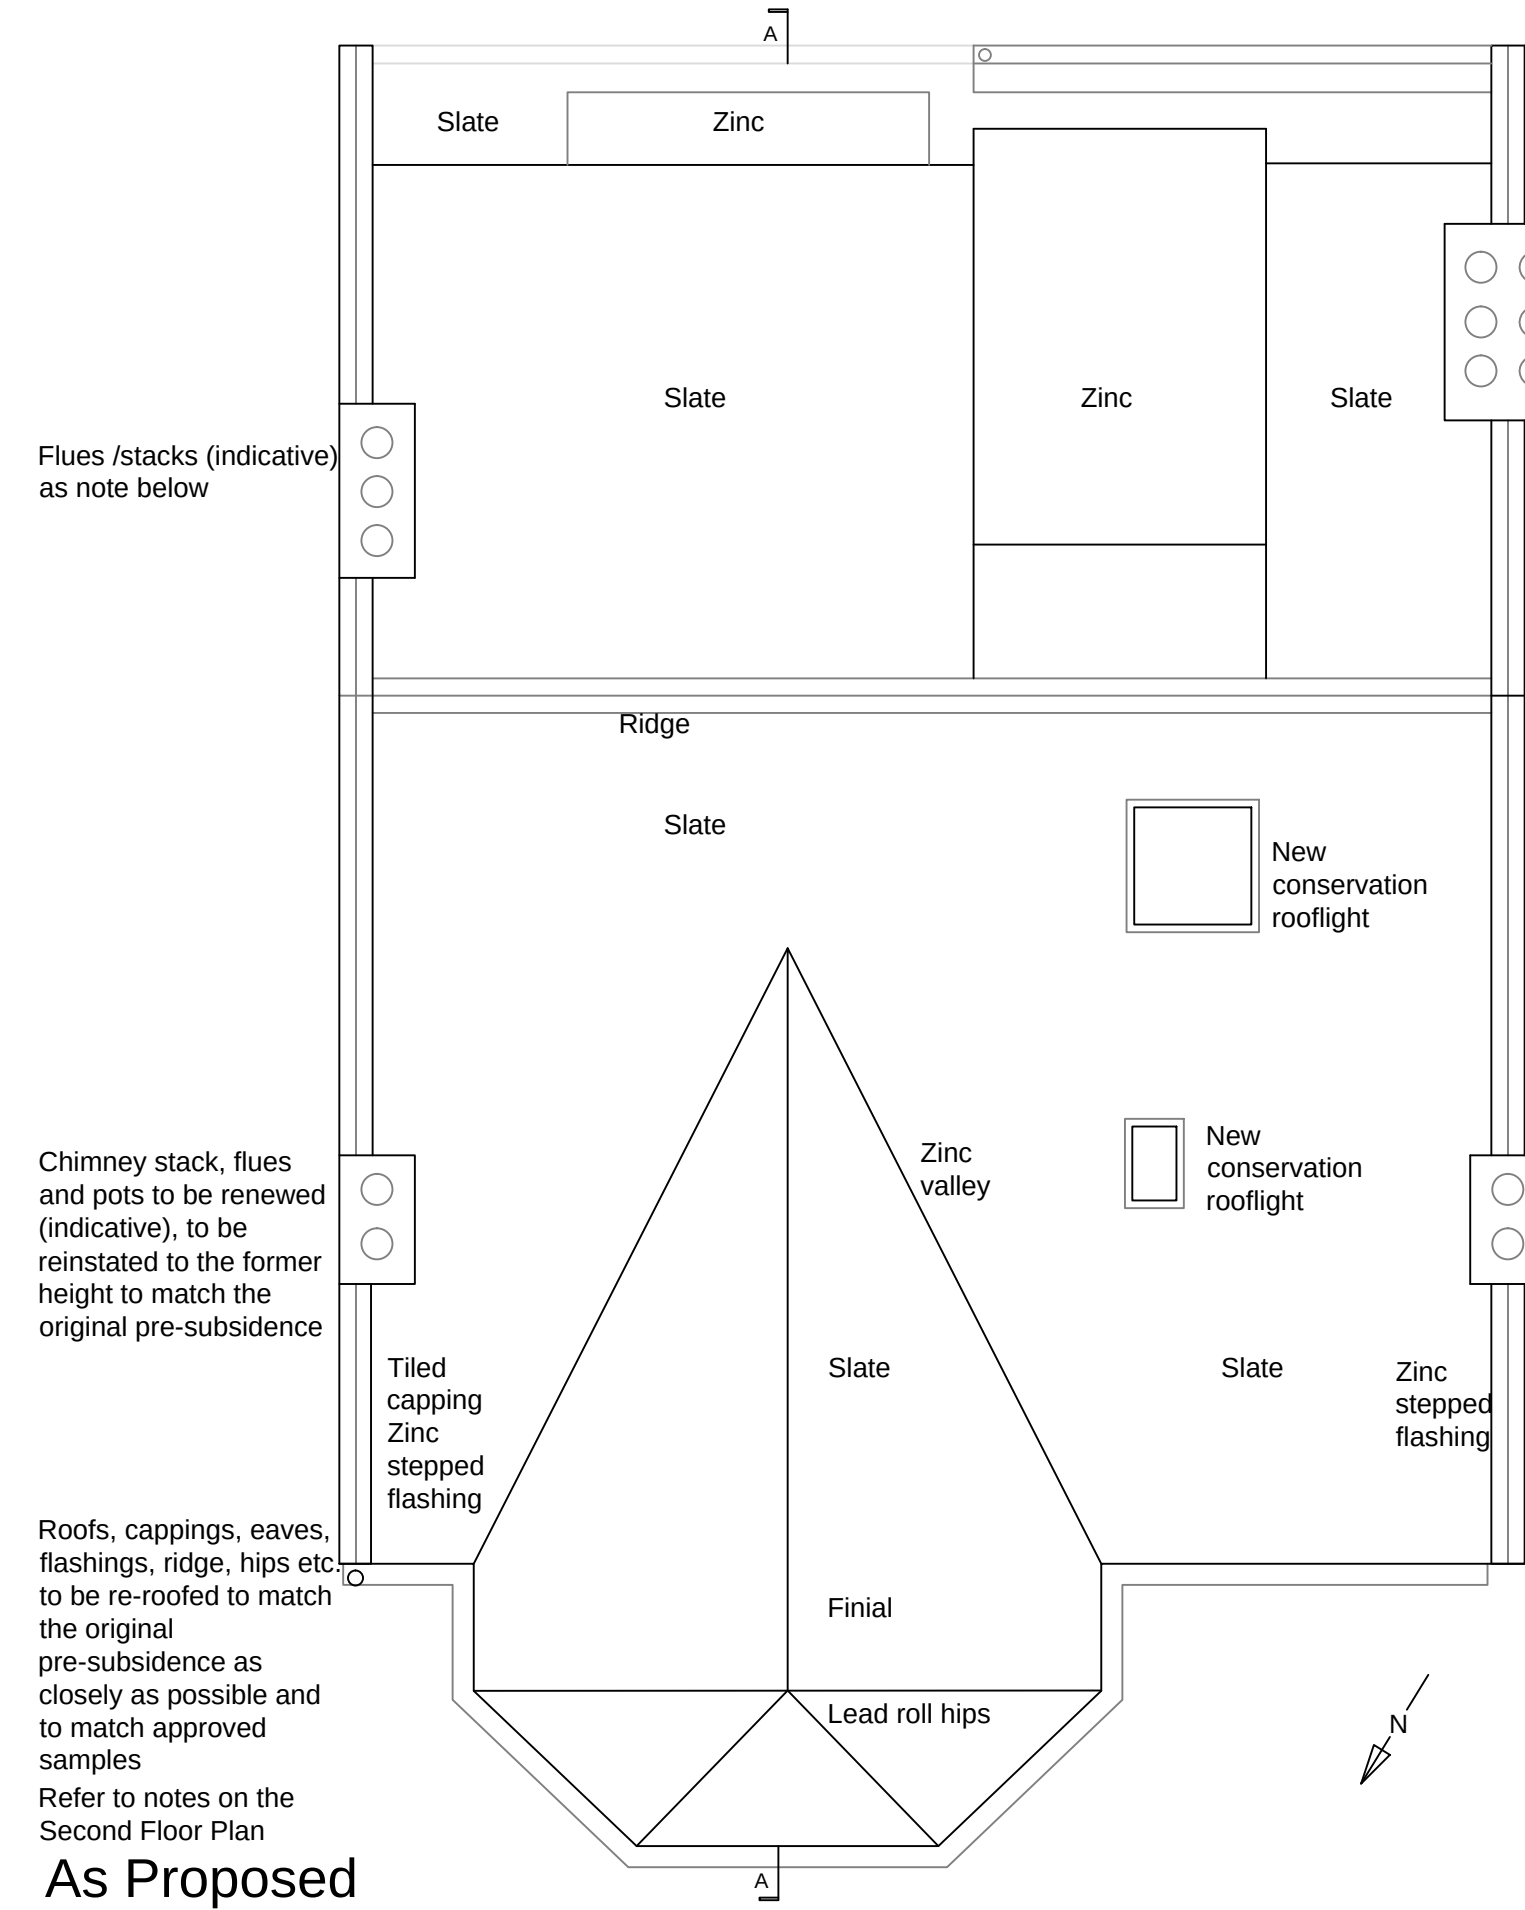
All areas to be re-roofed  
Sound slates and copings/ cappings to be set aside for reuse if suitable. Hips, ridges, flashing details and materials to be recorded by Contractor before and during dismantling to allow accurate reinstatement. Flashings, rooflights, pvc rainwater goods to be renewed  
Flues to be recreated  
Flues / pots / stack indicative, to match existing  
Original ridge materials and details to be recorded by Contractor before/ during dismantling  
London stock brick gable wall with tiled capping  
The chimney stack has been reduced temporarily for safety as it was dangerous due to the subsidence. Details and dimensions of flues to be recorded by the Contractor prior to dismantling to allow accurate rebuilding

Walls to be carefully taken down and rebuilt to match the original pre-subsidence
