EXISTING SIDE ELEVATION & SEC

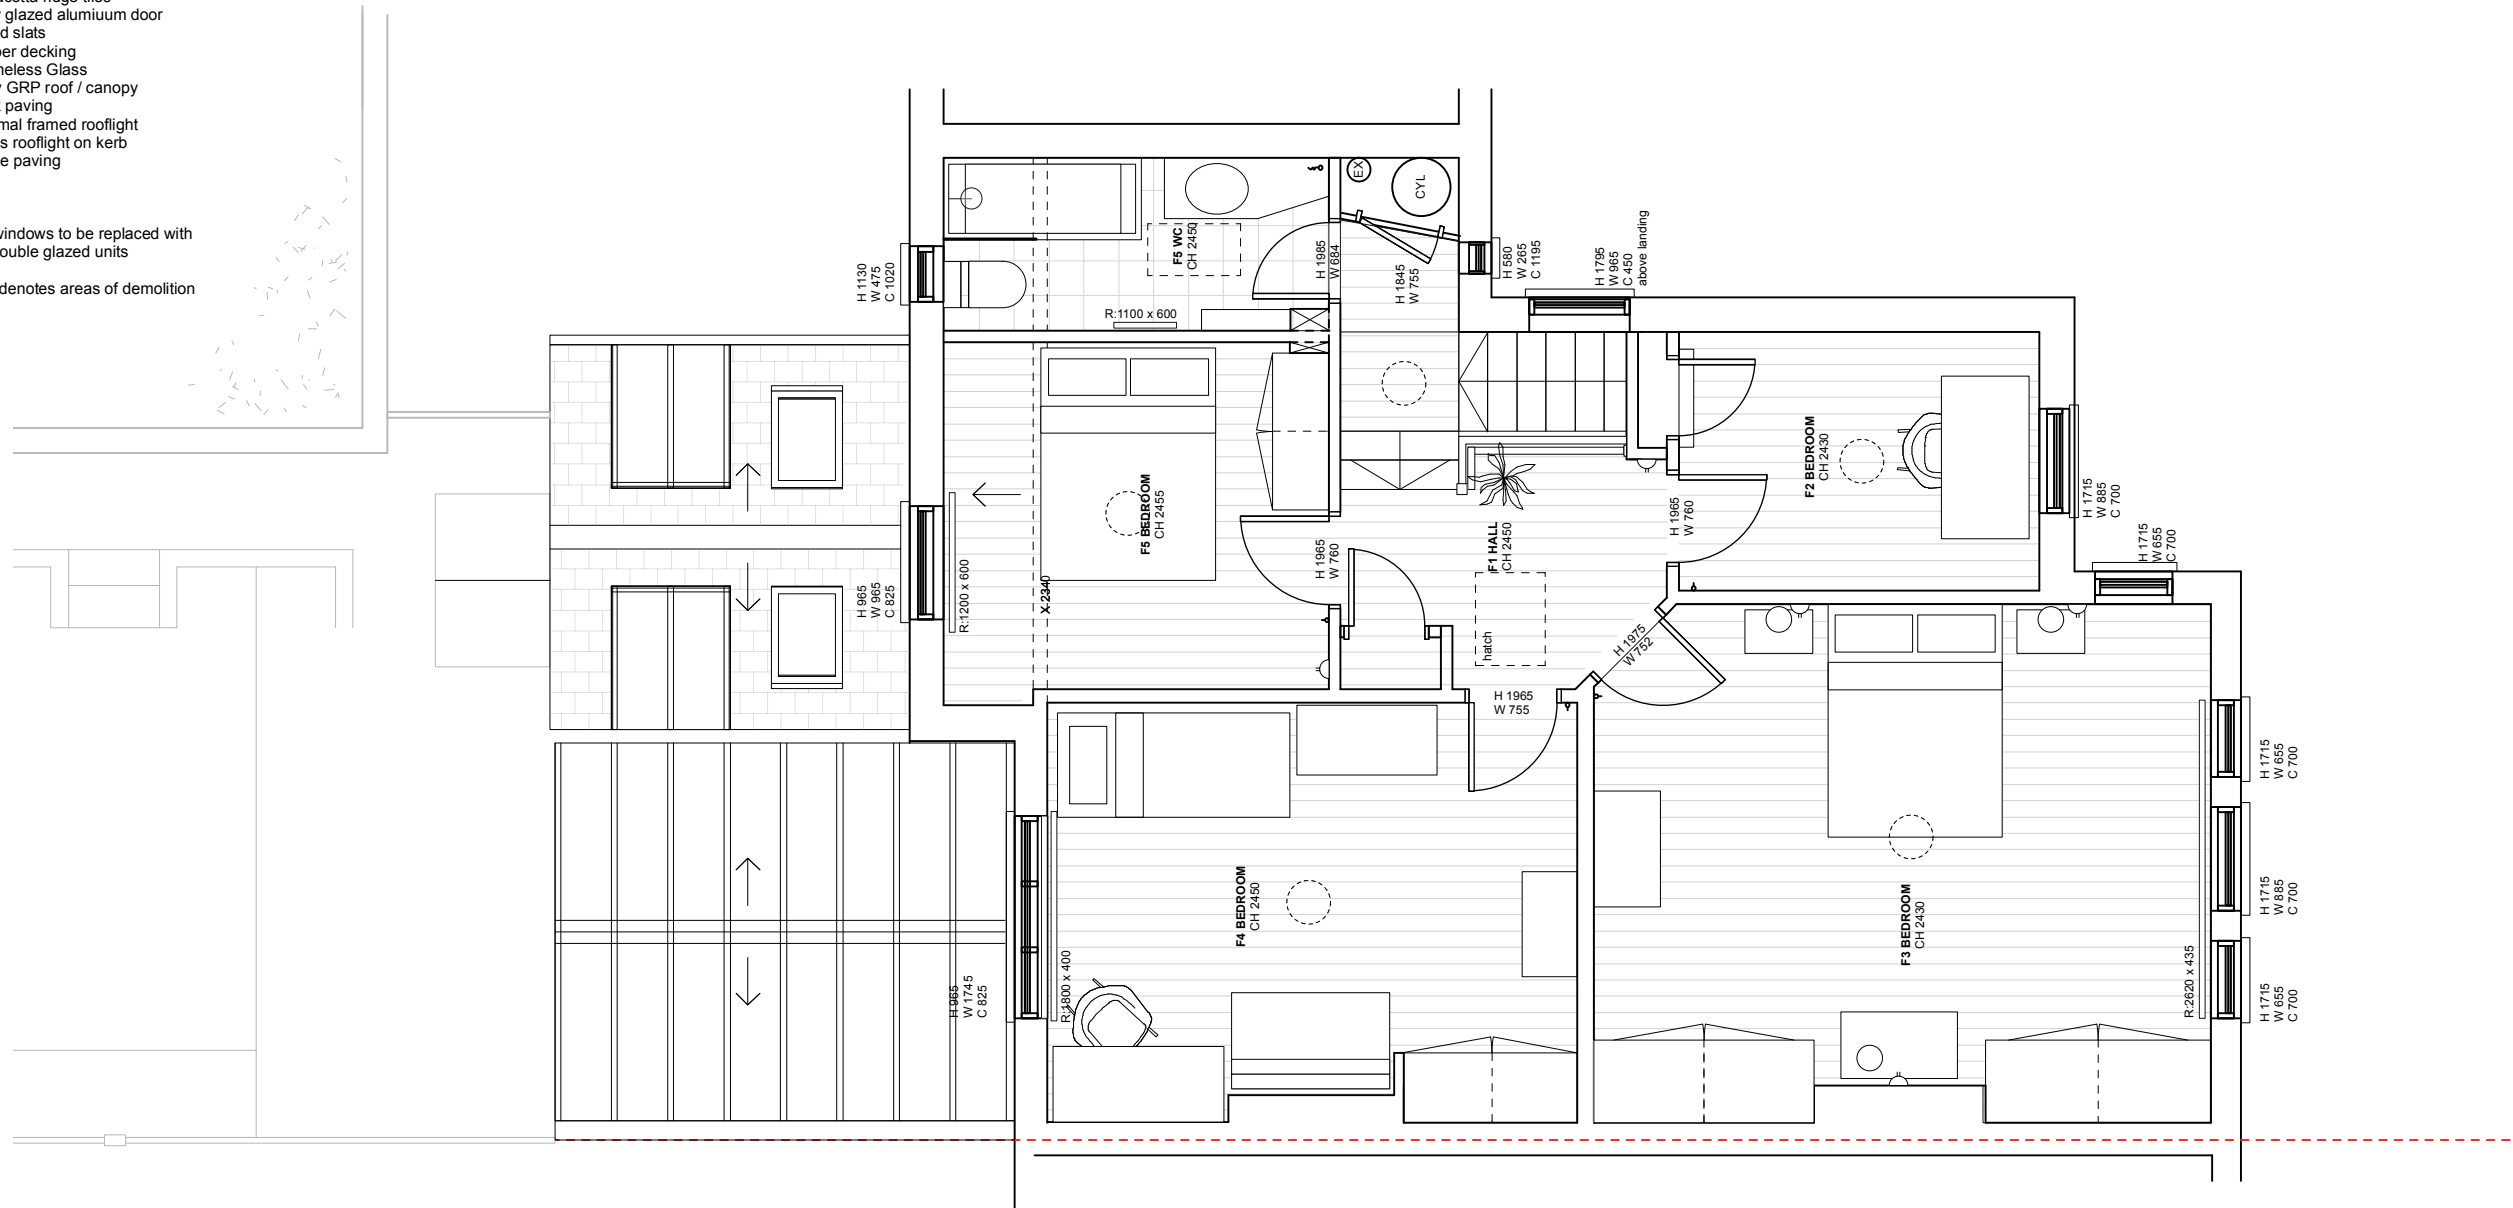
- 1 Brick
- 2 Timber sash window
- 3 Timber casement window
- 4 Render
- 5 Timber door with glazing
- 6 Timber fence / trellis
- 7 Velux / rooflight
- 8 Precast concrete capping
- 9 Black gutters and pipes
- 10 Terracotta chimney pots
- 11 Terracotta roof slates
- 12 Metal garage door
- 13 Terracotta ridge tiles
- 14 Fully glazed aluminium door
- 15 Wood slats
- 16 Timber decking
- 17 Frameless Glass
- 18 Grey GRP roof / canopy
- 19 brick paving
- 20 Minimal framed rooflight
- 21 Glass rooflight on kerb
- 22 Stone paving

All timber windows to be replaced with matching double glazed units

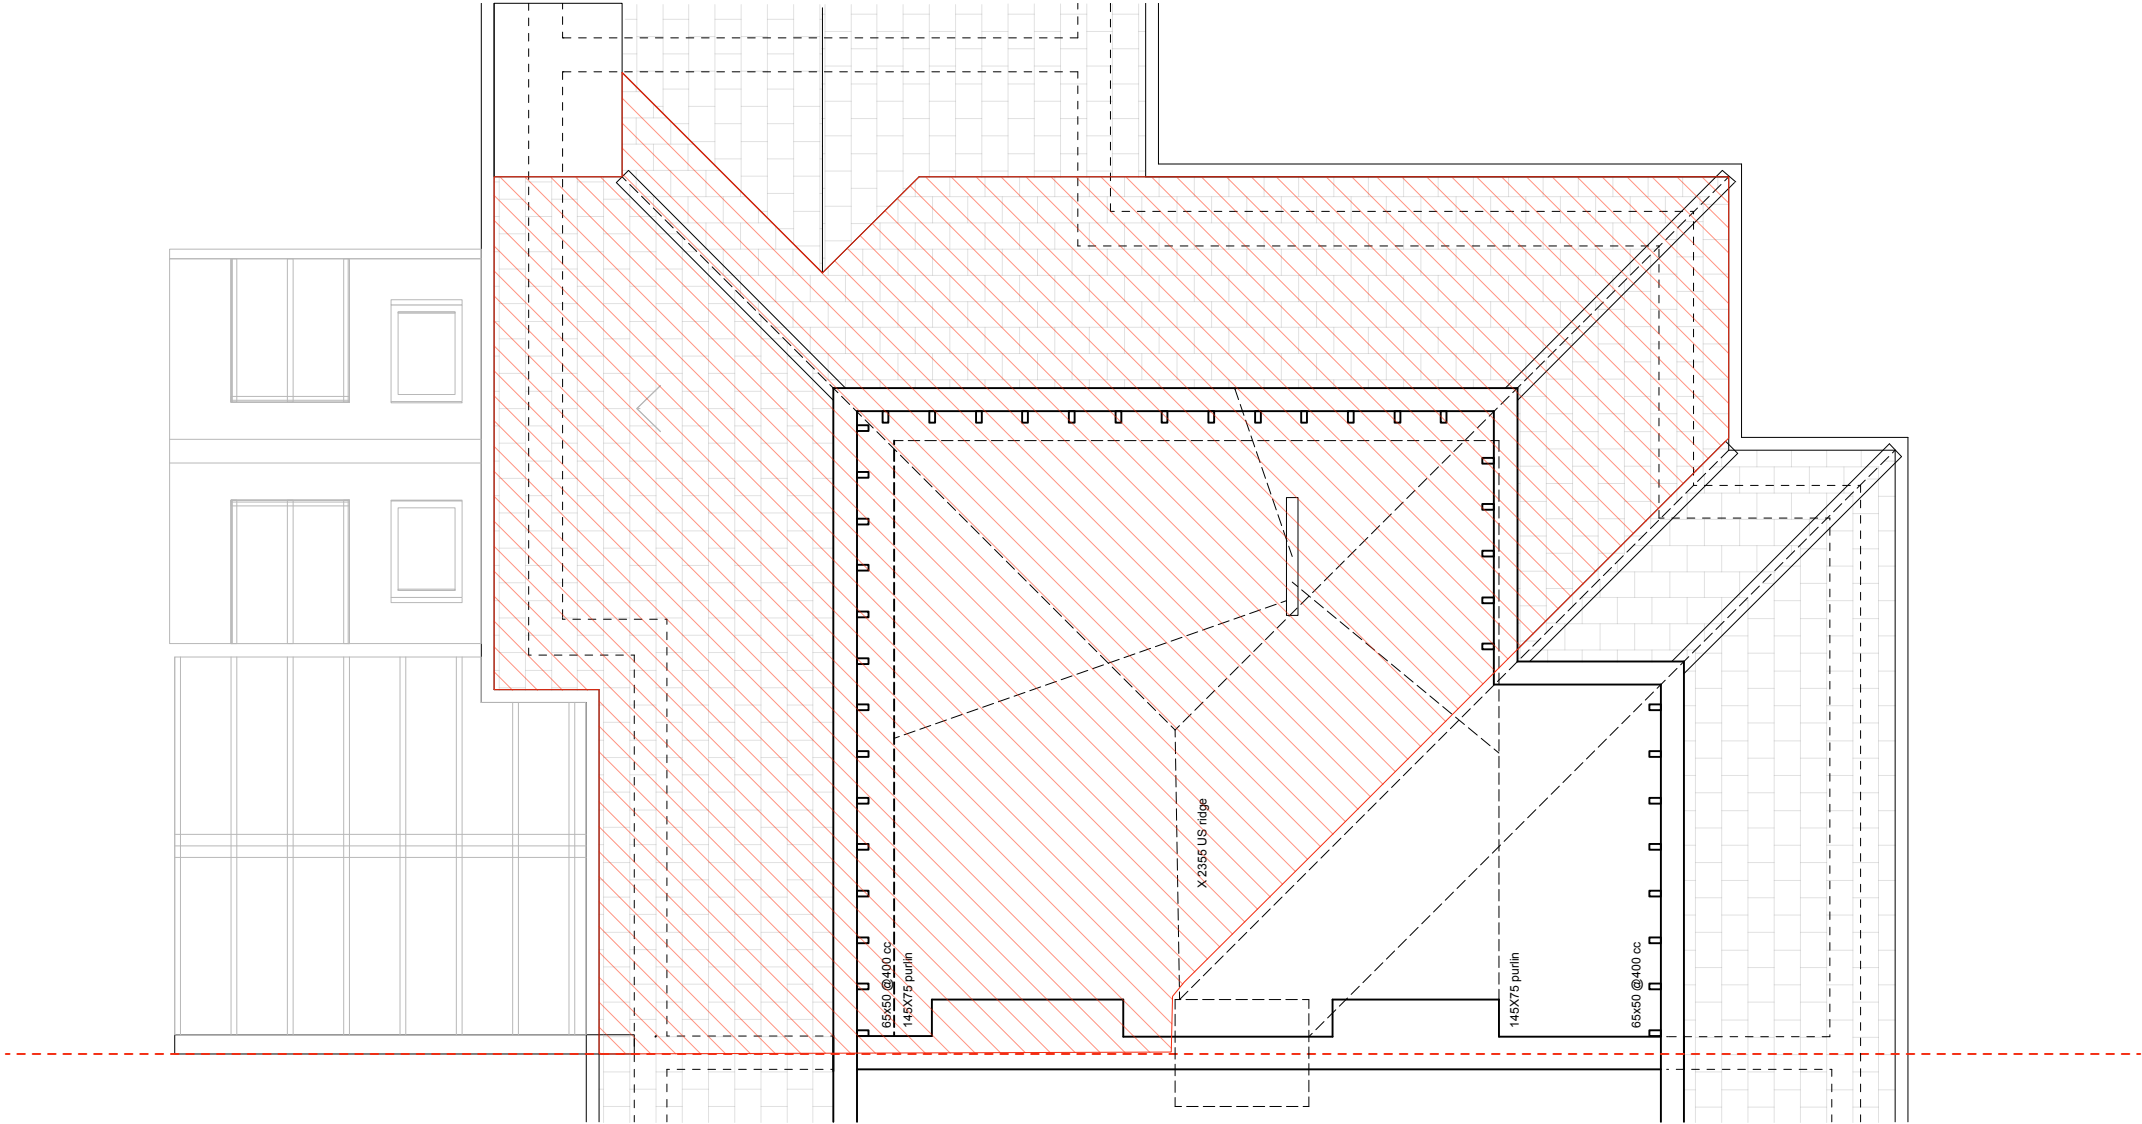
- 1 Brick
- 2 Timber sash window
- 3 Timber casement window
- 4 Render
- 5 Timber door with glazing
- 6 Timber fence / trellis
- 7 Velux / rooflight
- 8 Precast concrete capping
- 9 Black gutters and pipes
- 10 Terracotta chimney pots
- 11 Terracotta roof slates
- 12 Metal garage door
- 13 Terracotta ridge tiles
- 14 Fully glazed aluminium door
- 15 Wood slats
- 16 Timber decking
- 17 Frameless Glass
- 18 Grey GRP roof / canopy
- 19 brick paving
- 20 Minimal framed rooflight
- 21 Glass rooflight on kerb
- 22 Stone paving

All timber windows to be replaced with matching double glazed units

Red hatch denotes areas of demolition

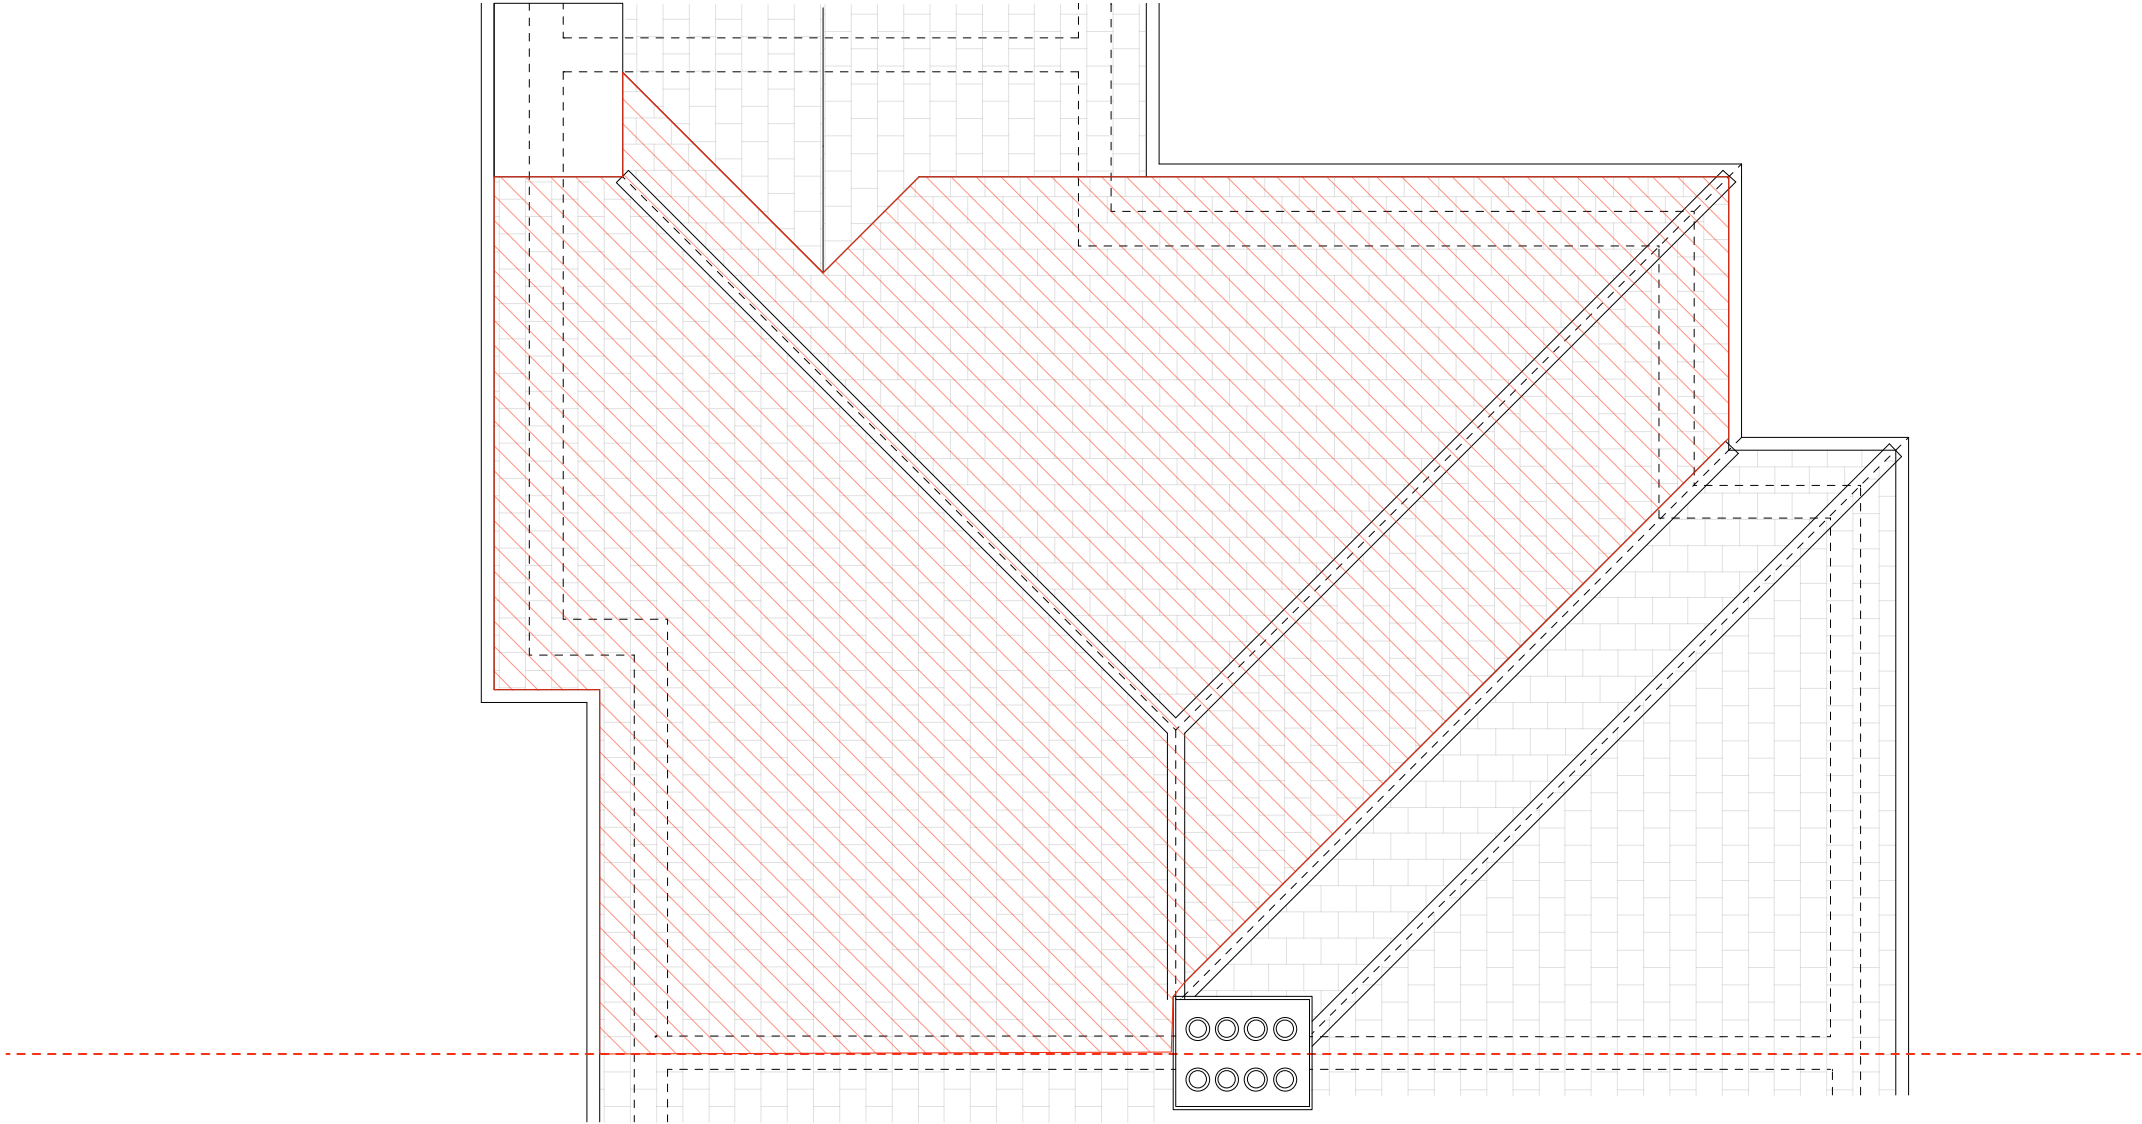
- 1 Brick
- 2 Timber sash window
- 3 Timber casement window
- 4 Render
- 5 Timber door with glazing
- 6 Timber fence / trellis
- 7 Velux / rooflight
- 8 Precast concrete capping
- 9 Black gutters and pipes
- 10 Terracotta chimney pots
- 11 Terracotta roof slates
- 12 Metal garage door
- 13 Terracotta ridge tiles
- 14 Fully glazed aluminium door
- 15 Wood slats
- 16 Timber decking
- 17 Frameless Glass
- 18 Grey GRP roof / canopy
- 19 brick paving
- 20 Minimal framed rooflight
- 21 Glass rooflight on kerb
- 22 Stone paving

All timber windows to be replaced with matching double glazed units

Red hatch denotes areas of demolition

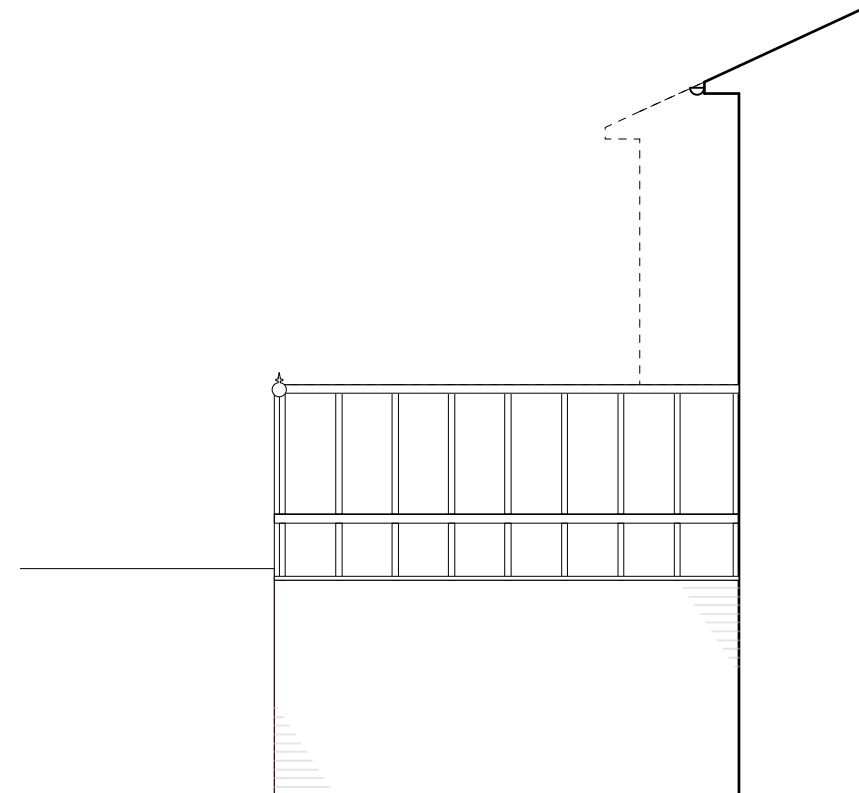
- 1 Brick
- 2 Timber sash window
- 3 Timber casement window
- 4 Render
- 5 Timber door with glazing
- 6 Timber fence / trellis
- 7 Velux / rooflight
- 8 Precast concrete capping
- 9 Black gutters and pipes
- 10 Terracotta chimney pots
- 11 Terracotta roof slates
- 12 Metal garage door
- 13 Terracotta ridge tiles
- 14 Fully glazed aluminium door
- 15 Wood slats
- 16 Timber decking
- 17 Frameless Glass
- 18 Grey GRP roof / canopy
- 19 brick paving
- 20 Minimal framed rooflight
- 21 Glass rooflight on kerb
- 22 Stone paving

All timber windows to be replaced with matching double glazed units

Red hatch denotes areas of demolition
