PROJECT  
Braemar Avenue, Wood Green

DRAWING TITLE  
Proposed Elevation C

STATUS  
Planning Application

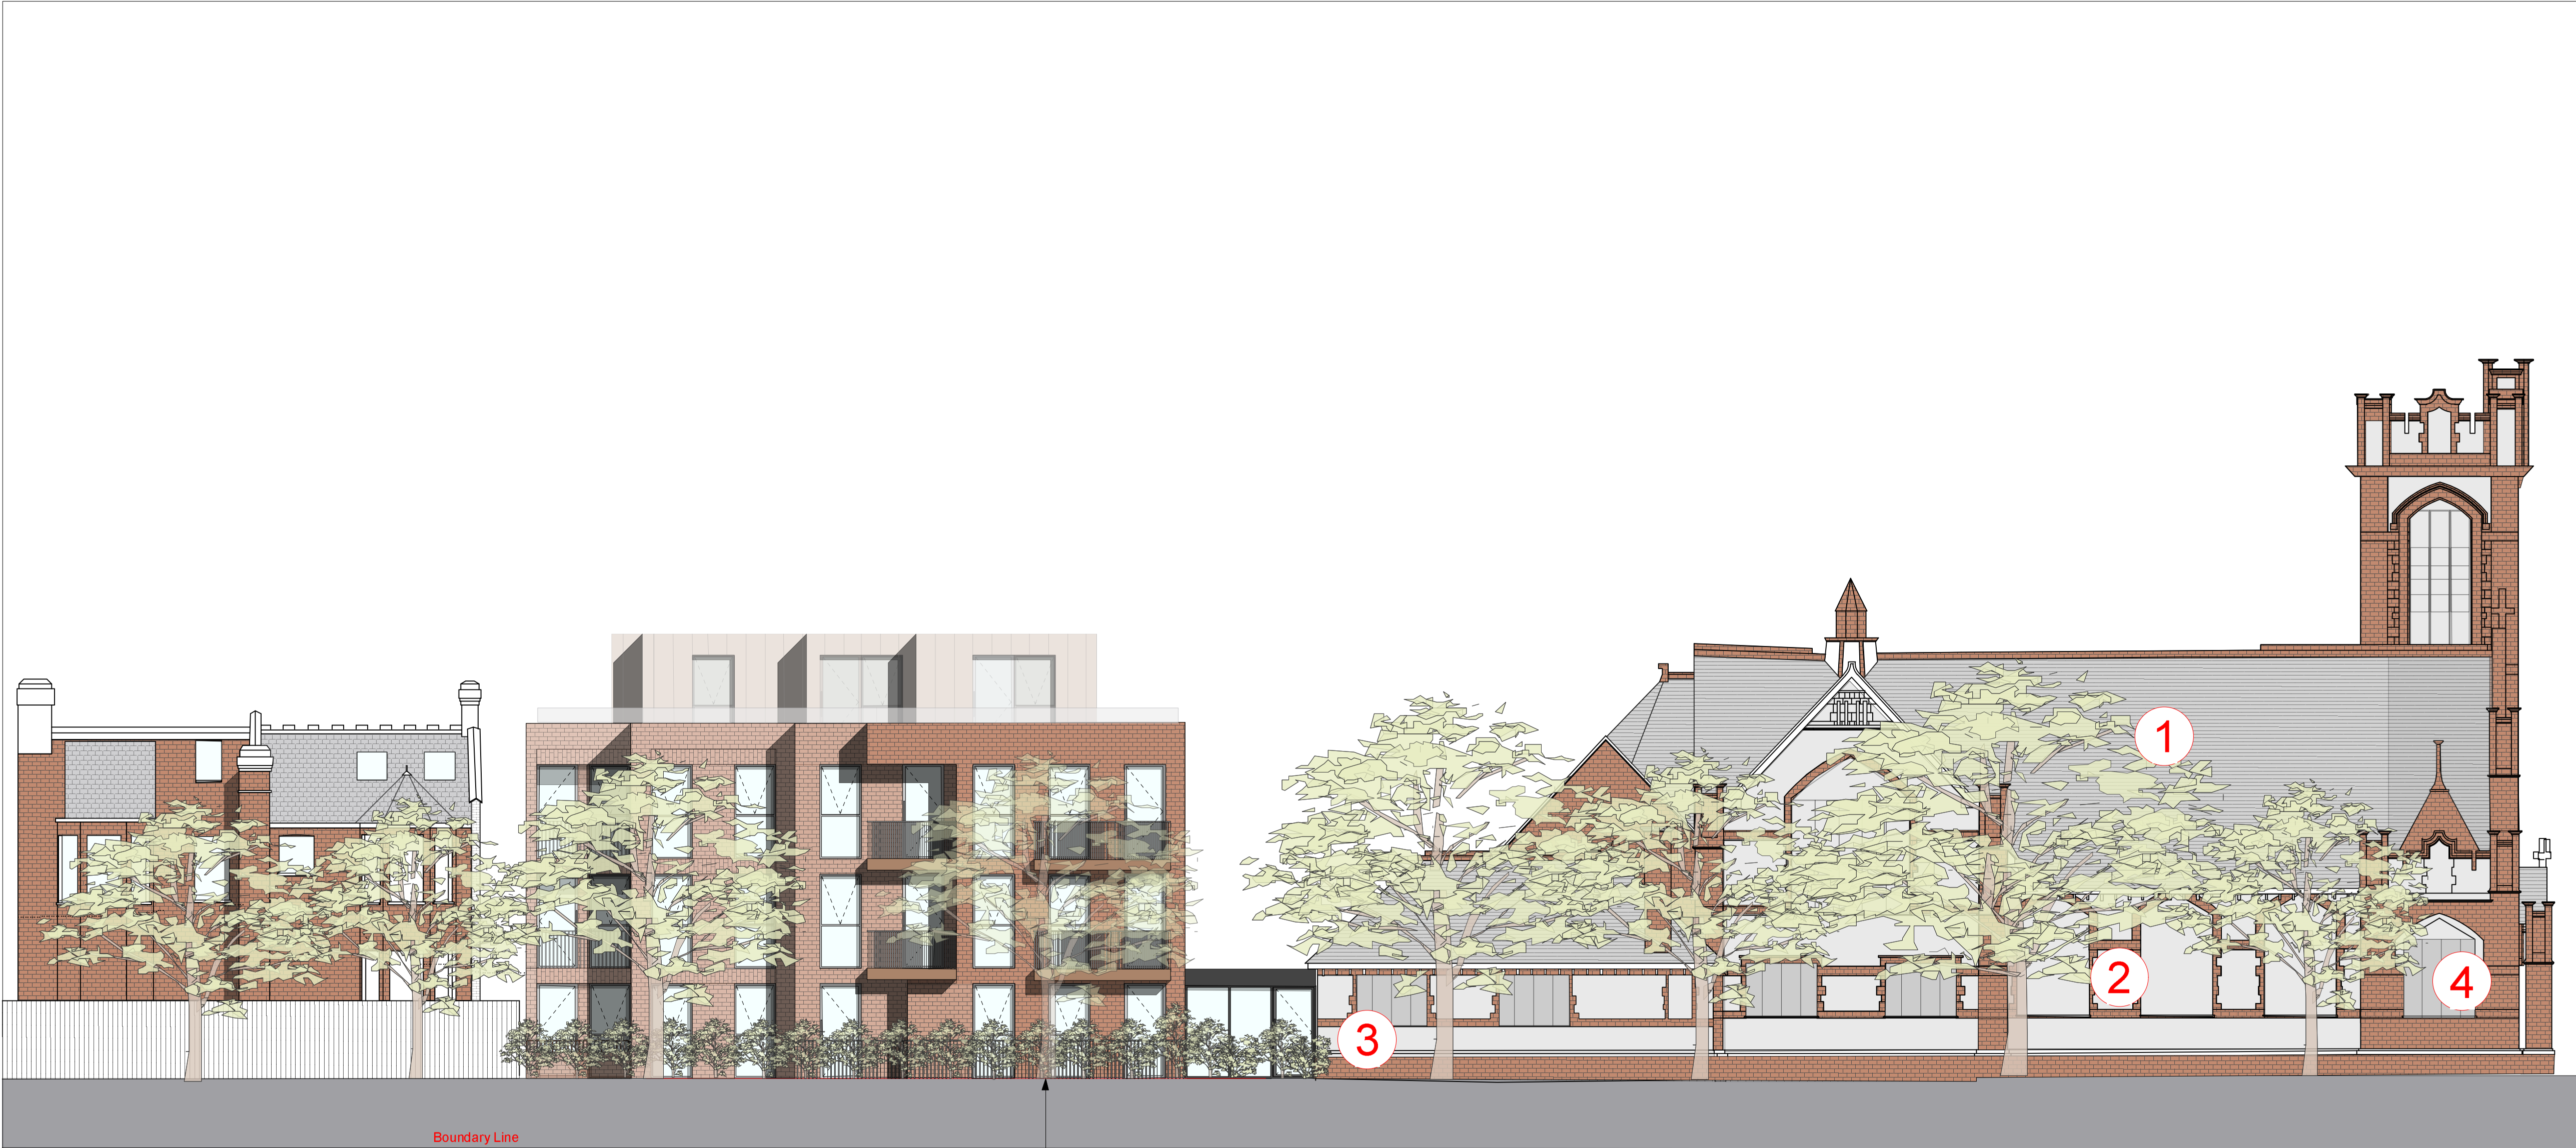
Church Works

- 1. Repairs to the existing roof where required including leak repairs and replacing missing terracota crestings
- 2. Cleaning of external elevations
- 3. Hard and soft landscaping
- 4. Stone/ Brickwork restoration where required. Like for like brickwork would be laid to match the surrounding bond, using mortar with flush joints

suggested new tree to be provided via S106
