Project Bruce Castle

Drawing Sash Window Repair Detail - Sheet 3  
Bottom Rail and Sash Repairs

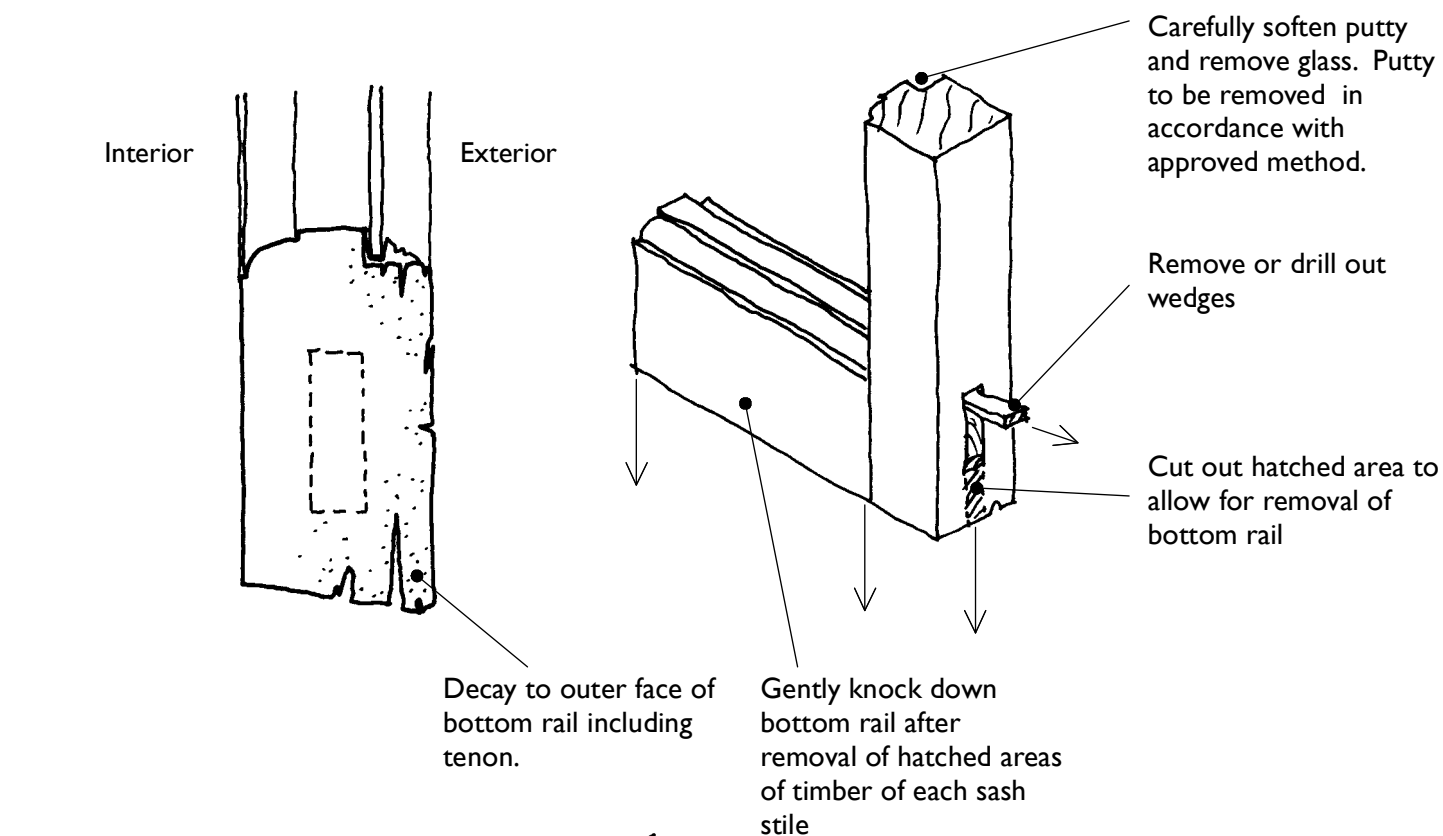
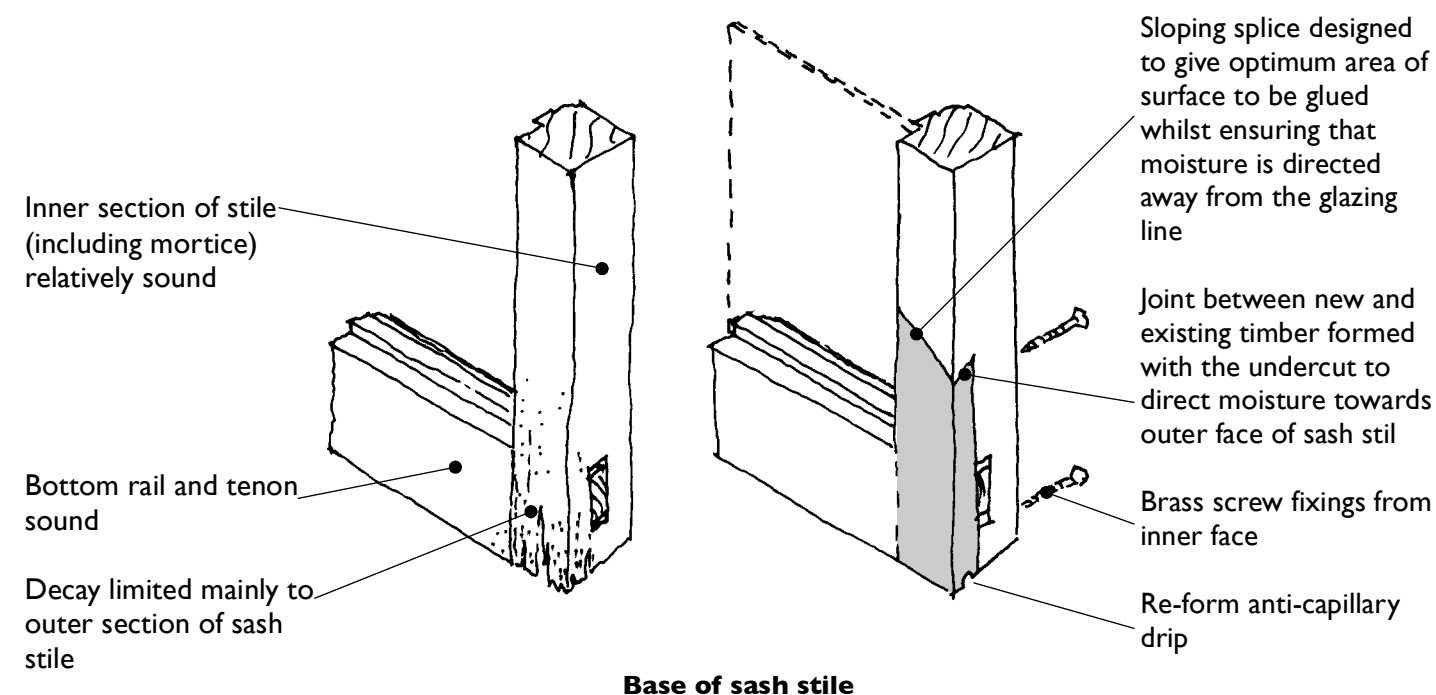
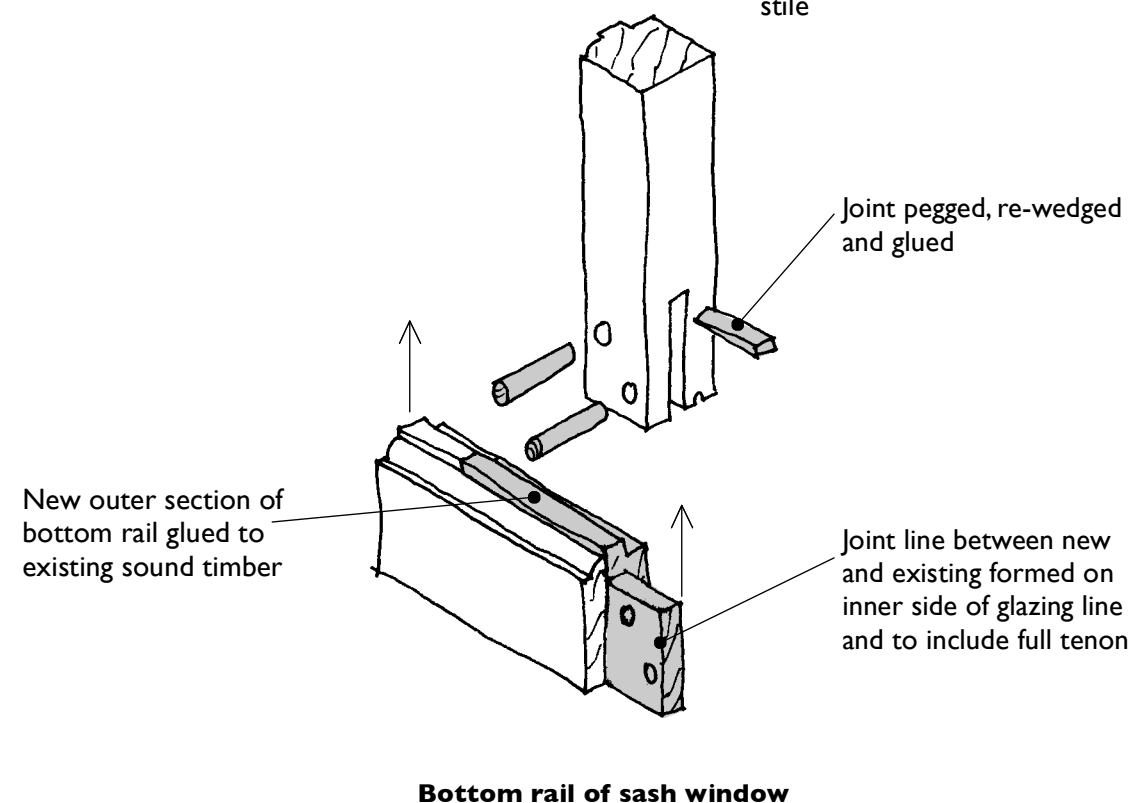
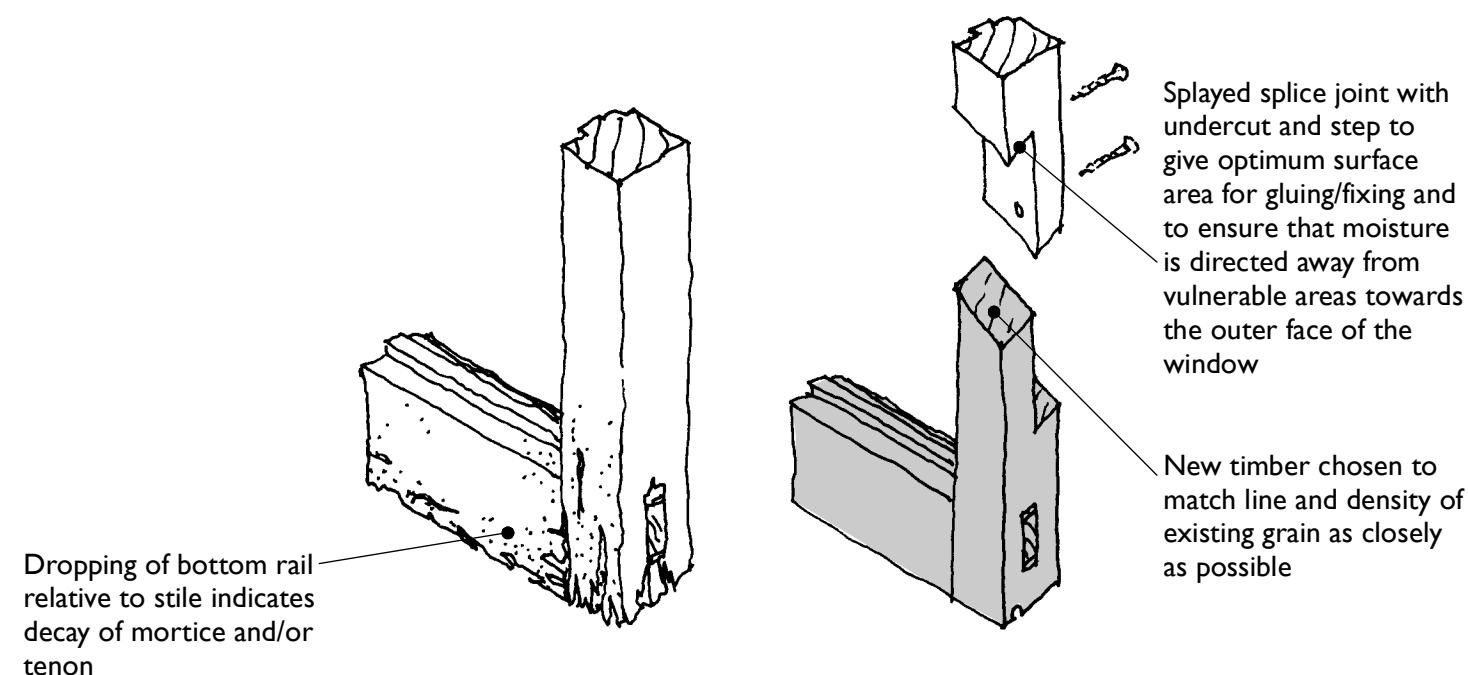
**Note:**  
Method for repairing bottom rail with dismantling sash. Same technique may be used for replacement of entire bottom rail.
