PROJECT  
20 Maidstone Road,  
London

TITLE  
Demolished - Front & Rear  
Elevations

2308\_FS\_P104\_

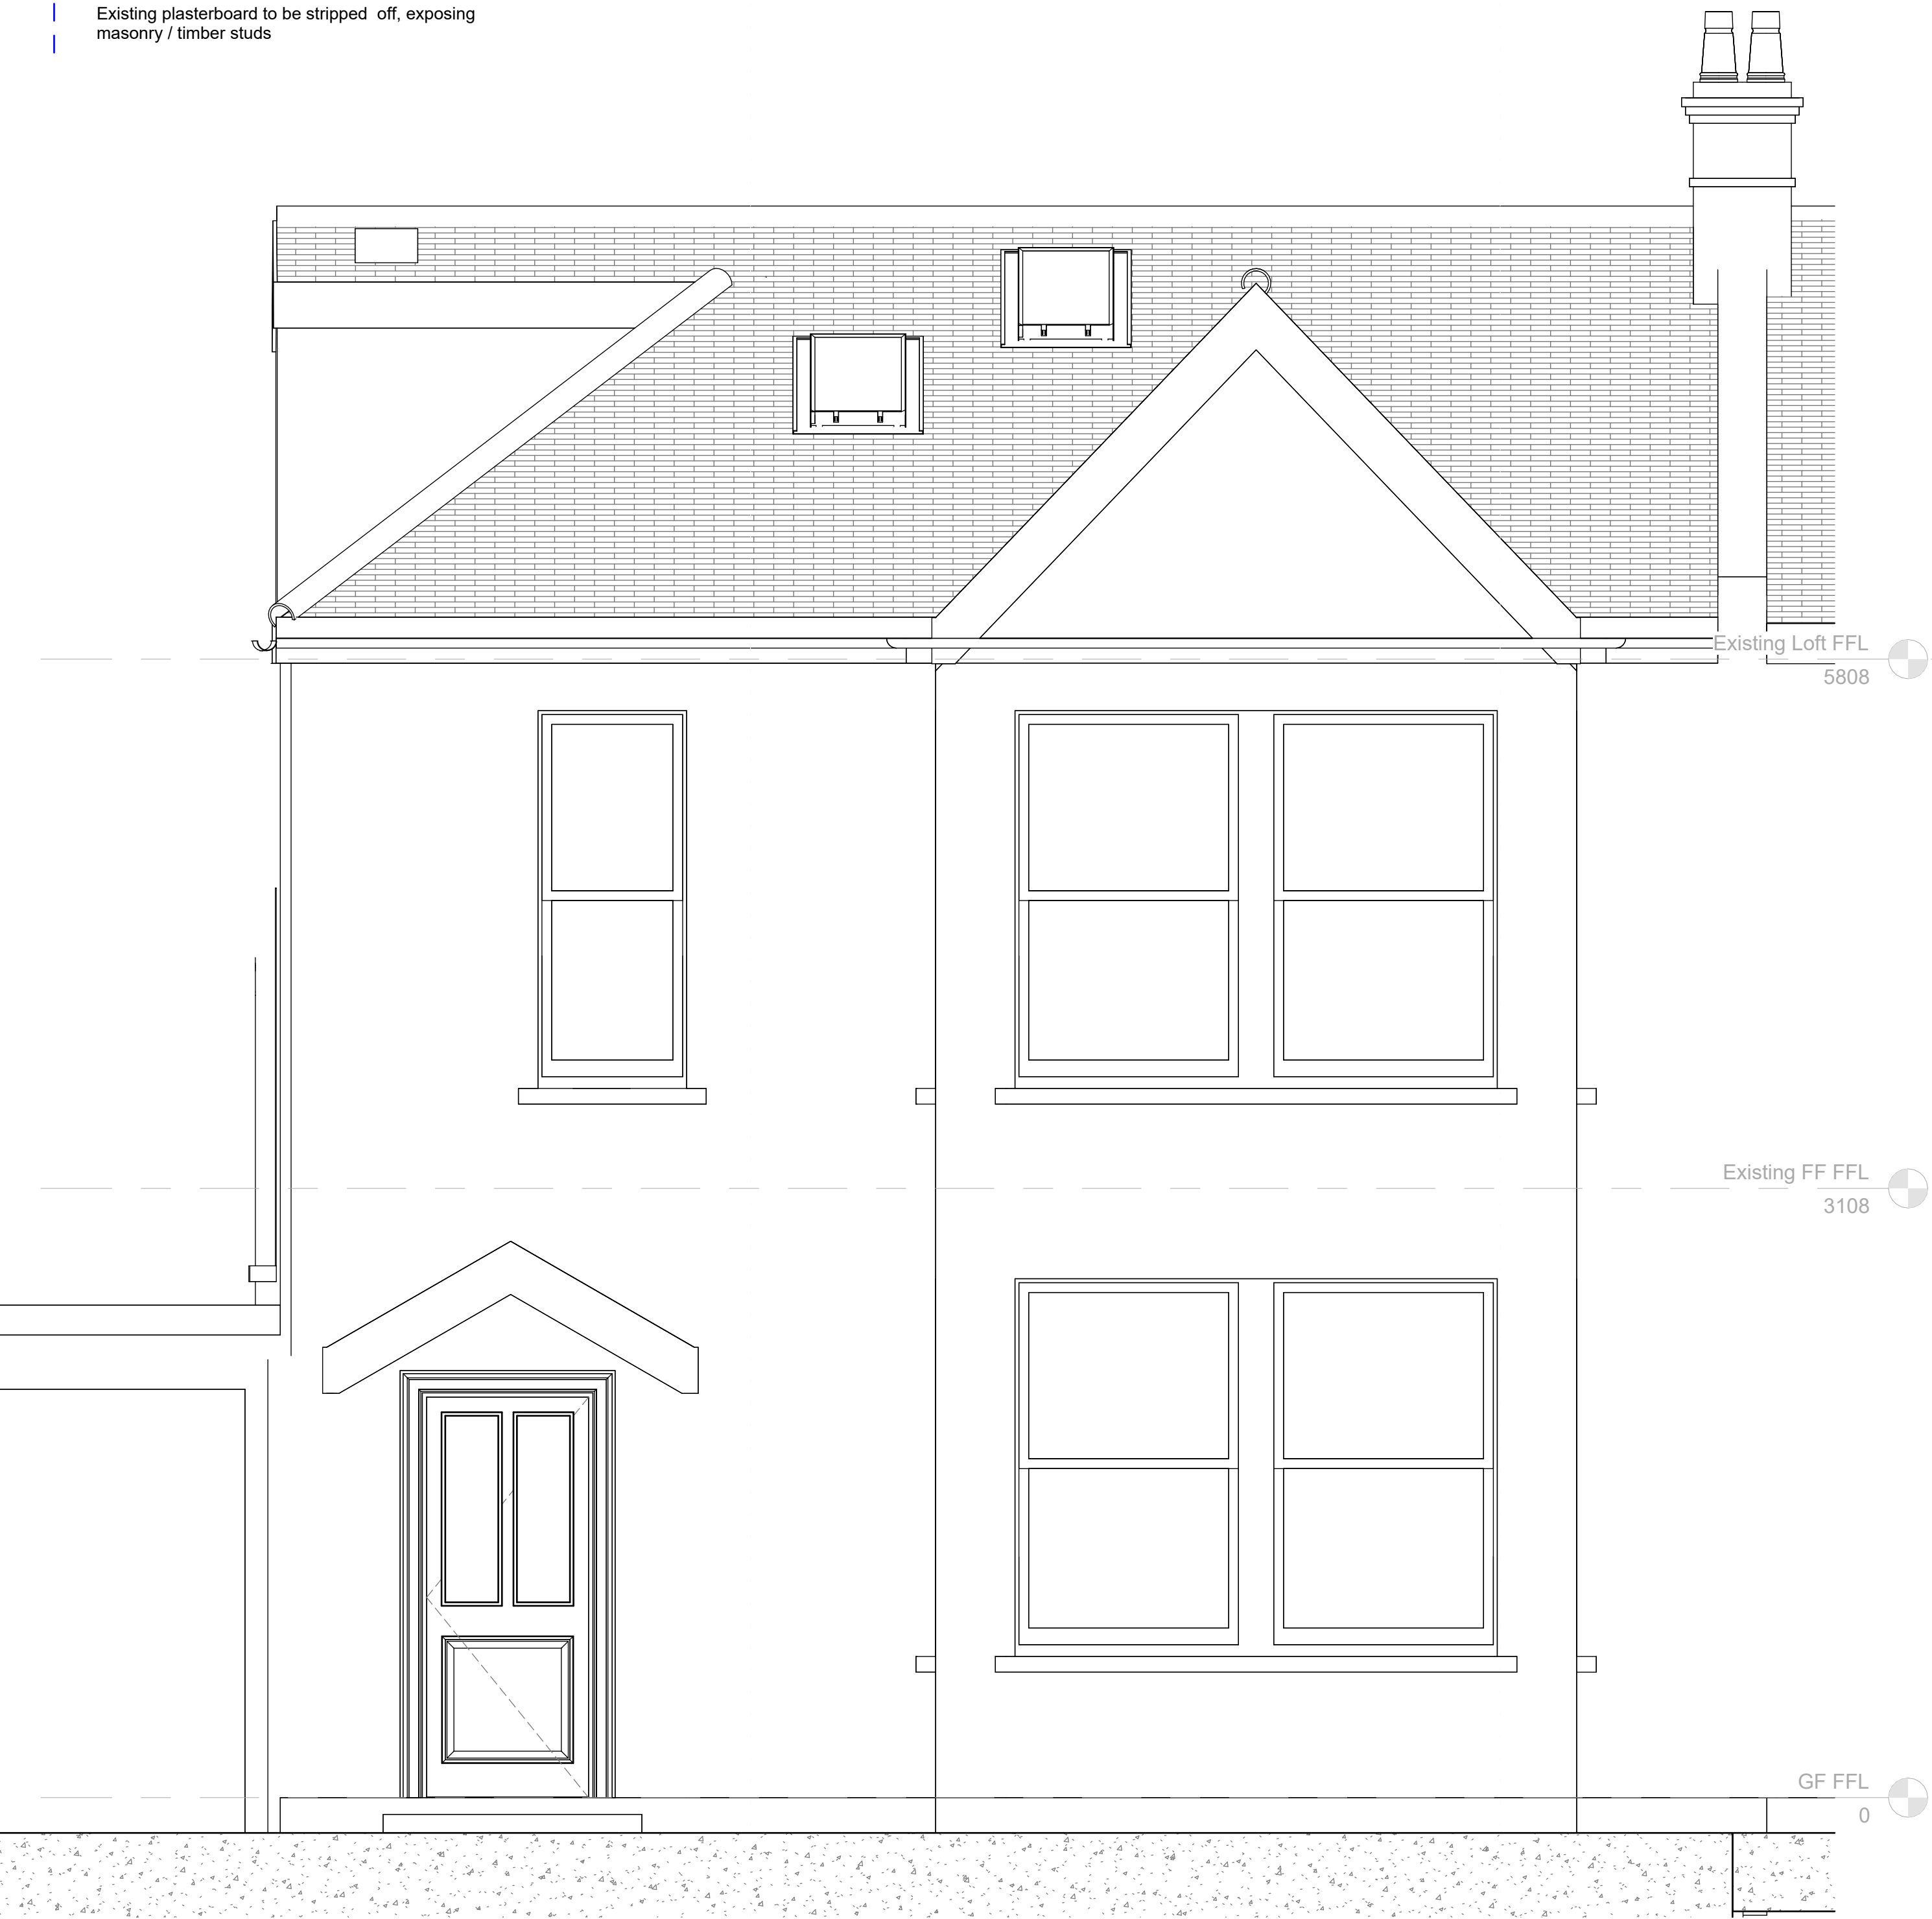
1 Demolished Front Elevation  
1 : 25

Removed existing elements. Temporary support to be provided where required.

Existing plasterboard to be stripped off, exposing masonry / timber studs
