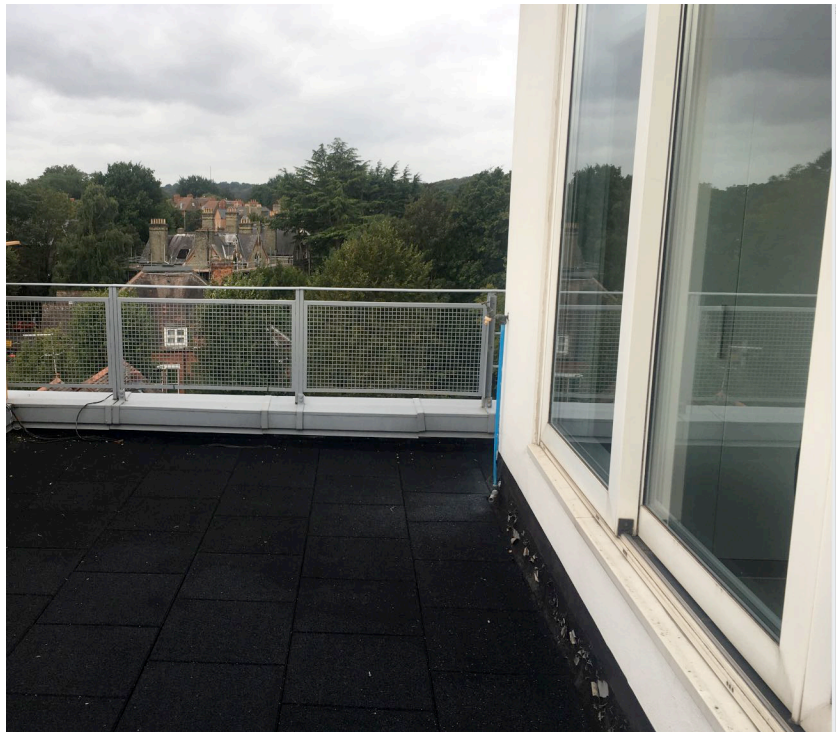
Existing guardings on West side of front terrace

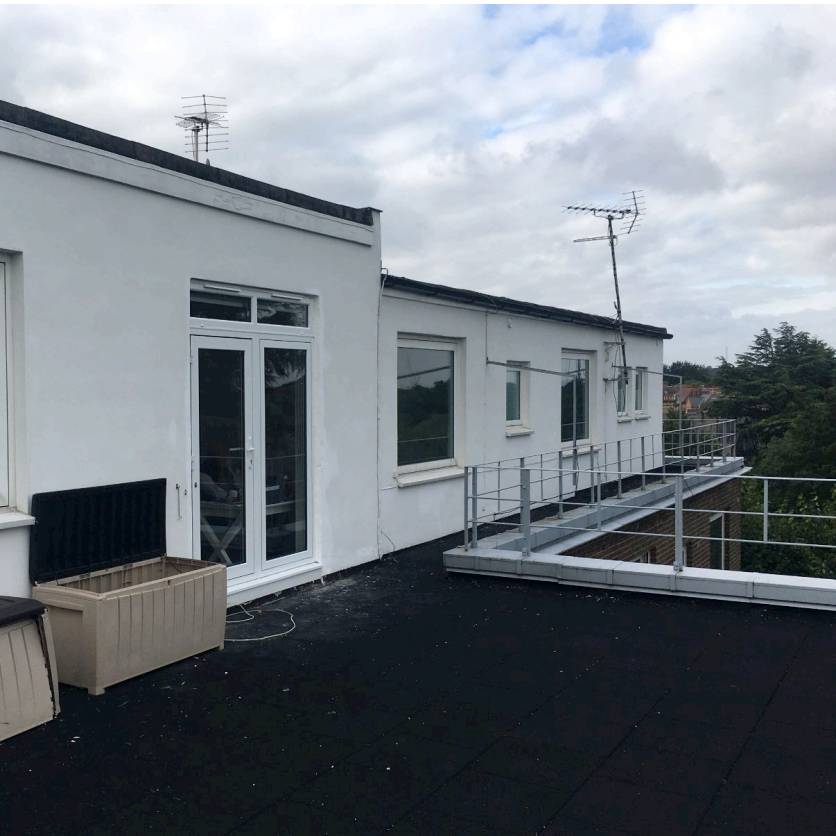
Existing guardings on rear terrace

Note: these guardings are even more non compliant than the others with no infil, voids larger than 100mm and are climbable

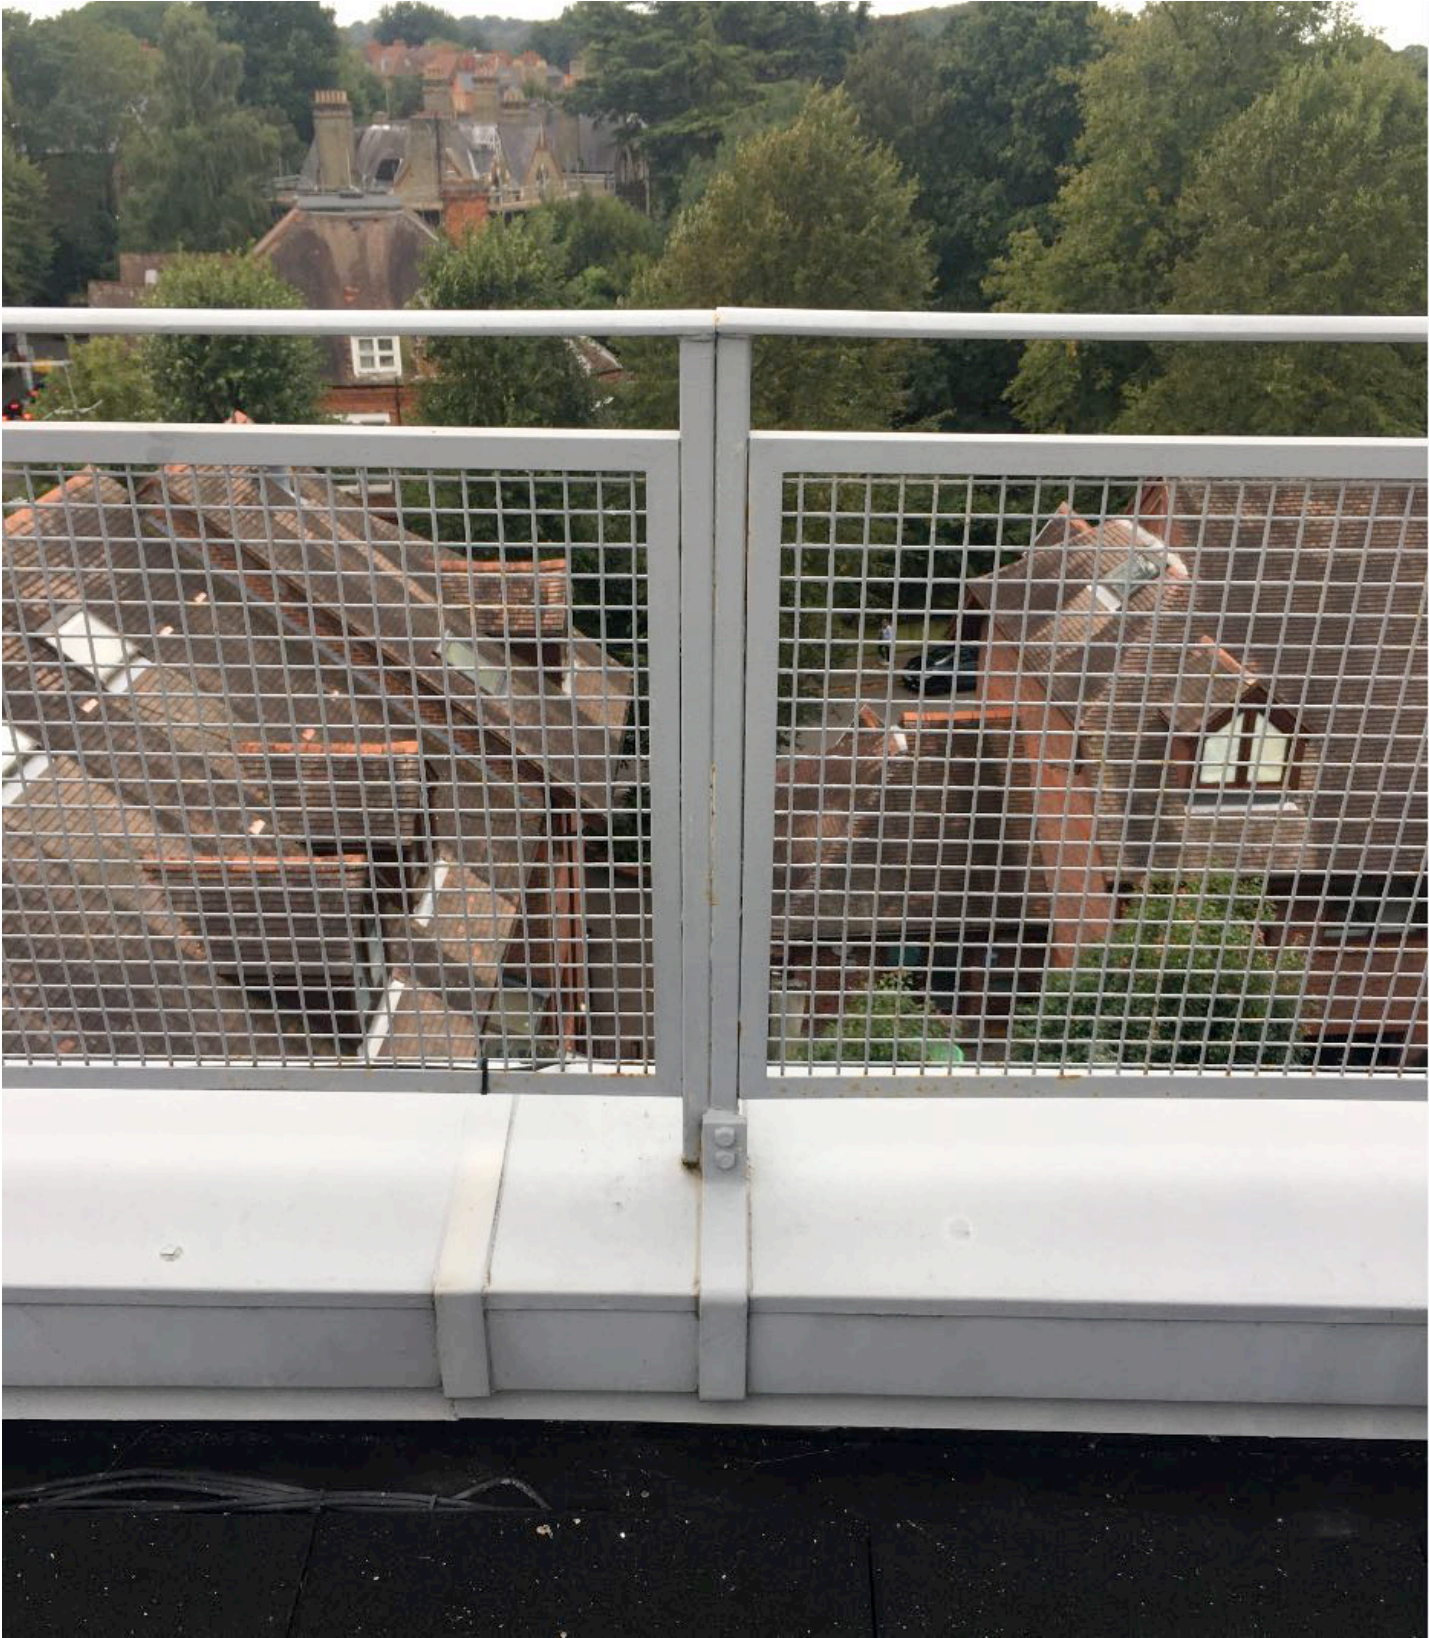
Existing guardings on South side (front) terrace

Note: Parapet that can be used as a step, compromising the effective height.
