Regarding the requirement of condition 3 to include details of the use and extent of bricks from the existing building in the new front elevation.

25 Sheldon Avenue  
Reclaimed Bricks

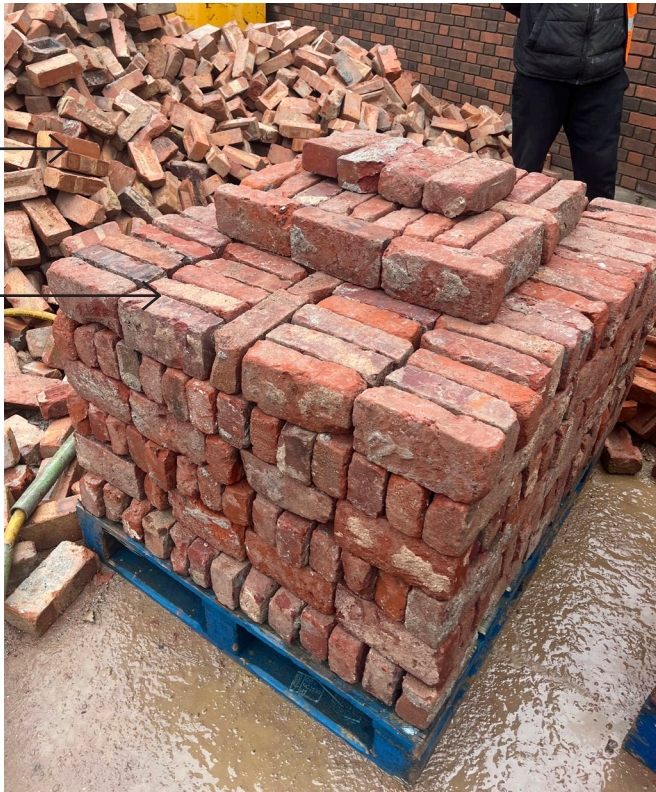
However, it was found that they were set within a hard cement mortar making it impossible to keep the bricks intact. The below photo shows a pallet of the salvaged bricks and it is clear that the arris has been knocked off, meaning that the bricks no longer have crisp corners, and the brick face is damaged with remnants of the cement mortar.

Inner leaf LBC common bricks

Outer leaf facing bricks

The Material Specification document details the new brick specification and shows that great effort has been taken to find the best match for the existing brick blend. Traditional hand-made bricks have been specified comprising of a bespoke blend of 4 bricks to exactly match the existing. Mixing these damaged salvaged bricks with the new would look unsightly and it is proposed to use only new on the front elevation to give the best visual appearance to the street.
