HGY/2022/2556  
Discharge Condition 3.1

3.1 - Heritage method statement for removal of canopy and drainage pipes from front elevation and subsequent repairs to façade.

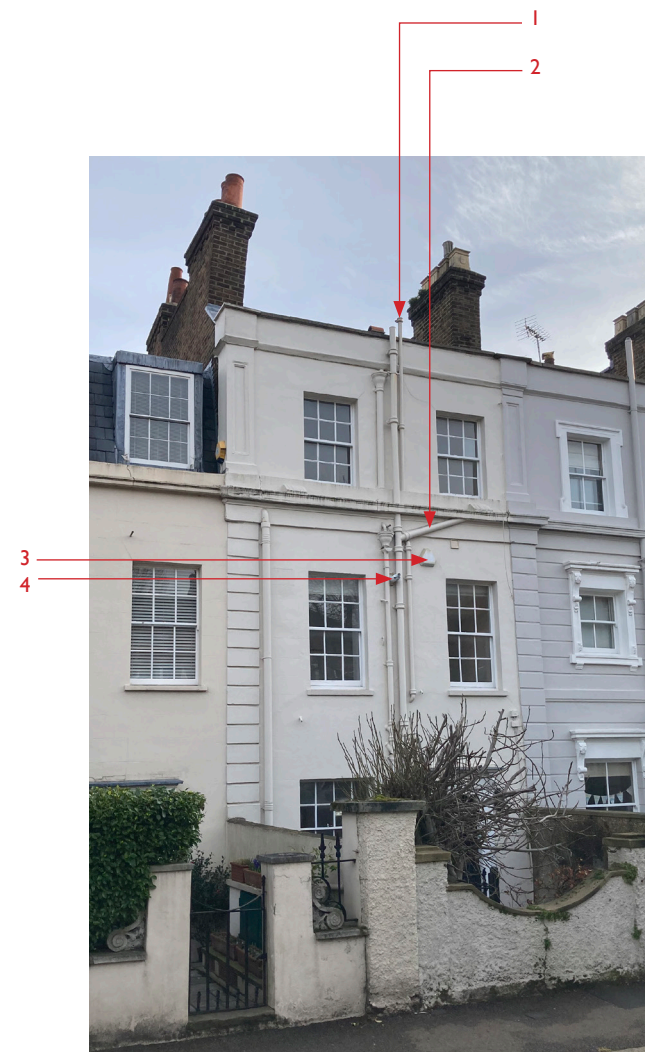
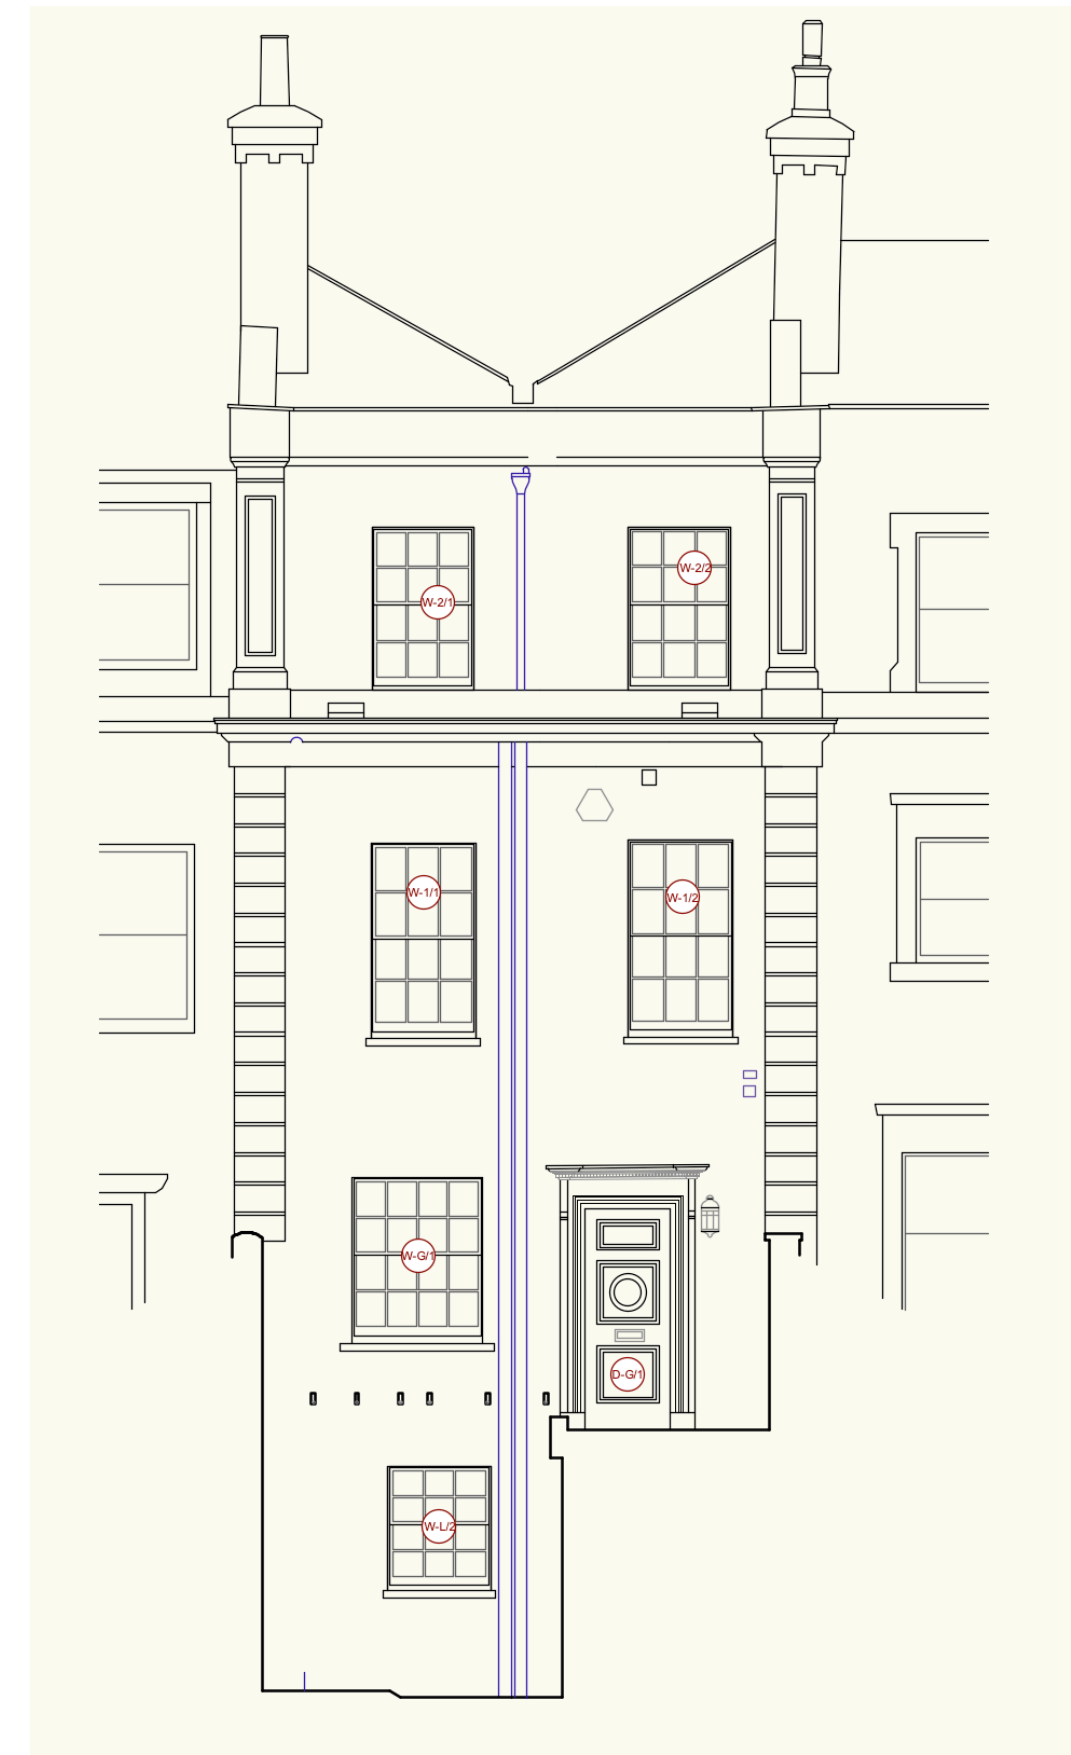
- Works to front elevation
- 1) Pipe Removed
  - 2) Pipe Removed
  - 3) Alarm Removed
  - 4) Boiler Flue removed
  - 5) Pipe Removed

Proposed Front Elevation - Two central pipes waste and rainwater run off from the roof

Any vegetable matter to be carefully removed along with any loose / damaged materials / mortar / paint. Missing or damaged areas of render to be carefully removed back to solid material Any holes or cracks to be filled using lime based mortar. Sills to be repainted white - to match existing - with breathable exterior grade paint to match host building.

All damaged & rotten timbers to window, sills & sash frames to be carefully removed and replaced with matching timber framing profiles. All glazed panels to be single glazed. Draught rebated strips to be installed between sash leaves and box frame to provide improved thermal performance. Sash weights, pulleys and ropes to be carefully removed, refurbished and / or replaced where necessary. Replacement items to match existing.

All timbers to be repainted white to match existing colouration. All surrounding interior & exterior finishes to be made good with re-pointing (where required) to be with a lime mortar and to match colour and pointing style of host building. Interior areas of redecoration around windows to be made good with lime based plaster.
