### BRUCE CASTLE WEST BOUNDARY WALL EXTERNAL ELEVATIONS 01

**Bruce Castle Wall**

Title: Bruce Castle West Boundary Wall External Elevations 01  
Drawing No: 0722422-Sk06 Scale: 1:50 @ A3

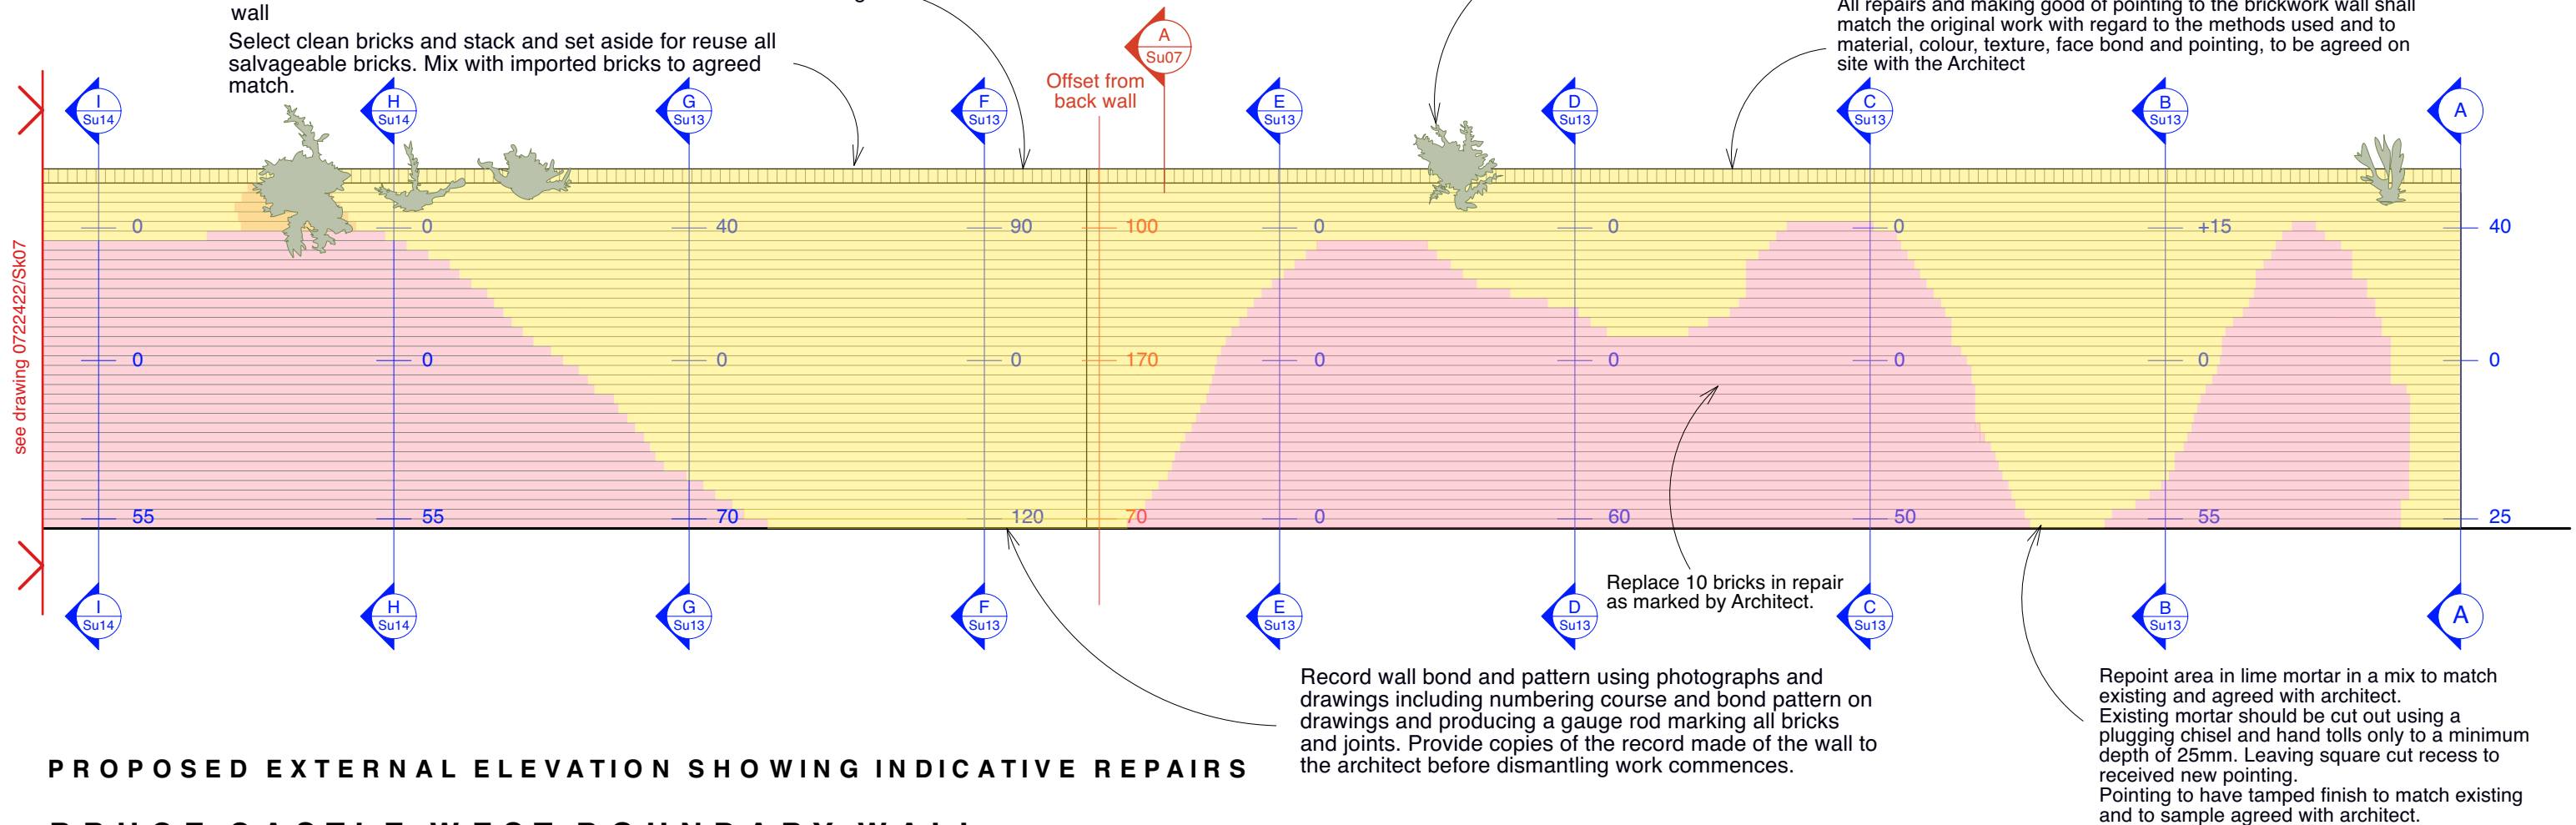
## PROPOSED EXTERNAL ELEVATION SHOWING INDICATIVE REPAIRS

Carefully take down area of bowing and dislodged brickwork as agreed with architect.

Rebuild brickwork bonded to core of wall where it can be salvaged and retained. All brickwork to be rebuilt to bond to match existing wall

Select clean bricks and stack and set aside for reuse all salvageable bricks. Mix with imported bricks to agreed match.

Carefully cut away or trim any vegetation which can easily be removed from the wall. Small plants and moss cushions should be removed with stiff fibre brushes and spatulas or a low pressure water lance where surfaces are sound. Buddelia should be cut back as close as possible to the face of the wall. Immediately spray with an appropriate herbicide before roots and shoots seal themselves.

All repairs and making good of pointing to the brickwork wall shall match the original work with regard to the methods used and to material, colour, texture, face bond and pointing, to be agreed on site with the Architect
