## **1. Summary**

- 1.1. Treework Environmental Practice are instructed by OCI Architecture to provide a brief Technical Note discussing arboricultural impacts and methods of mitigating those impacts from the replacement of the existing wooden fence located adjacent to trees T25 and T26, with a higher wooden fence supported by concrete posts at 11-13 Stanhope Gardens, Highgate, N6 5TT, as shown in sketch CFM-85447-SK-041.
- 1.2. I met online with Oana Ciurescu of OCI Architects on 23 February 2024 to discuss the methodology used during the installation of the existing fence, and the acceptable methodology of the installation of the new fence.
- 1.3. This document seeks to discuss the principals of removal of the existing fence and installation of the new in relation to the current tree stock and to outline methodologies to demonstrate feasibility of methodology.

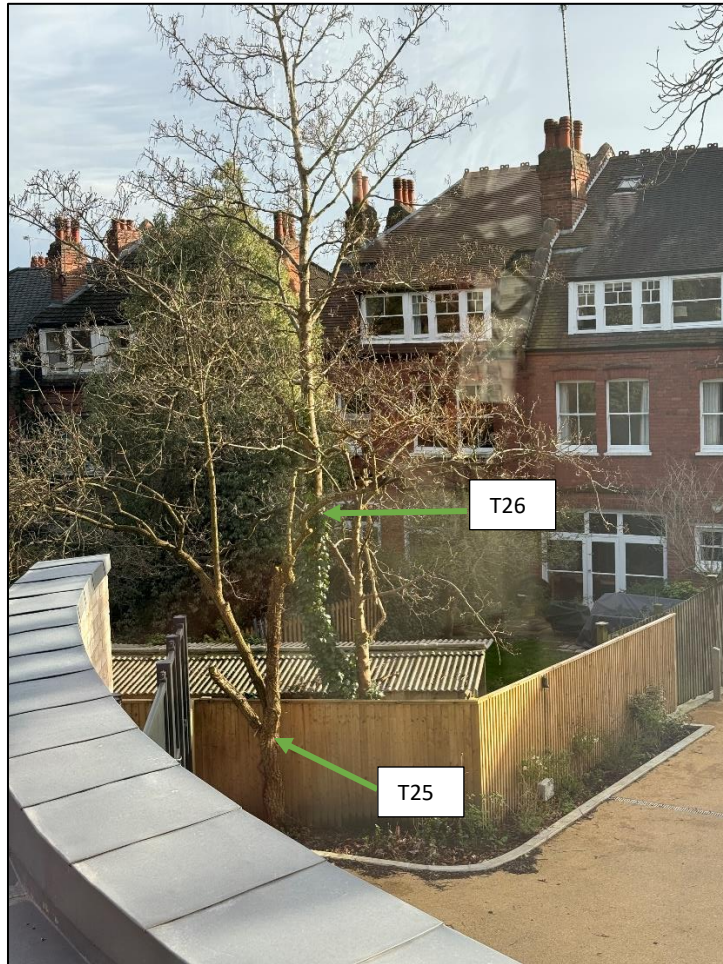
**Photo 1:** Showing trees T25 & T26 and existing fence.

- 3.1. Our previous tree survey indicates that two trees will be impacted through this operation. T25 is a low-quality category C elder and T26 is a low-quality category C sycamore. Both trees are set back from publicly accessible areas at the end of a private drive. They have very little public amenity value due to their location and low quality. As such I consider them to have very little value to the wider landscape.

- 4.1. During our discussion I've been informed by Oana Ciurescu that installation of the existing fence was carried out in a highly tree sensitive manner. This included trial pits at each of the post spike locations to ensure no significant roots were impacted. I also understand that it is entirely possible for new fence posts to be located in the same positions to support the new panels.

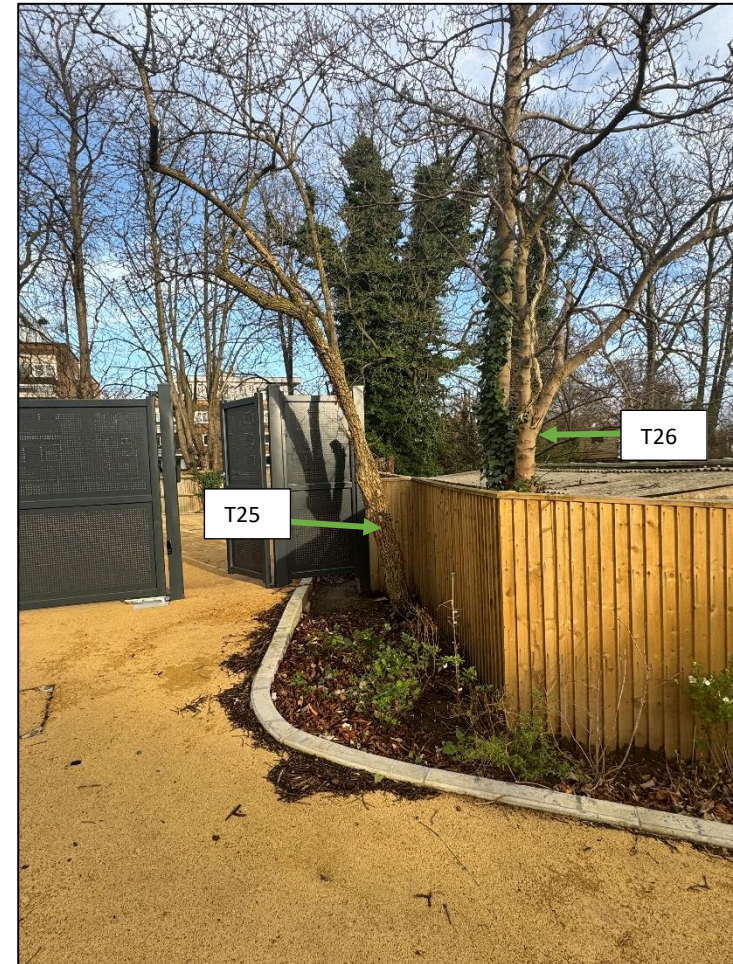
**Photo 2:** Showing trees T25 & T26 and existing fence.
