Project:  
No. 2 Courtenay Avenue, Kenwood, London N6

Plan: Landscape/  
Hard Landscaping layout

Drawing No. 003-2CA

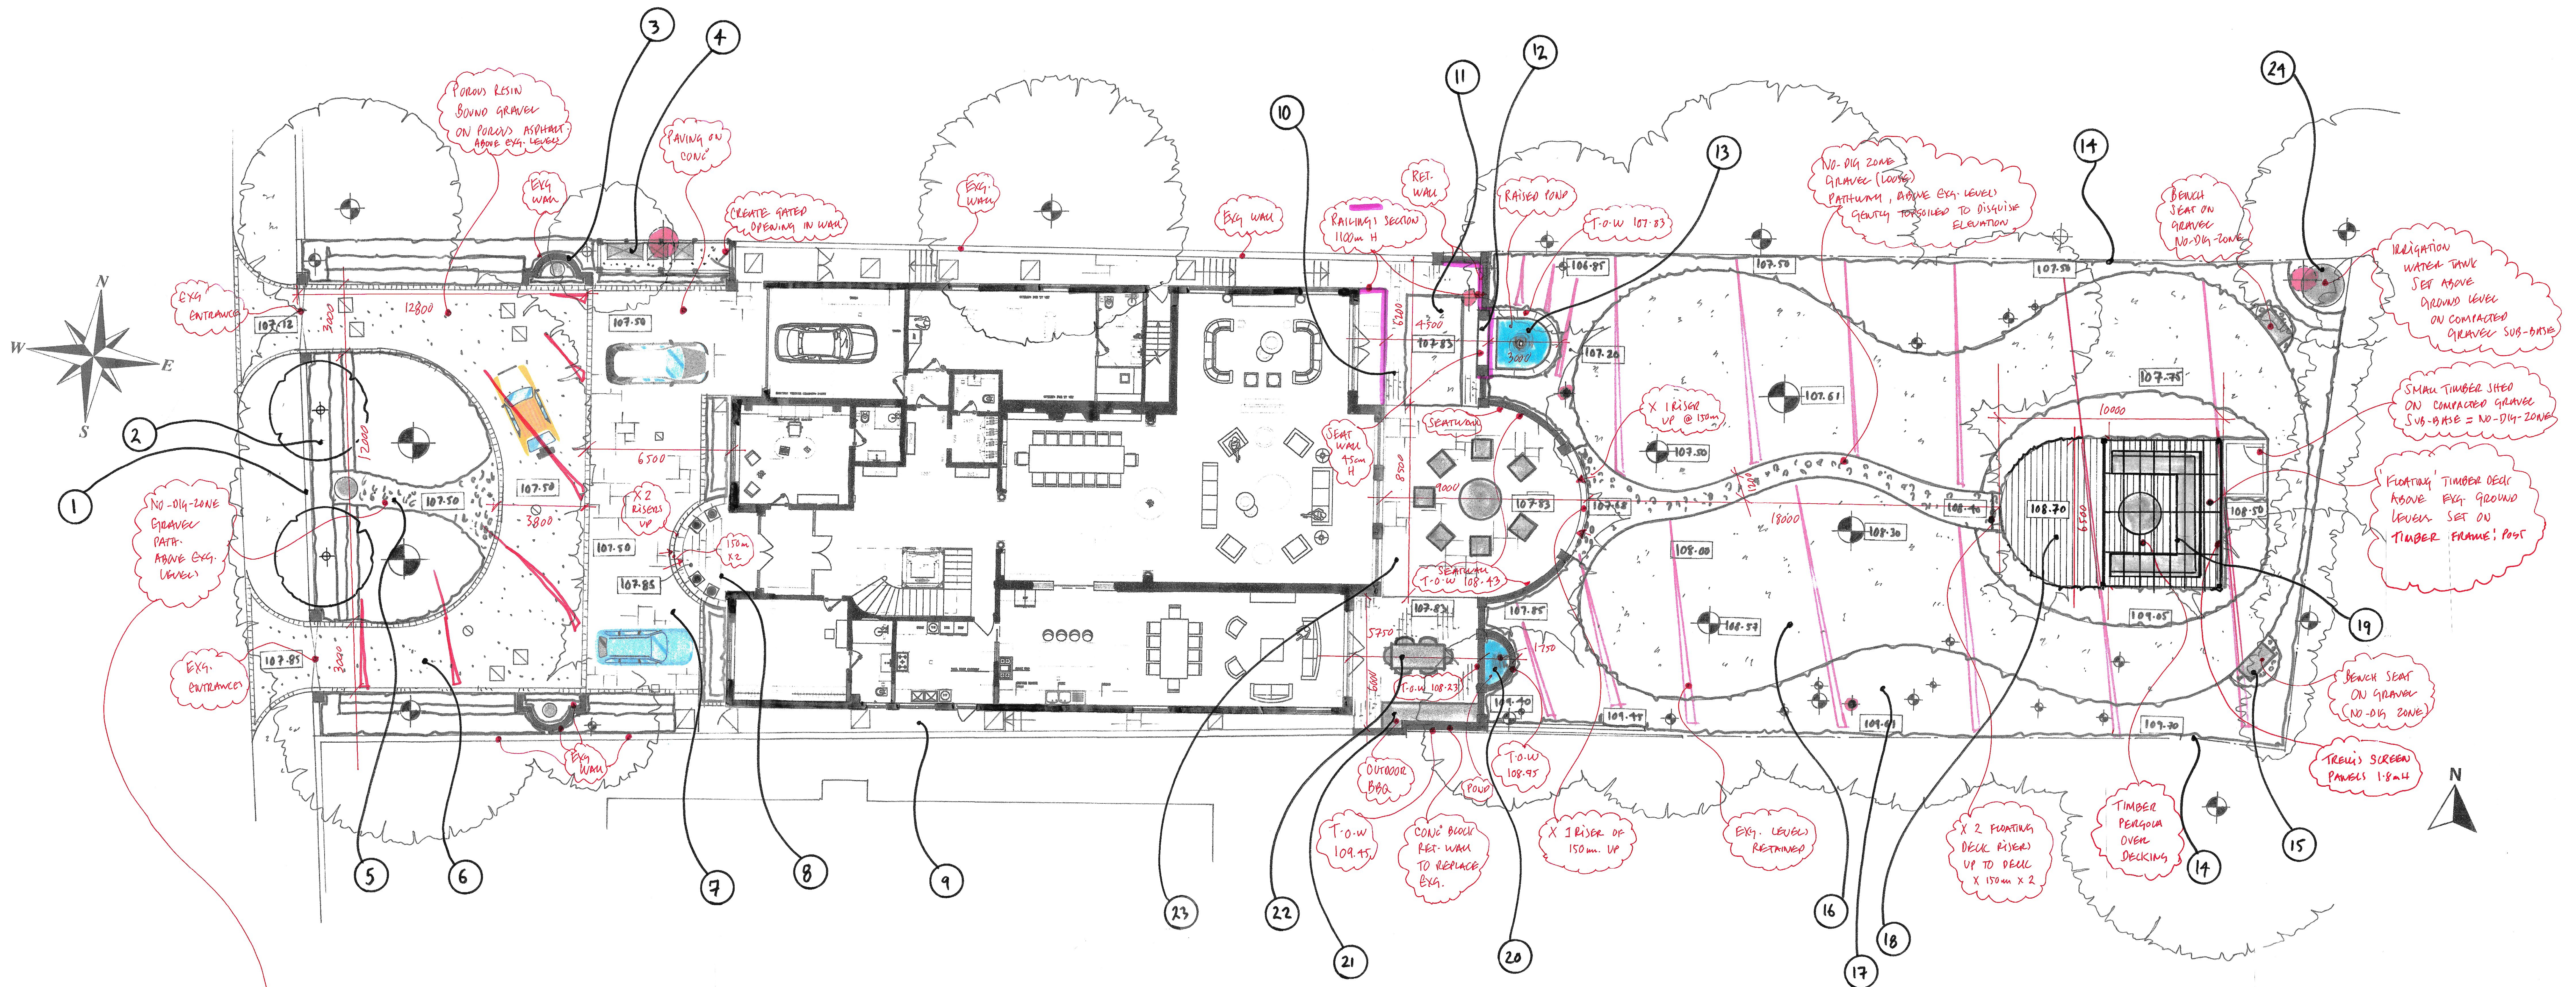
- 1 Boundary Wall Repaired/ replaced as necessary.
- 2 New Bay Hedge and Evergreen magnolia trees to replace failing X Cupressus leylandii hedge.
- 3 Existing Wall features restored.

- 4 Hidden bin/recycling/ composting enclosure.
- 5 Gravel pathway (No-Dig zone)
- 6 Porous resin bound gravel driveway/ over porous asphalt, edges with Granite setts.

- 7 Stone paved area (On concrete) for parking. Edged with granite setts.
- 8 Portland stone tiled entrance portico.
- 9 Sandstone paved side pathways.
- 10 New York Stone - Paved terrace areas (Small unit size)

- 11 Lawn/ astroturf children's play area.
- 12 Seat-wall to view children and pond.
- 13 Raised pond with fountain.
- 14 New dark green stained 2m High close boarded fence with timber posts. Softened with planting.

- 15 Seating Benches on no-dig gravel areas.
- 16 Lawn areas following existing sloped levels.
- 17 Densely planted areas. Refer to Planting Plan.
- 18 Hardwood deck terrace set above existing ground levels.

- 19 Timber pergola dining area, above deck. With Climbing plants.
- 20 Retaining wall with waterfall to lower pool.
- 21 BBQ area.
- 22 Dining terrace. With Small unit size New York stone.

- 23 Large random New York stone paved terrace.
- 24 GRP Irrigation tank, above existing ground levels/ on compacted gravel base. Screened by hedge.
