Cranwood House

| Topographical Survey & Laser Scanning | 1:200@ A1 | Survey Information | |
| CTS-MC 0129 20-21(1) | B | 15-12-20 | 17-06-21 |

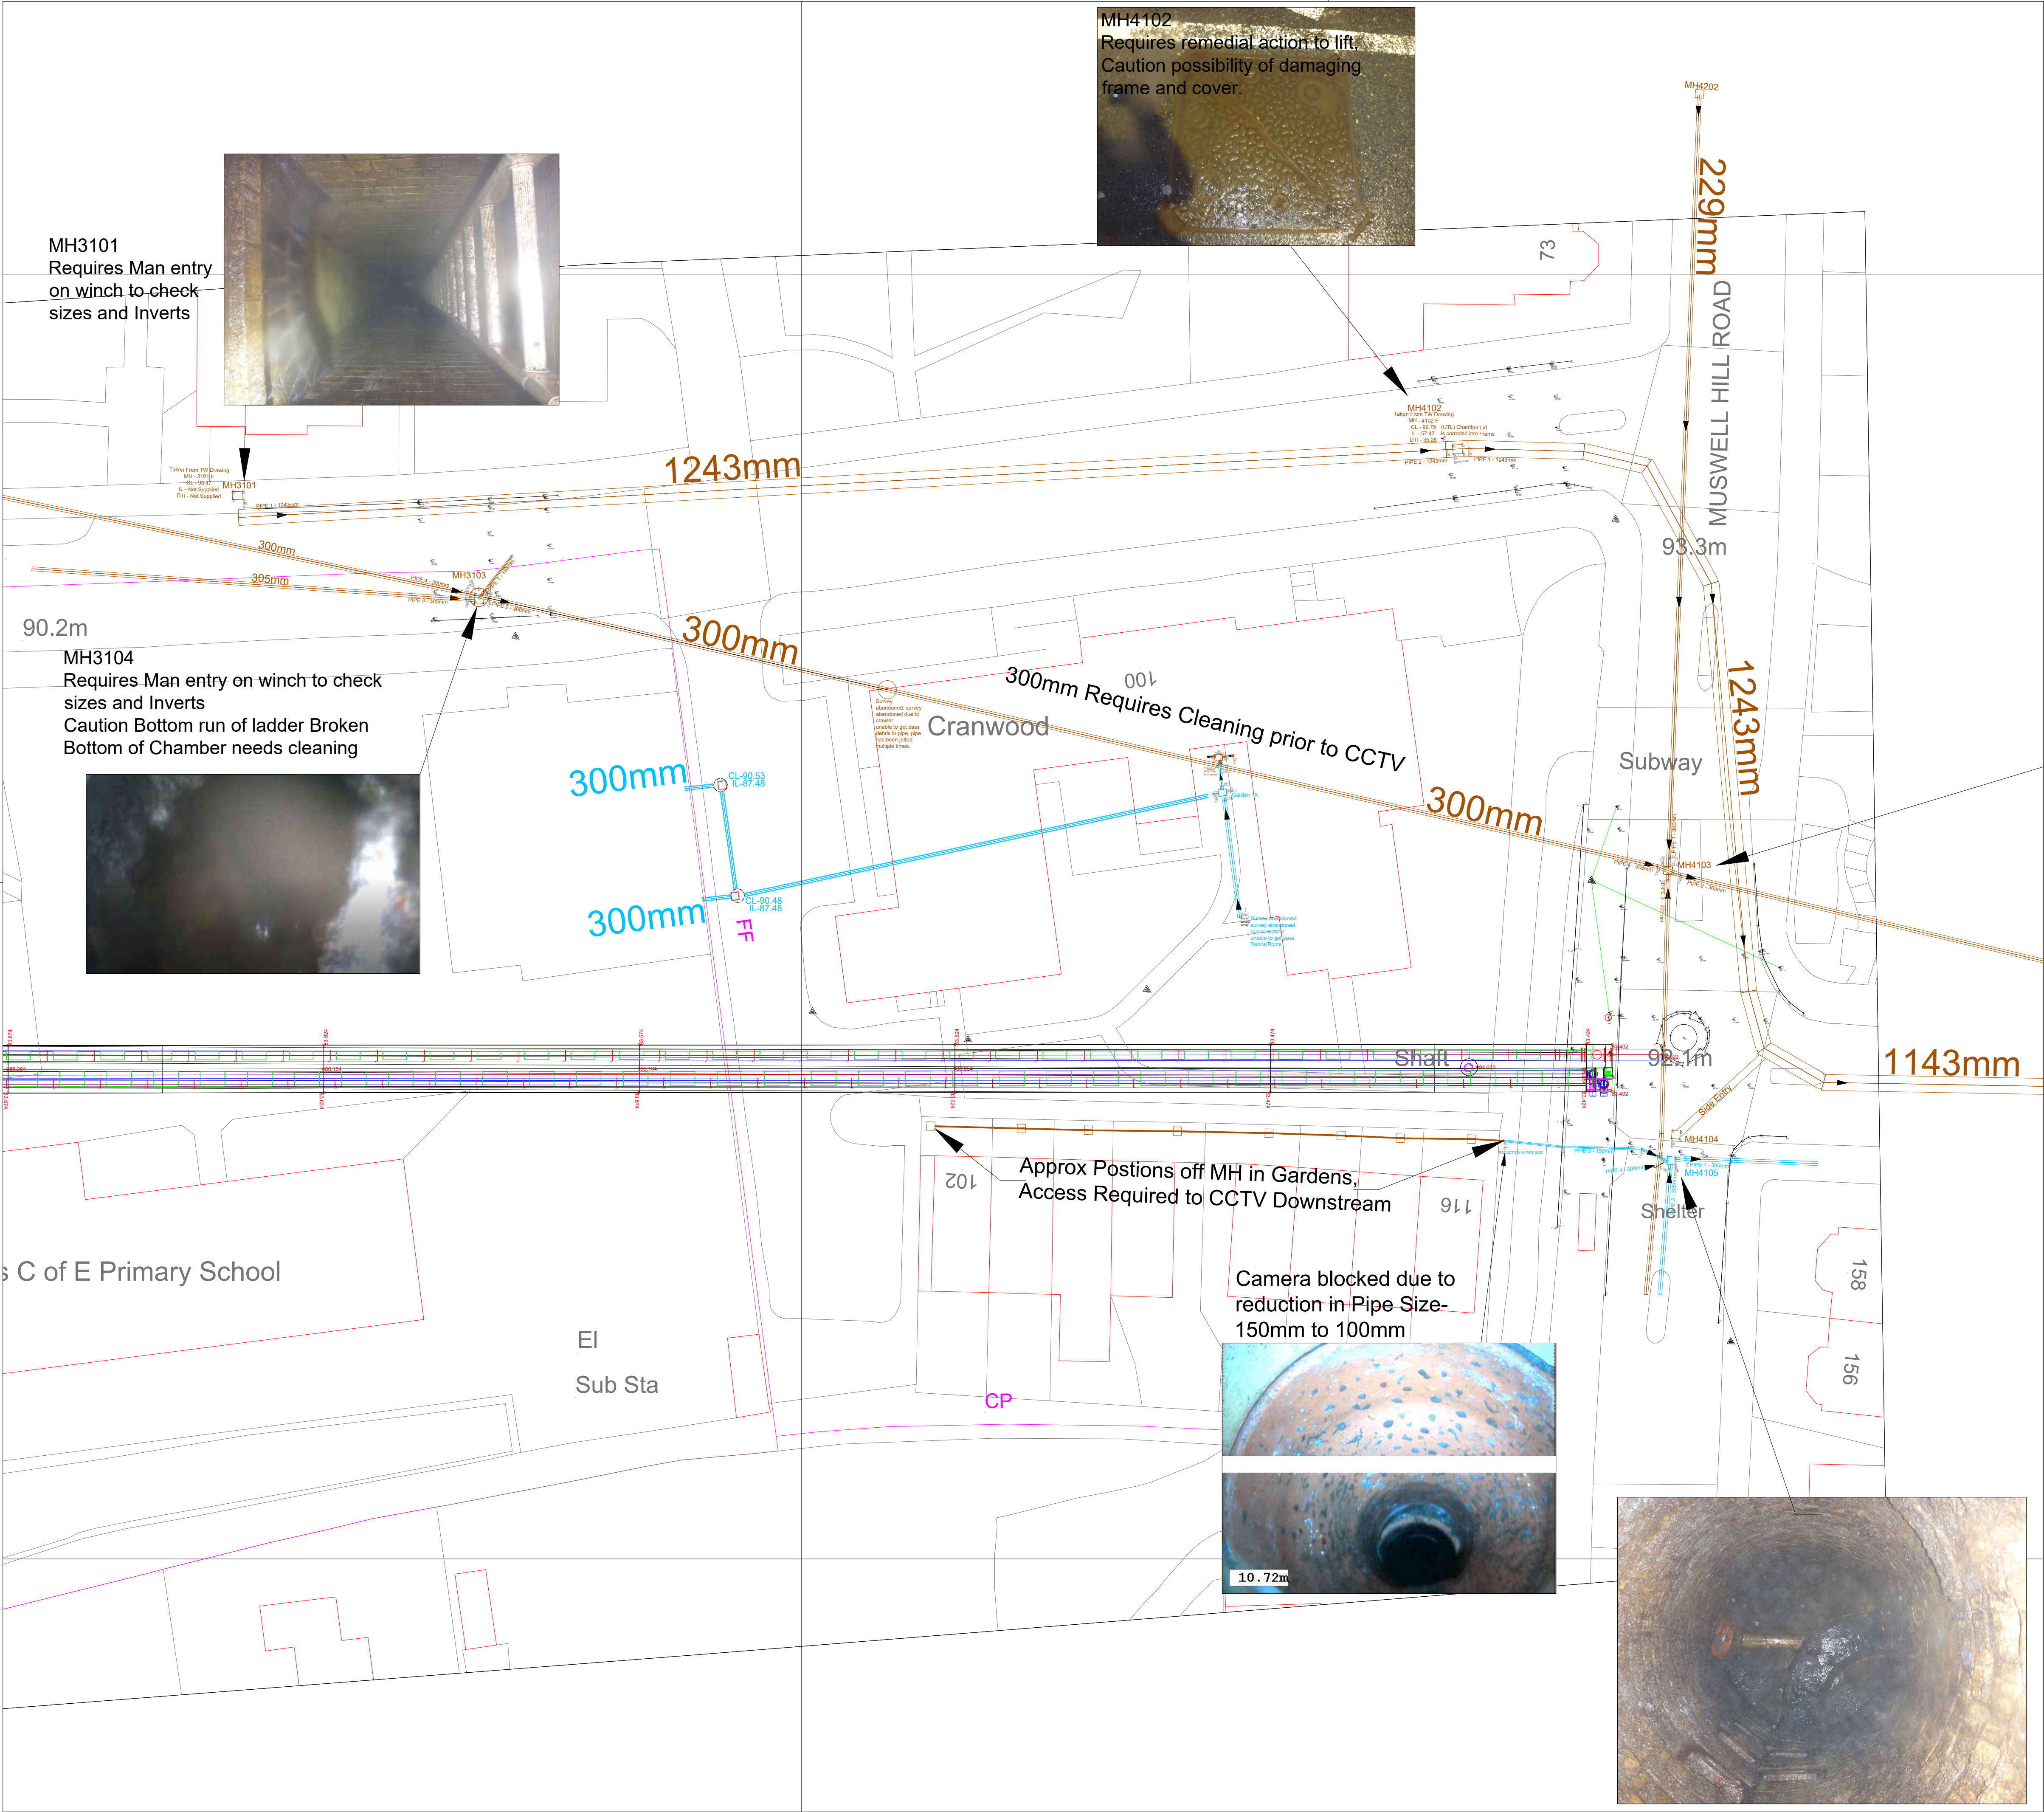
MH3101  
Requires Man entry  
on winch to check  
sizes and Inverts

MH4102  
Requires remedial action to lift.  
Caution possibility of damaging  
frame and cover.

MH3104  
Requires Man entry on winch to check  
sizes and Inverts  
Caution Bottom run of ladder Broken  
Bottom of Chamber needs cleaning
