## 5.0 Heritage Statement

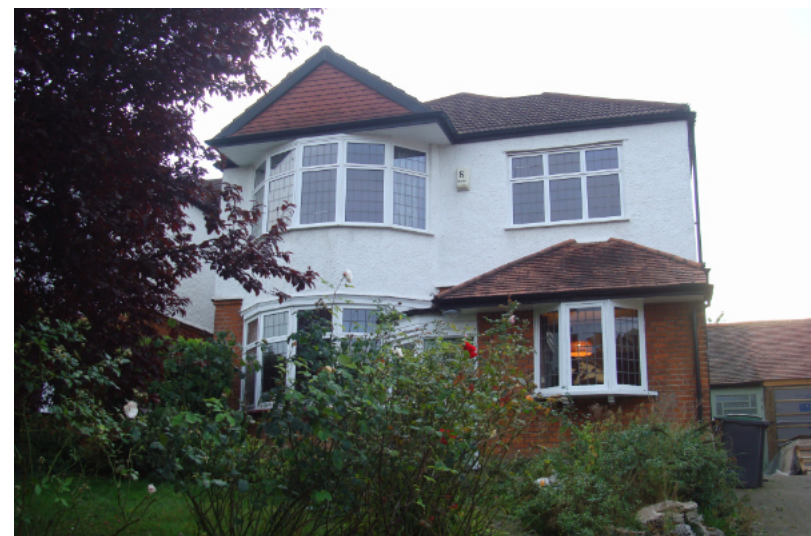
Fig 19. Front elevation of number 57.

Number 57 is no exception to these original features though noticeably it has to date received virtually no additional development. Modern UPVC framed windows have replaced the original timber ones. Internal features largely remain in tact with timber panelling to the entrance lobby and simple decoration in the form of picture rails and cornicing. A fine, stain-glass window serves the tall stairwell to the side elevation; a common feature on this particular street.

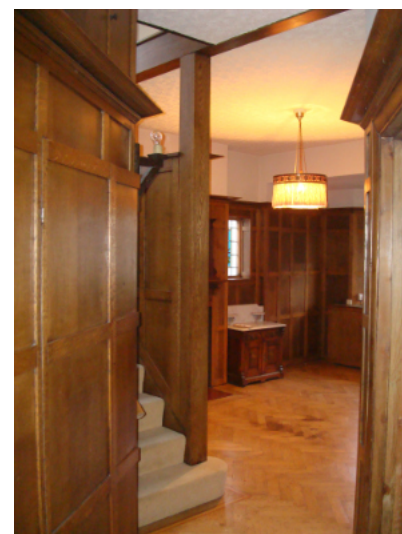
Fig 20. Entrance lobby featuring original timber panelling.
