## ASBESTOS DEMOLITION SURVEY

| Site | Cranwood, 100 Woodside Avenue, Muswell Hill, London, N10 3JA |
| Survey reference | J050727 |

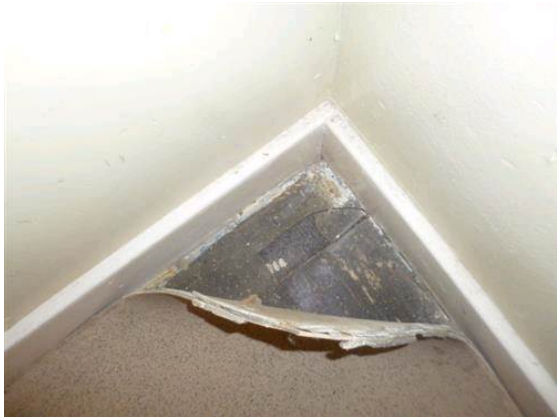
| <b>Comments:</b> Chrysotile found in adhesive & floor tile | |

| <b>Recommended Action</b> | Remove |

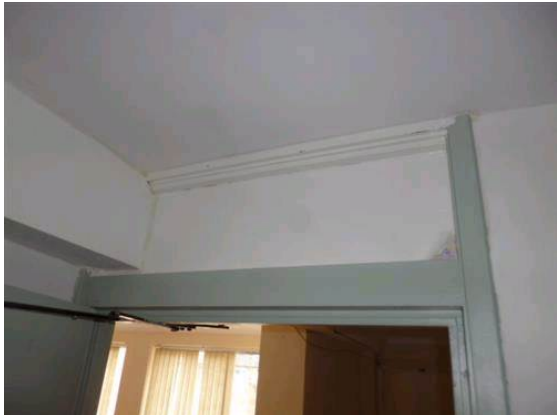
| Risk code | Risk code D |

| Recommended Action | Remove |

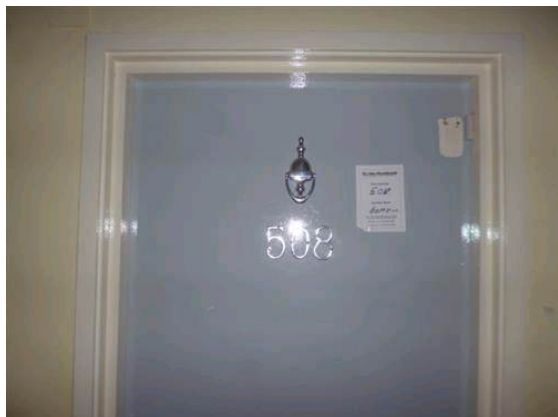
| Item Reference | J050727 #42 |

**Recommended Action****Comments:** occupied

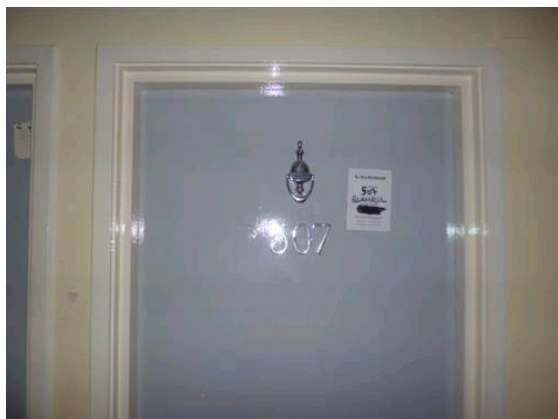
| Item Reference | J050727 #43 |

**Recommended Action****Comments:** occupied

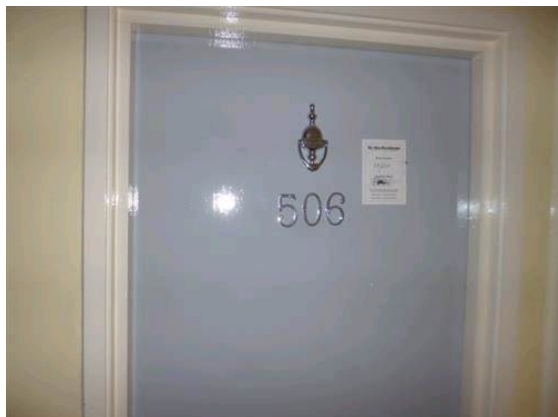
| Item Reference | J050727 #44 |

**Recommended Action****Comments:** occupied

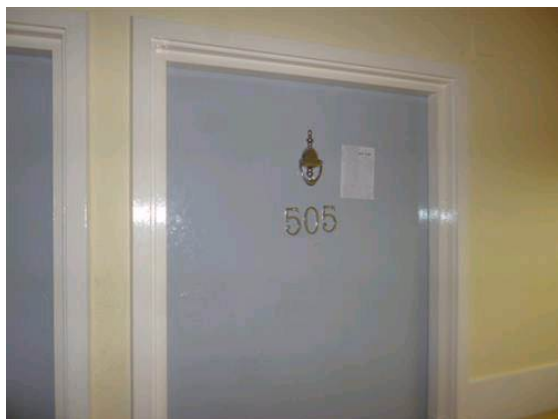
| Item Reference | J050727 #45 |

**Recommended Action****Comments:** occupied

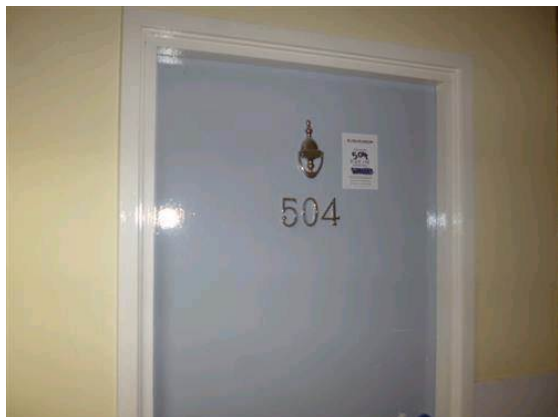
| Item Reference | J050727 #46 |

**Recommended Action****Comments:** occupied

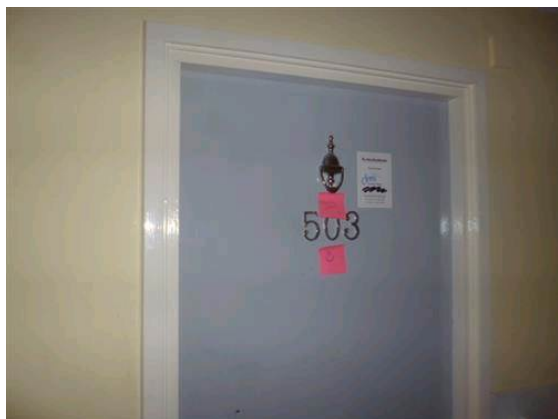
| Item Reference | J050727 #47 |

**Recommended Action****Comments:** occupied

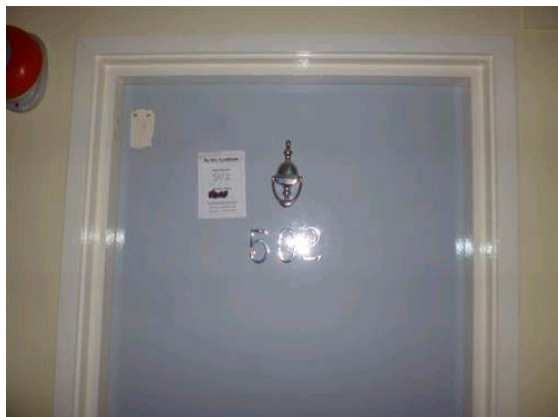
| Item Reference | J050727 #48 |

**Recommended Action****Comments:** occupied

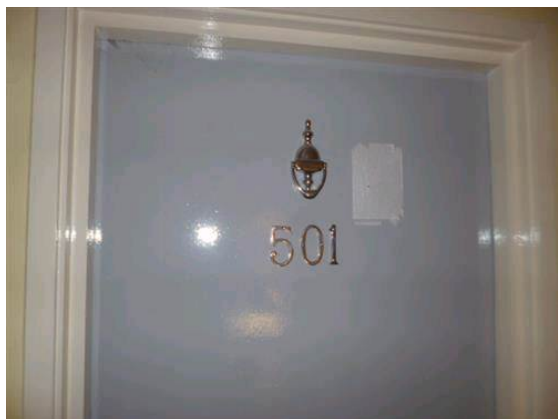
| Item Reference | J050727 #49 |

**Recommended Action****Comments:** occupied

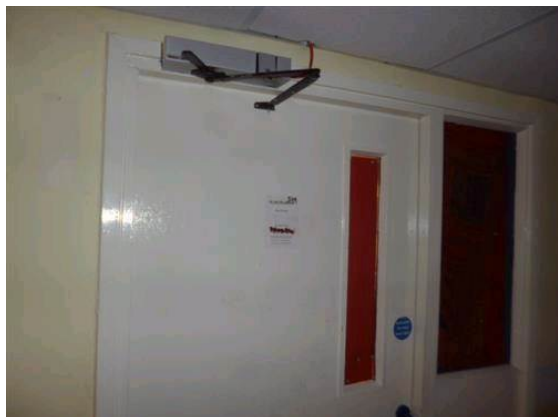
| Item Reference | J050727 #58 |

**Recommended Action****Comments:** occupied

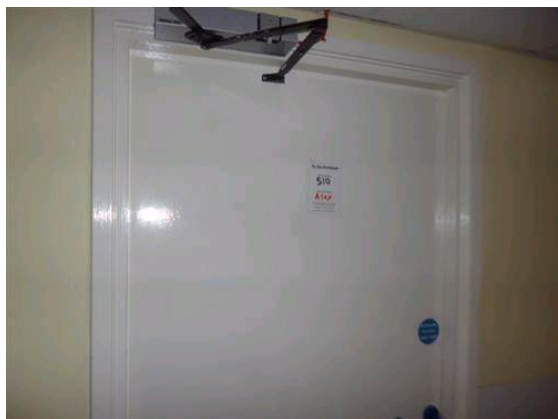
| Item Reference | J050727 #59 |

**Recommended Action****Comments:** occupied

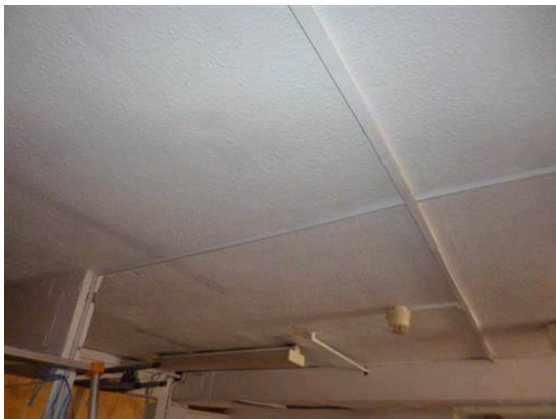
| | Item Reference | J050727 #61 |

| | Condition / damage | (0) Good Condition |
| | Risk code | Risk code E |

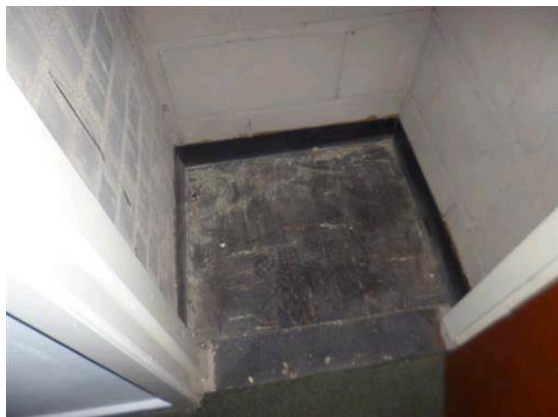
| Item Reference | J050727 #66 |

| Condition / damage | (0) Good Condition |

**Comments:** Chrysotile found in adhesive & floor tile

**Recommended Action** Remove

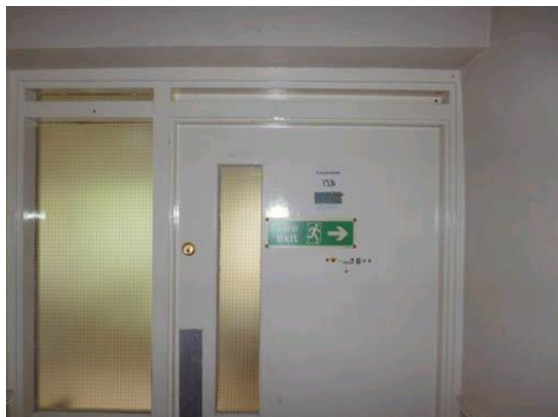
| Item Reference | J050727 #70 |

**Recommended Action****Comments:** occupied

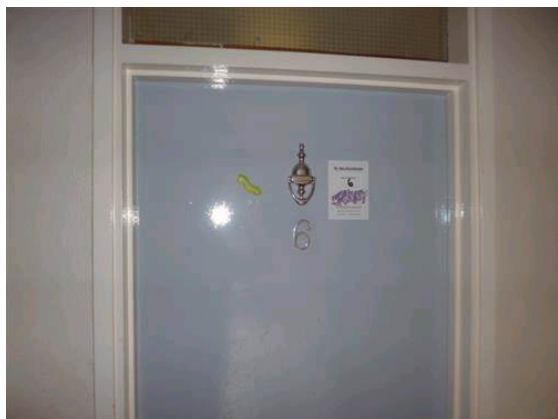
| Item Reference | J050727 #71 |

**Recommended Action****Comments:** occupied

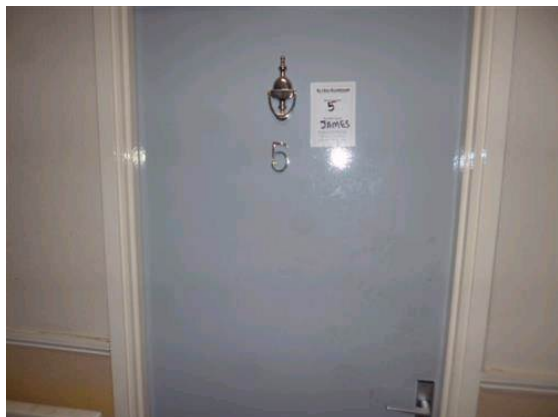
| Item Reference | J050727 #74 |

**Recommended Action****Comments:** occupied

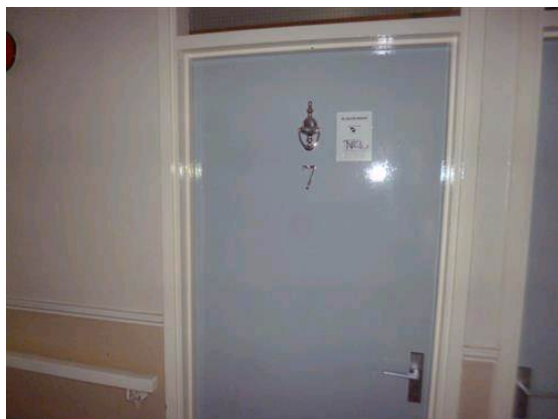
| Item Reference | J050727 #75 |

**Recommended Action****Comments:** occupied

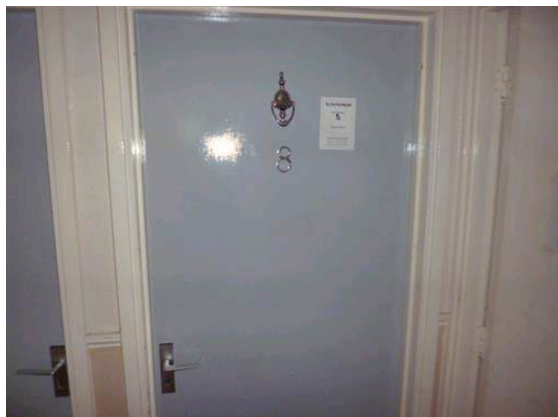
| Item Reference | J050727 #76 |

**Recommended Action****Comments:** occupied

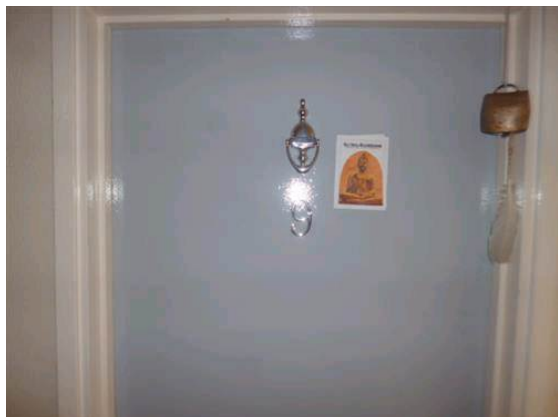
| Item Reference | J050727 #78 |

**Recommended Action****Comments:** occupied

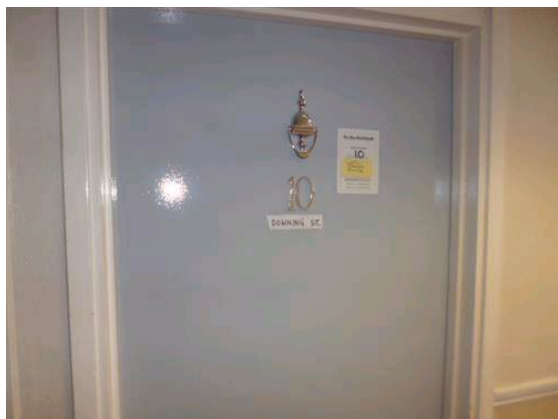
| Item Reference | J050727 #79 |

**Recommended Action****Comments:** occupied

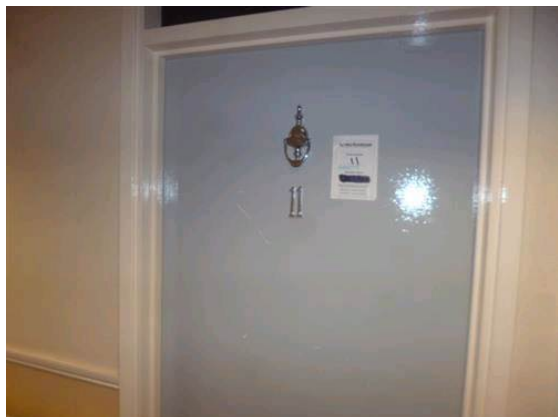
| Item Reference | J050727 #80 |

**Recommended Action****Comments:** occupied

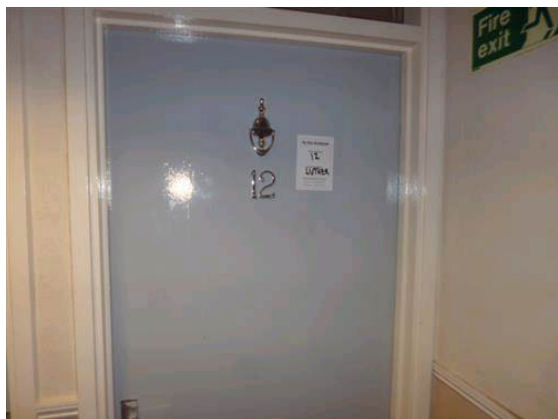
| Item Reference | J050727 #81 |

**Recommended Action****Comments:** occupied

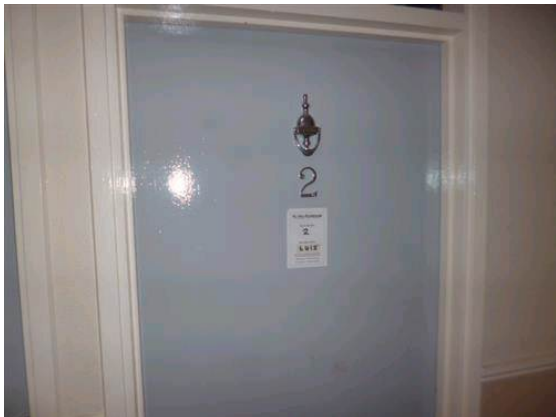
| | Item Reference | J050727 #92 |
| <b>Recommended Action</b><br><b>Comments:</b> occupied | Asbestos Type | No access to room/area presume asbestos. |

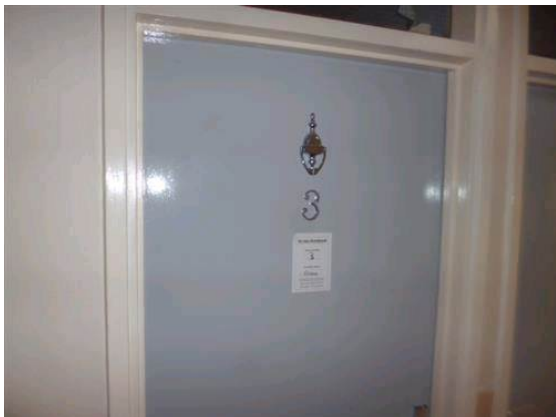
| | Item Reference | J050727 #93 |
| <b>Recommended Action</b><br><b>Comments:</b> occupied | Asbestos Type | No access to room/area presume asbestos. |

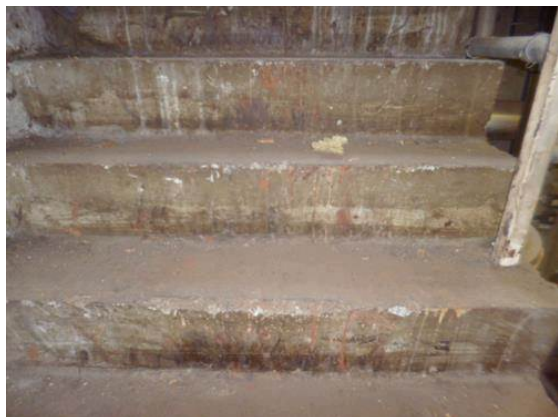
| Item Reference | J050727 #110 |

| Condition / damage | (3) High Damage |

Restrict access to area and remove

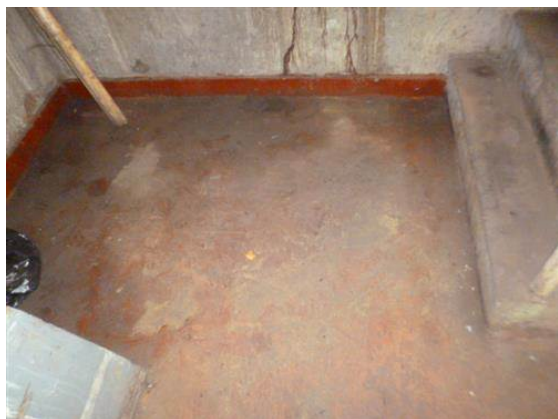
| Item Reference | J050727 #111 |

| Condition / damage | (3) High Damage |

Restrict access to area and remove

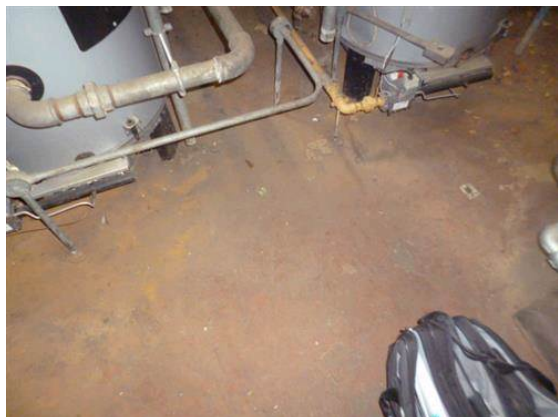
| Item Reference | J050727 #112 |

| Condition / damage | (3) High Damage |

Restrict access to area and remove

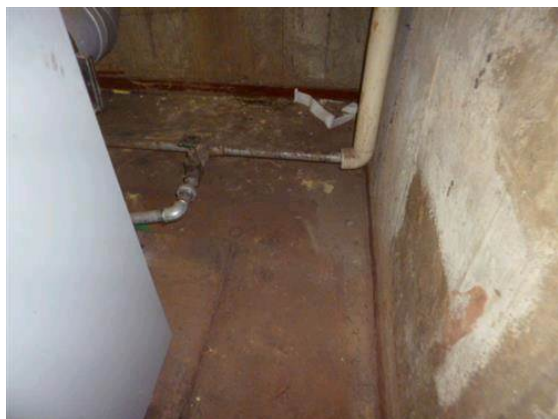
| Item Reference | J050727 #113 |

| Condition / damage | (3) High Damage |

Restrict access to area and remove

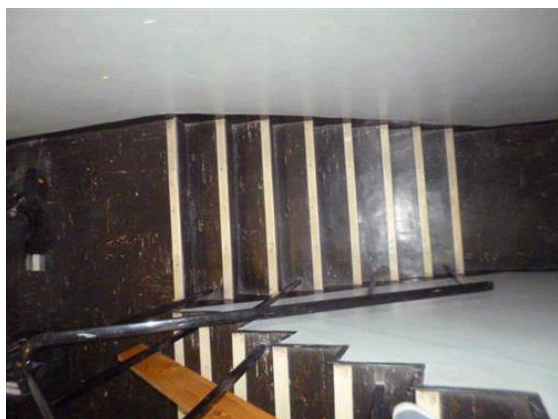
| Item Reference | J050727 #116 |

| Condition / damage | (0) Good Condition |

**Recommended Action** Remove  
**Comments:** Chrysotile found in adhesive & floor tile

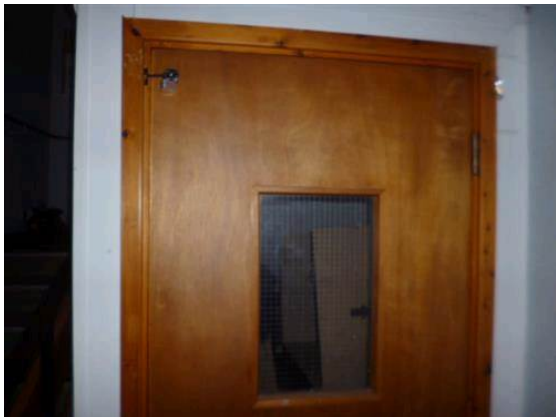
| | Item Reference | J050727 #118 |
| Comments: no keys | Material assessment score | |
| | Risk code | Risk code F |

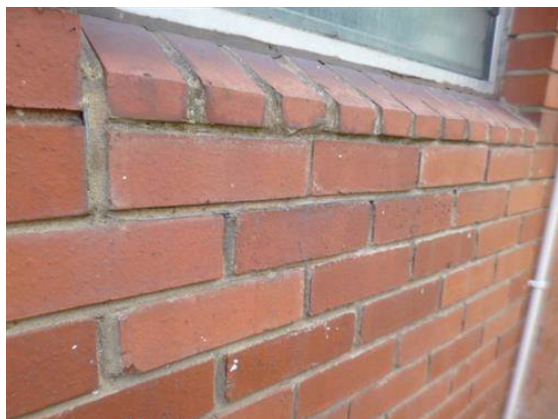
| Item Reference | J050727 #123 |

| Condition / damage | (0) Good Condition |

Remove

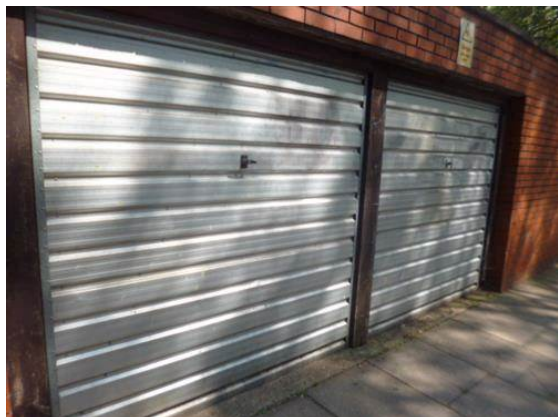
| Item Reference | J050727 #124 |

| Risk code | Risk code F |

**Recommended Action****Comments:** no keys
