## Condition Survey Photos

Condition Survey Schedules

**Roger Mears Architects LLP**

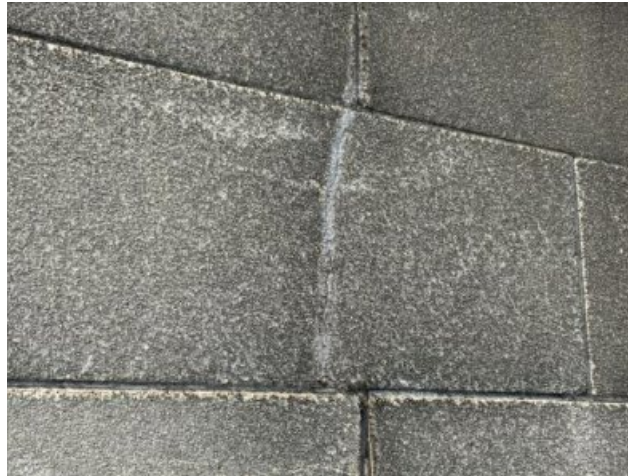
CRACK /  
LOAD  
PARTY?

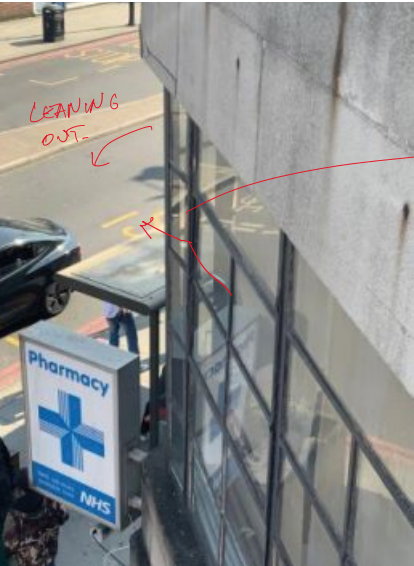
kink  
in  
window

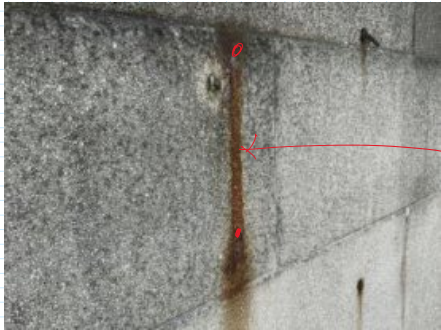
CRACKING  
FROM  
OLD  
BRACKET  
PLATING

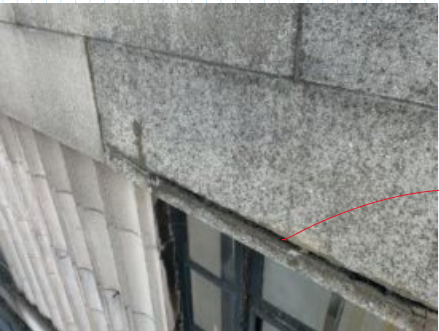
CORRODED  
REINFORCE

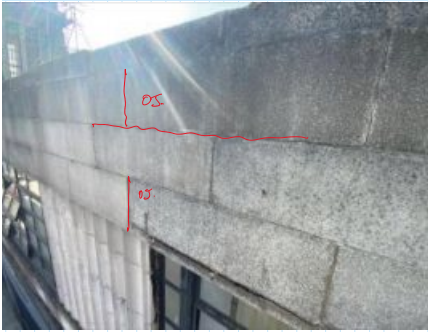
LOW-LEVEL  
CRACKING

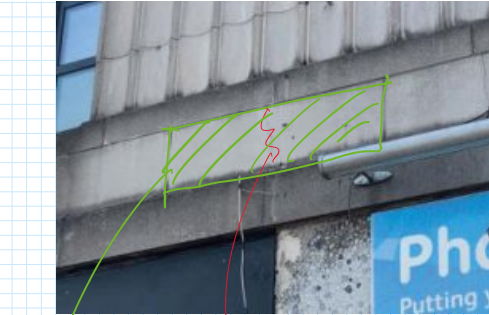
CUT OUT  
PARAPET  
- SLIP -

CRACK

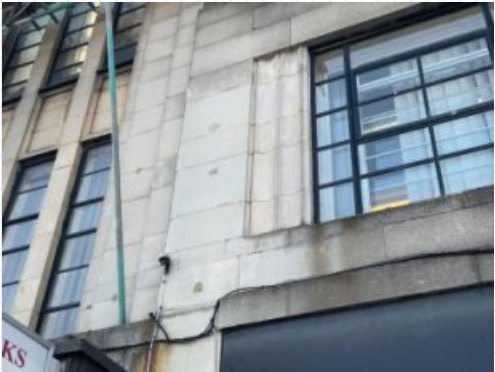
DR. DOOR  
PANELED

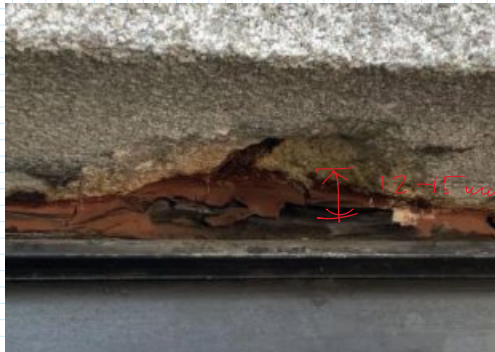
12-15 mm

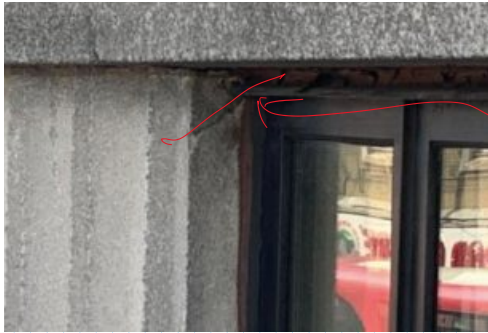
CRACK

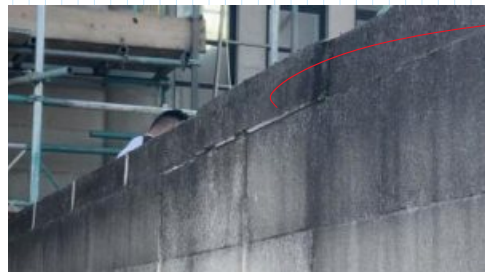
DISLODGED

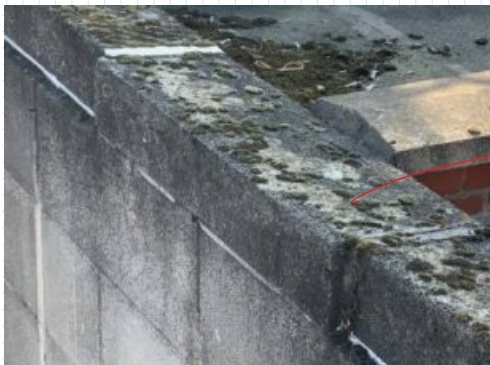
DISLODGED  
- OVER HEATED CURE

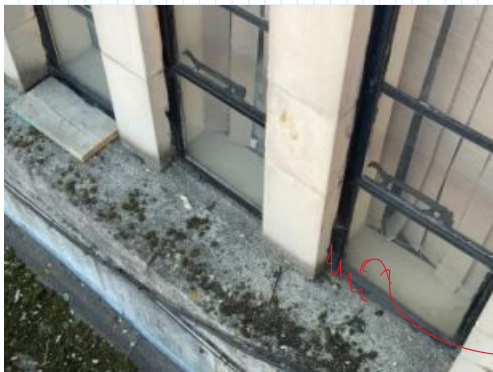
MOSS ON  
CILL  
- COARDED  
PLANT

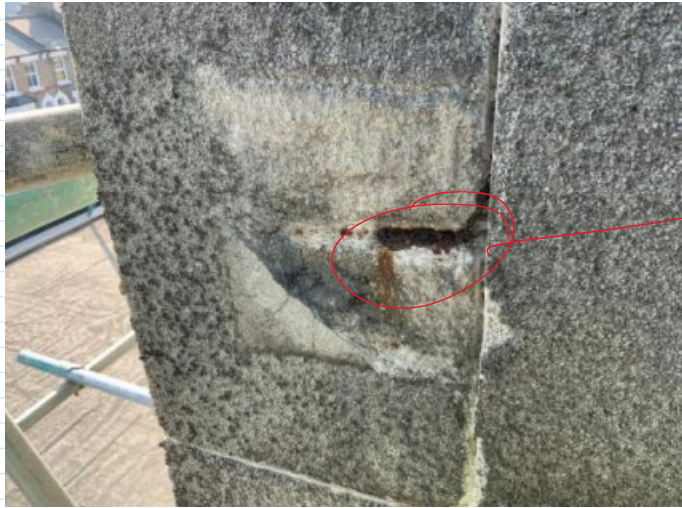
AE SIDE LIGHT

PATCH  
REPAIR.
