**Haringey Civic Centre – Masonry Façade Condition Survey**

# Haringey Civic Centre

## Masonry Façade Survey February 2023

REF 23018-PAYE-RPT-002

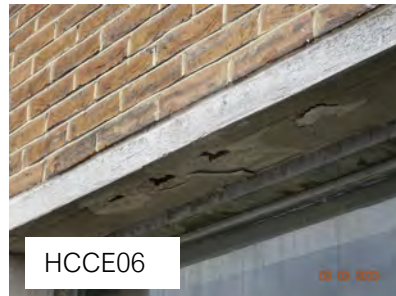
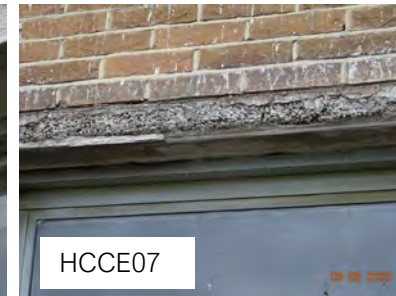
PHOTOS: HCCE06-07a

RISK: RED

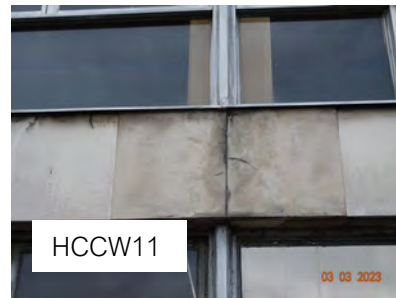
PHOTOS: HCCW08-13

**RISK: RED**
