| PROJECT | S-2310 | HARINGEY CIVIC CENTRE |

| ELEVATION | EAST |
| FLOOR | GROUND FLOOR |

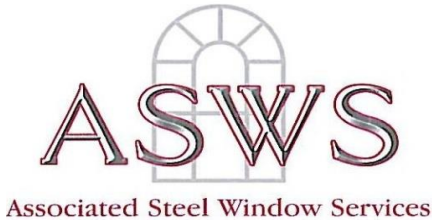
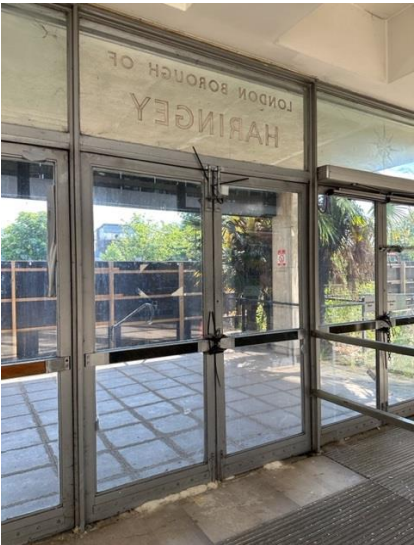
| NOTES |
|---|
| All surfaces showing signs of deterioration |
| Doors in poor condition, closer and plates corroded |

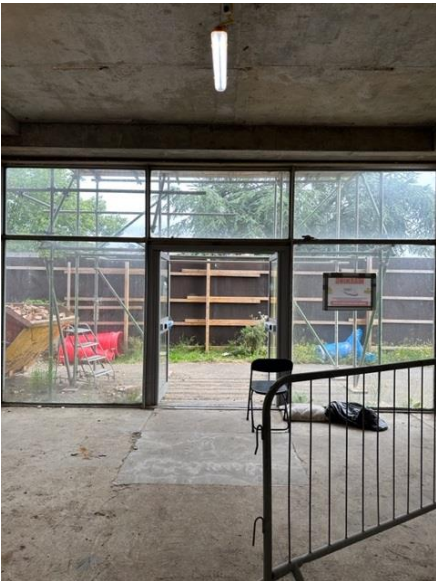
| All surfaces showing signs of deterioration |
