# Broadwater Farm Estate

## Mural mosaic

Condition Survey  
September 2023

Authored by Paolo Volpi & Ian Devine  
Reviewed by Adrian Attwood ACR

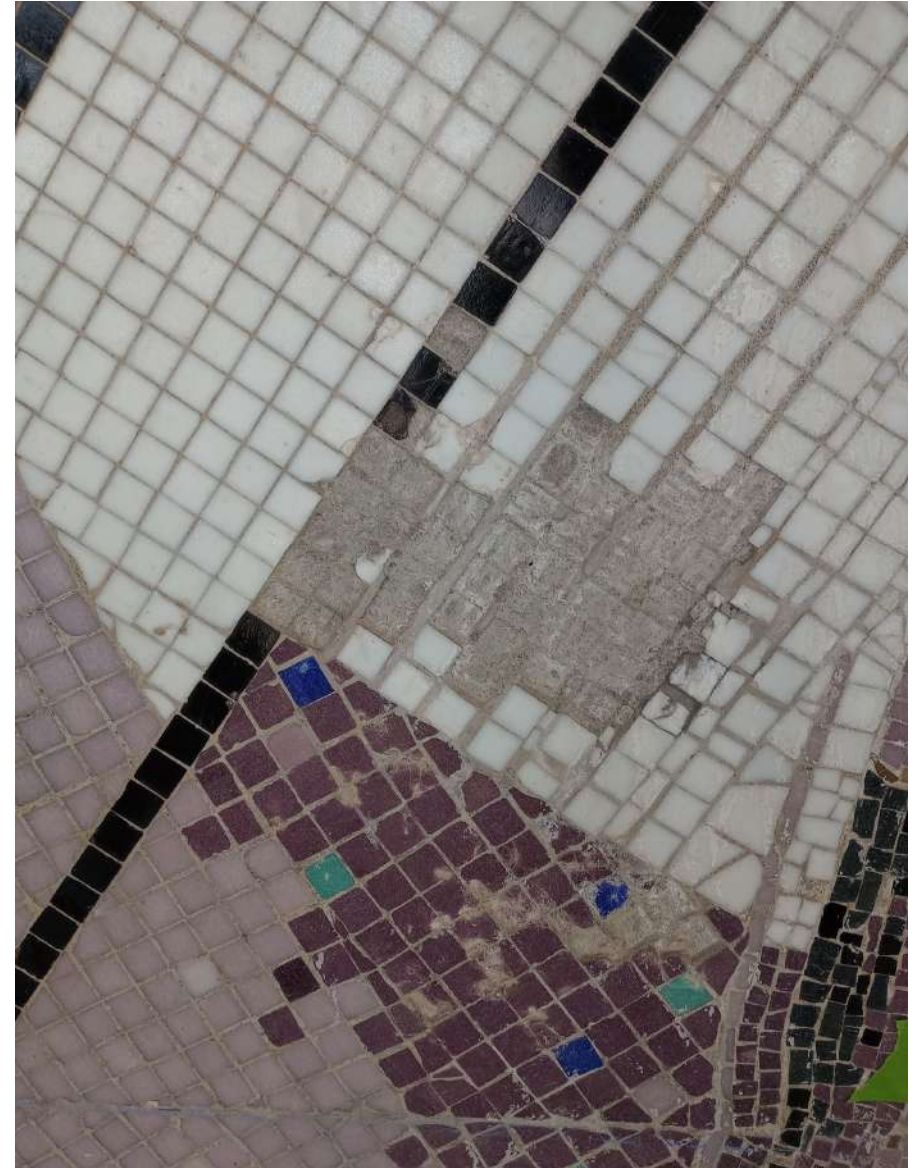
Panel B, section 4

## Missing/Losses

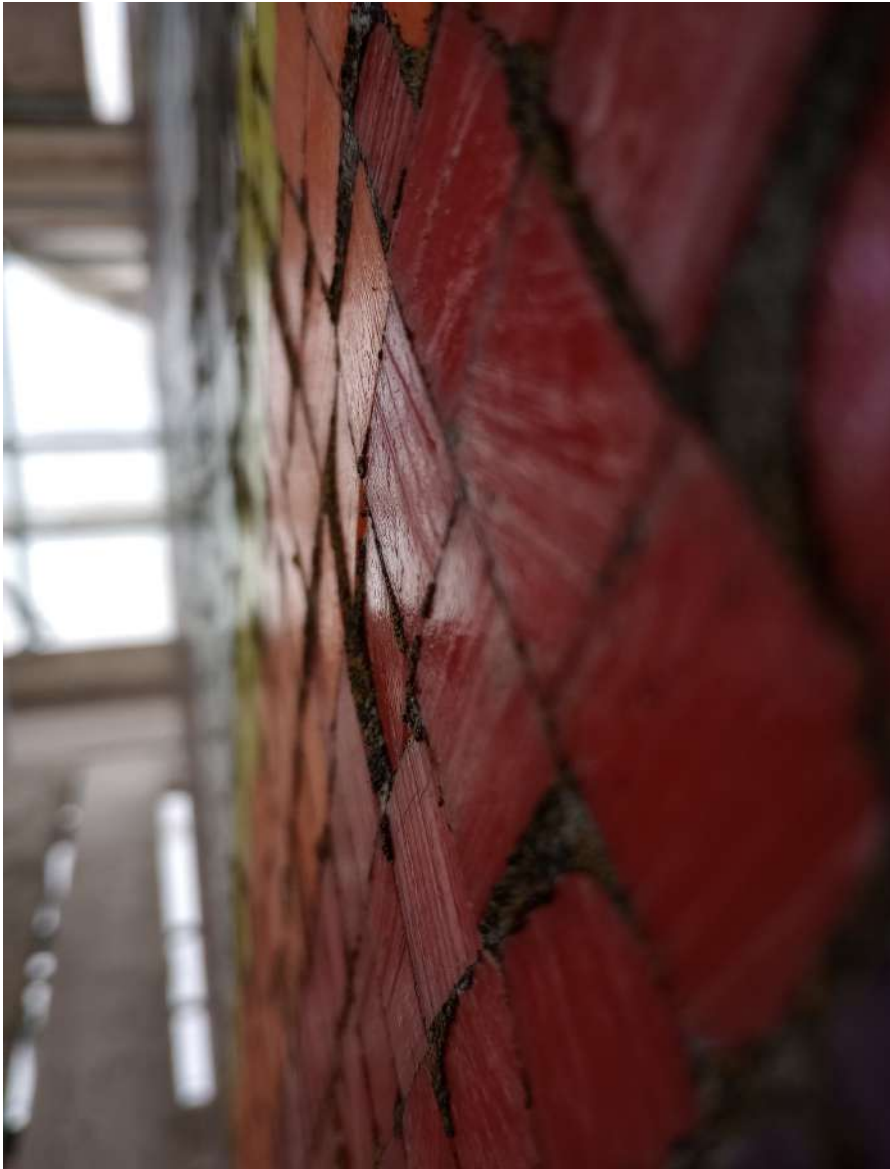
Panel B, section 3

# Depressions

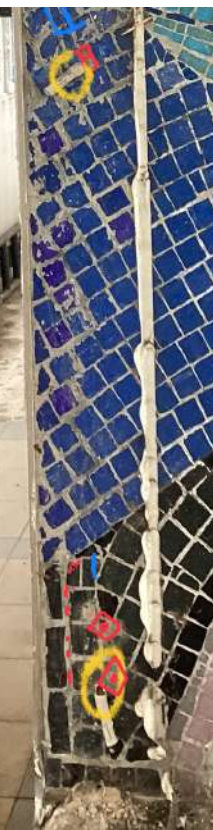
## Panel F1

1180mm x 895mm

General Fair condition

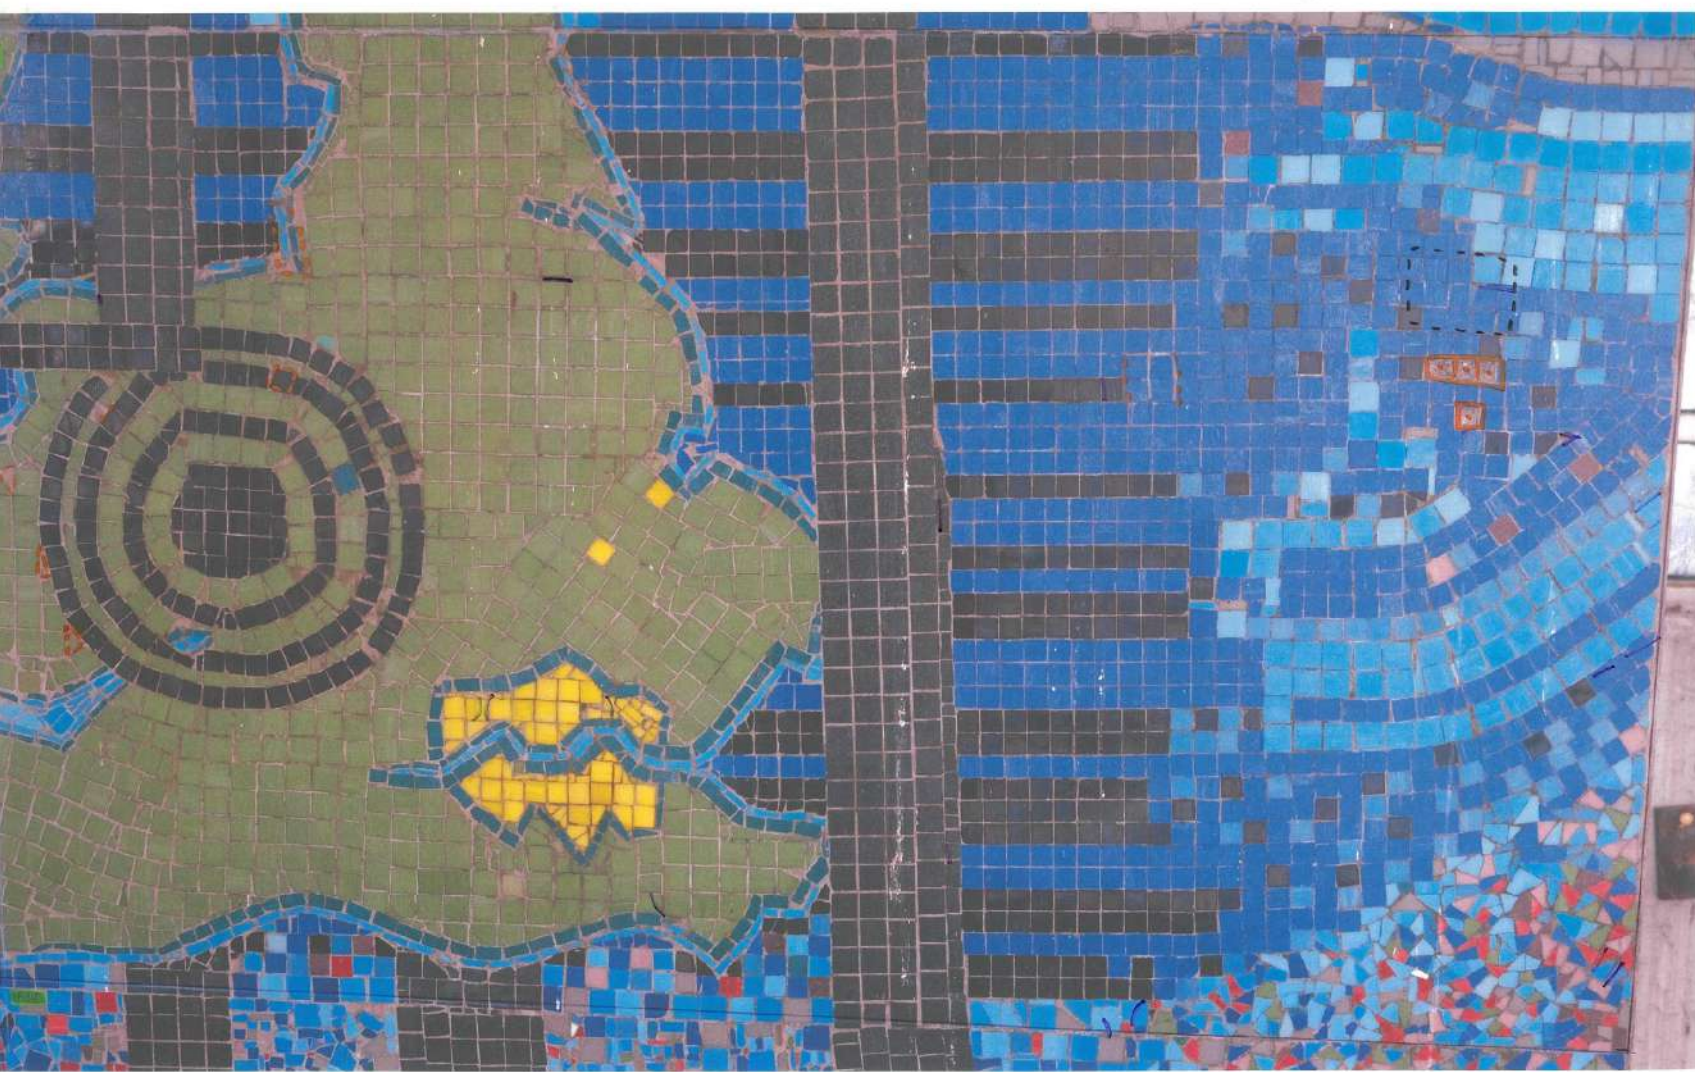
## Panel F3

1520mm x 895mm

General Fair condition

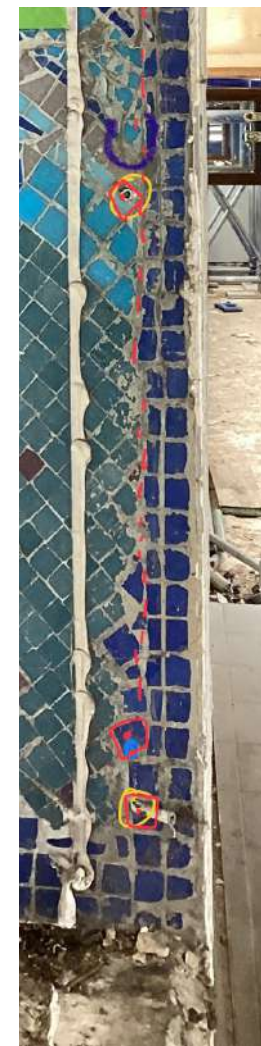
## Panel F4

1200mm x 895mm

General Fair condition
