# Cooke Fawcett Architects

## 28 Wood Lane, N6 5UB Condition Survey-Rev A (Windows Only) 23.03.2025

CF\_225\_REP\_Condition-Survey-RevA

## 5. Windows

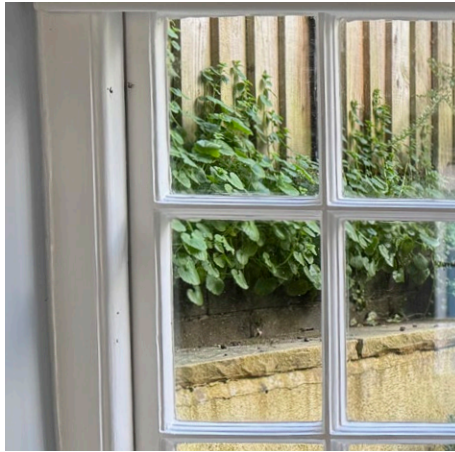
Screw marks present on frame

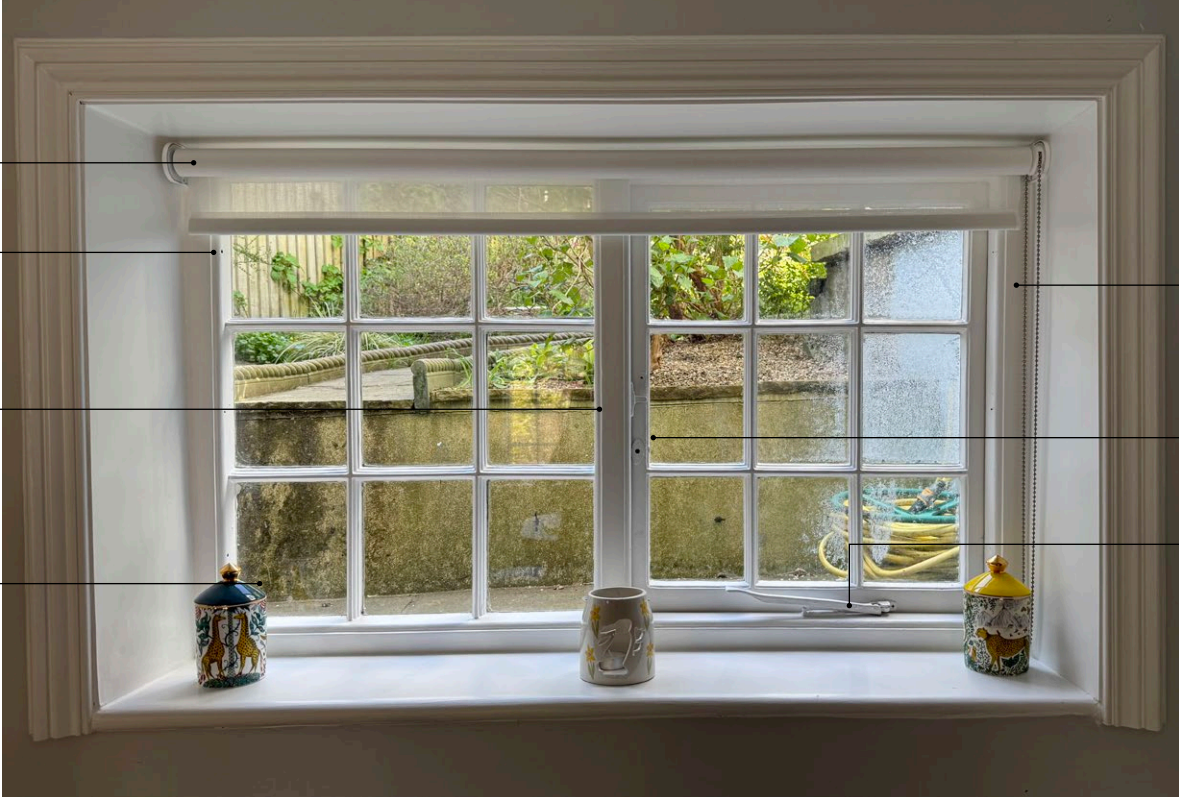
Cill and frame in relatively good condition

Handle missing

Window stay not operable / painted over

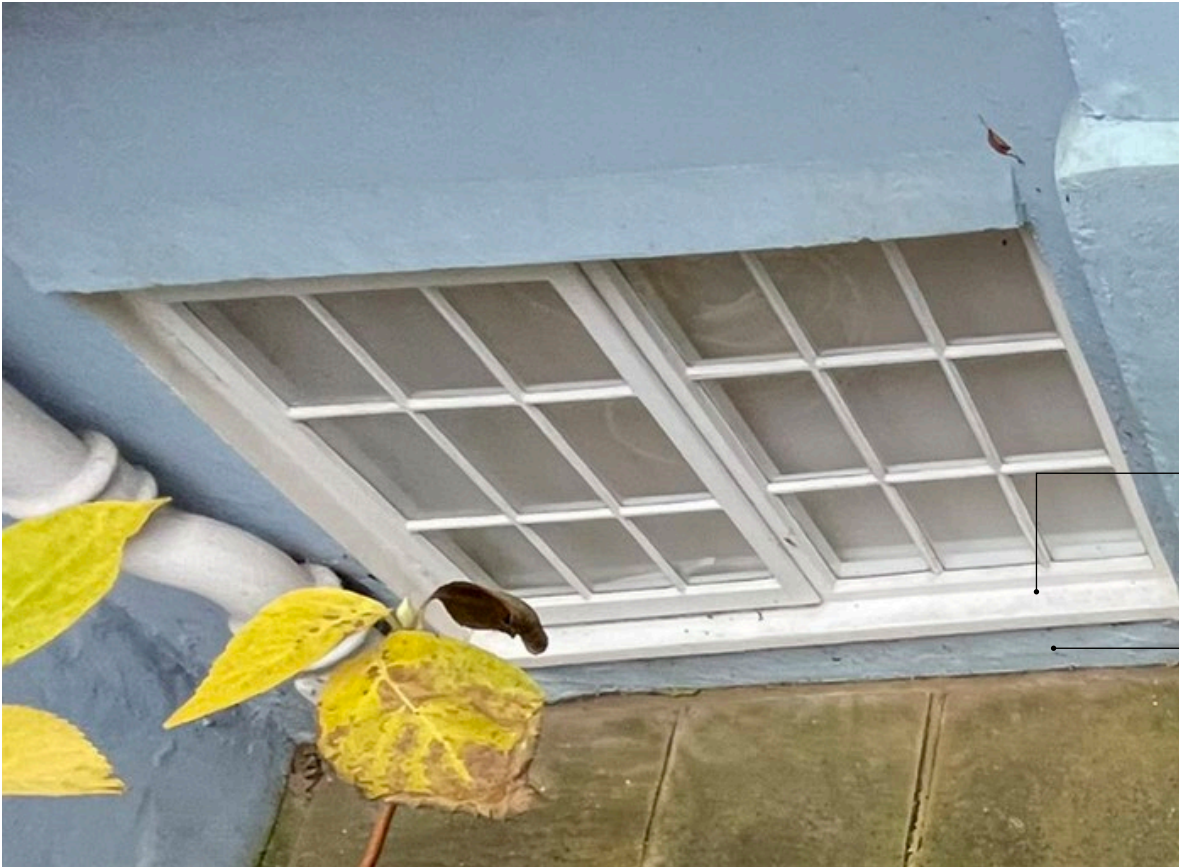
Cill and frame in relatively good condition

Signs of paint flaking on brick mould

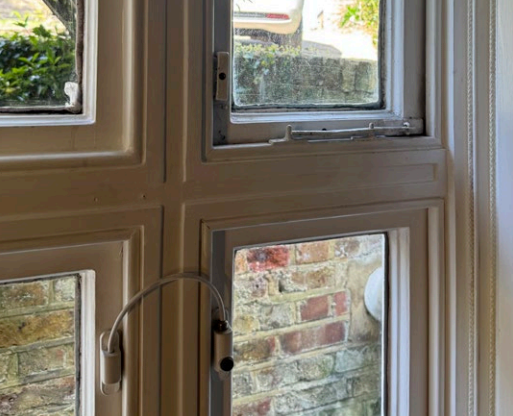
Modern locking system, window stay for top right casement not operable

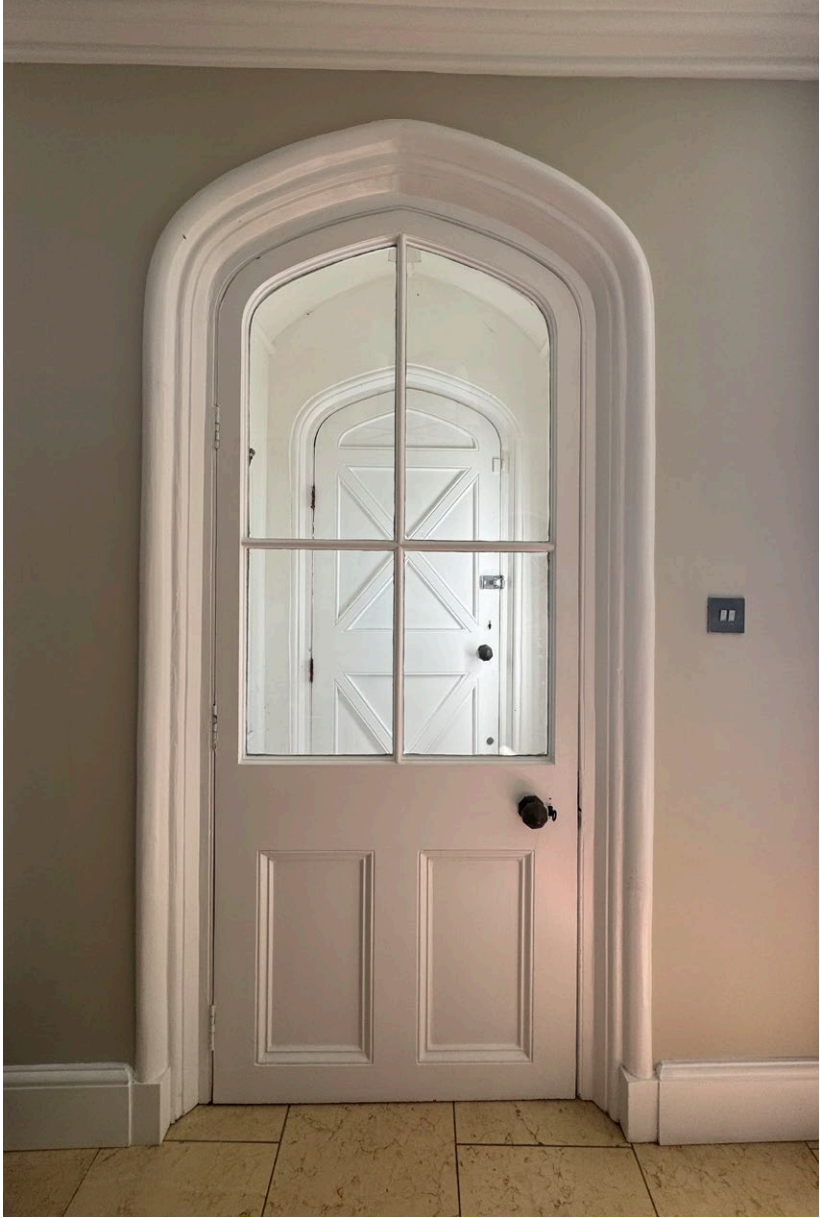
Interior

| Element | Description | Condition |
|---|---|---|
| Internal | -Internal arched glazed door into porch with decorative panels below | -Some scuff marks and chips on paintwork<br>-Minor scratches on glass panels<br>-Door operable but difficult to open with very large brush seal to reduce draft into living area<br>-Hinges painted white-no sign of rusting<br>-Evidence that bottom rail of door cut down (due to proportions of door and length of timber posts shown externally) |

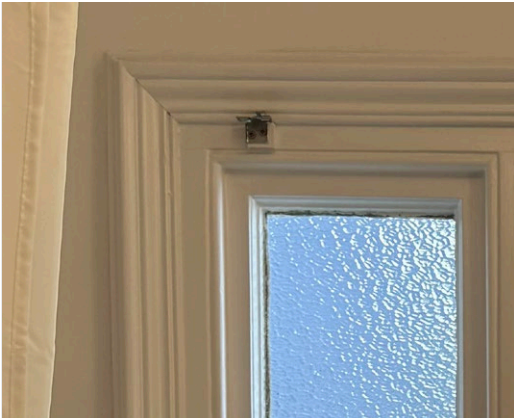
Previous blind fixing

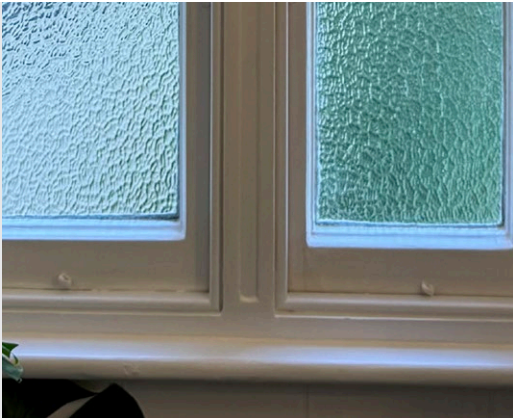
Latch fixings operable with external latches

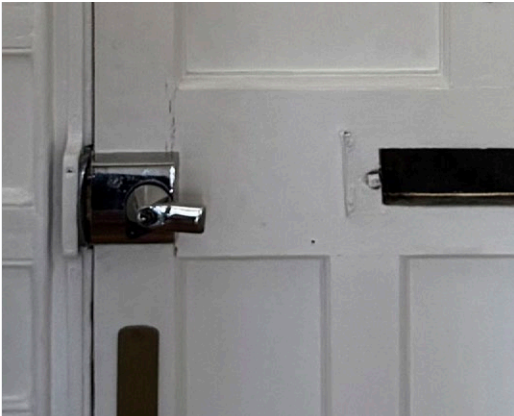
Lock system

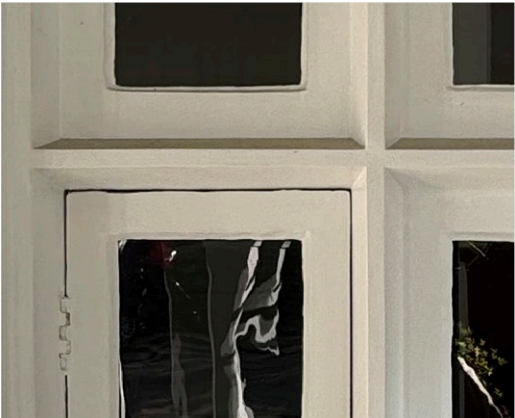
Not fully sealed when closed

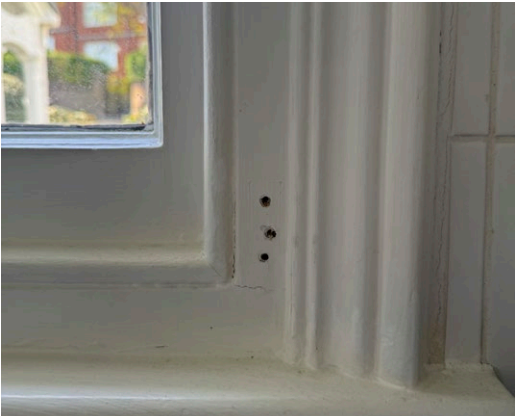
Screw holes/marks left by previous security or blind system, some splits in paintwork

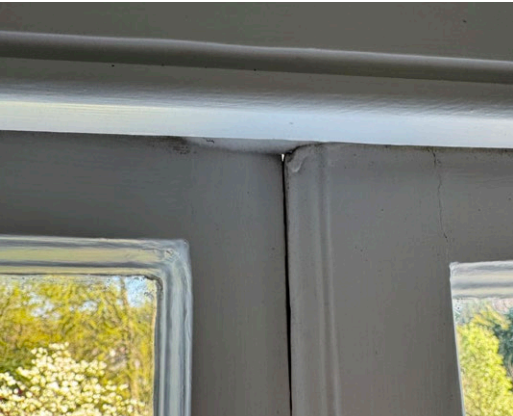
Significant gaps to exterior. Large brush seal placed around frame to reduce draft

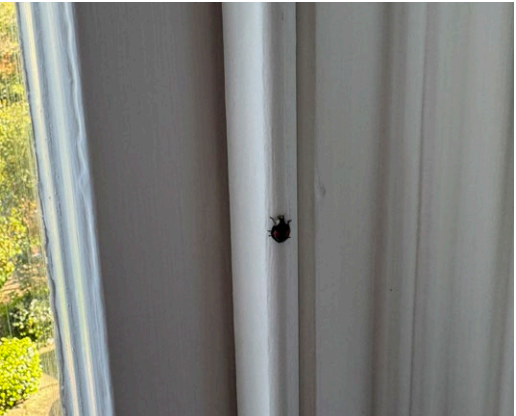
Presence of ladybirds

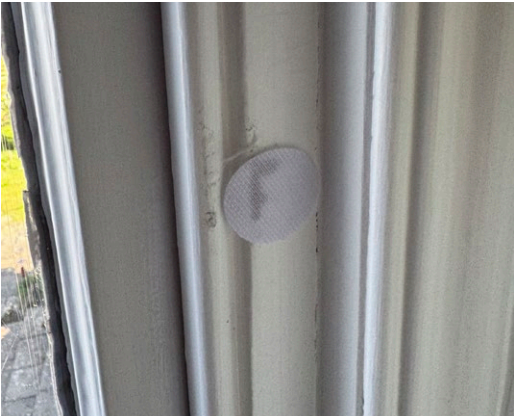
Velcro stickers for black-out blinds
