# Defect Advisory Report

93 Mountview Road  
London N4 4JA

28 July 2022

EKA220563

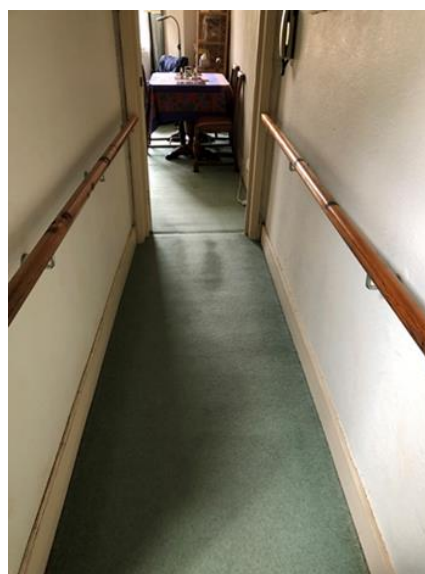
Photo 2: Overview of hallway leading to living room

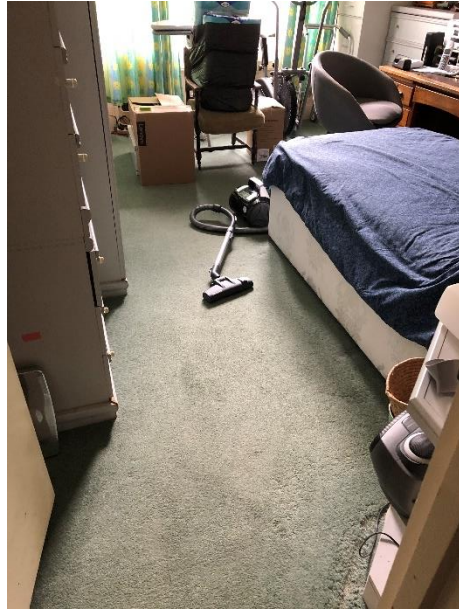
Photo 9: Overview of front bedroom

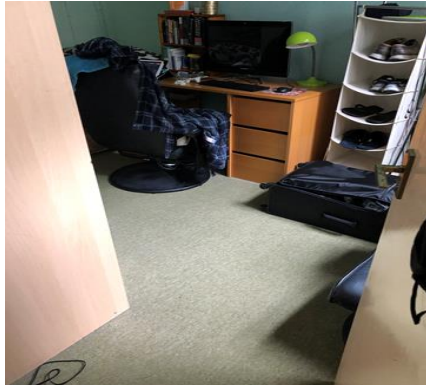
Photo 13: Overview of bedroom 2

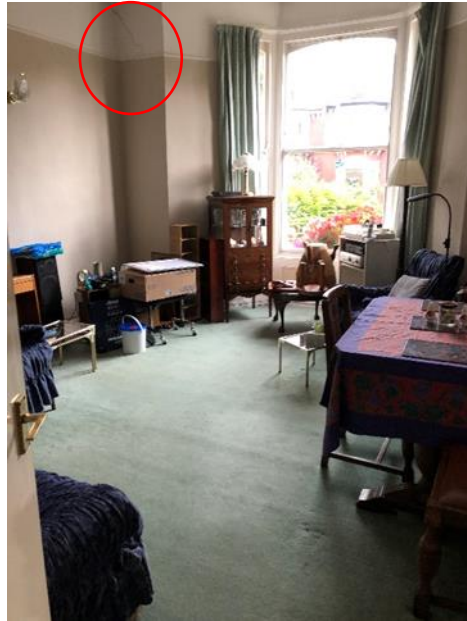
Photo 21: Overview of Living Room

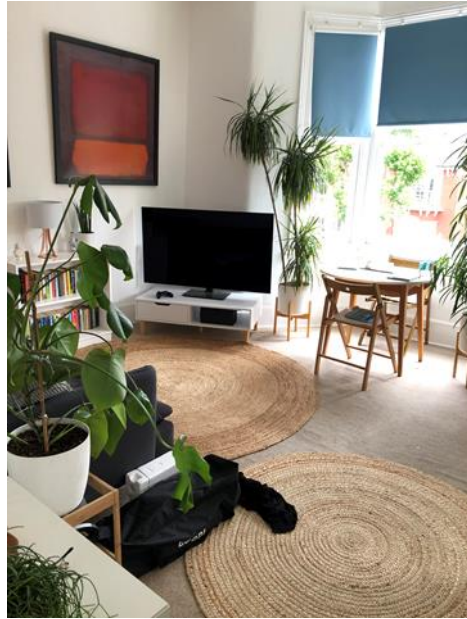
Photo 28: Overview of living room area

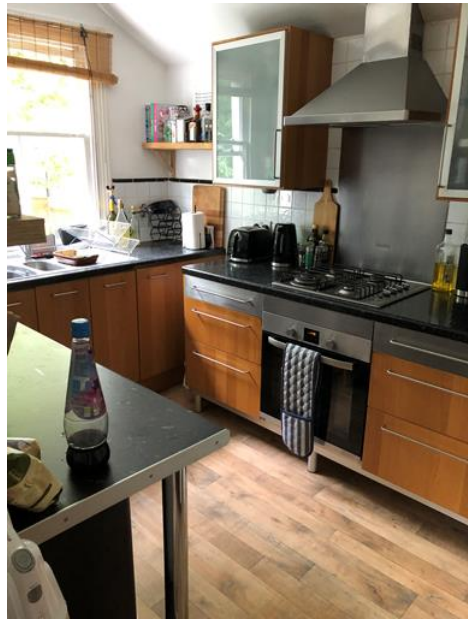
Photo 36: Overview of kitchen

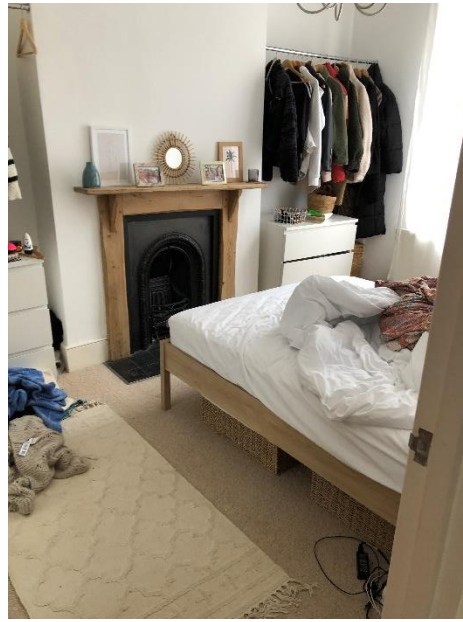
Photo 39: Overview of bedroom

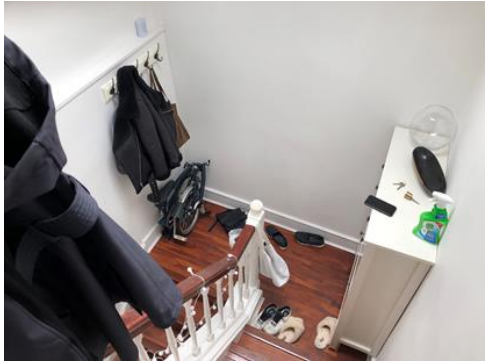
Photo 45: Overview of half landing leading to top floor flat

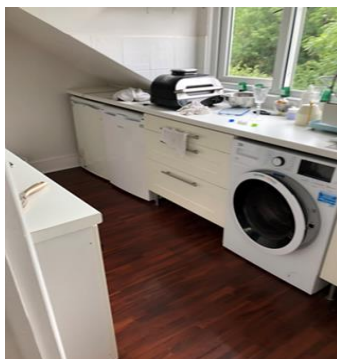
Photo 52: Overview of kitchen

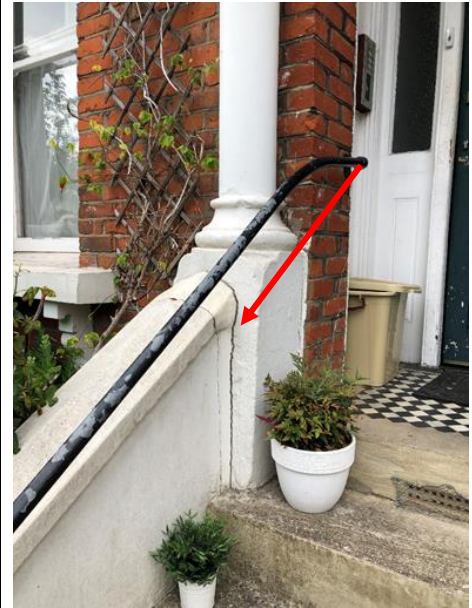
Photo 61: Close view of steps

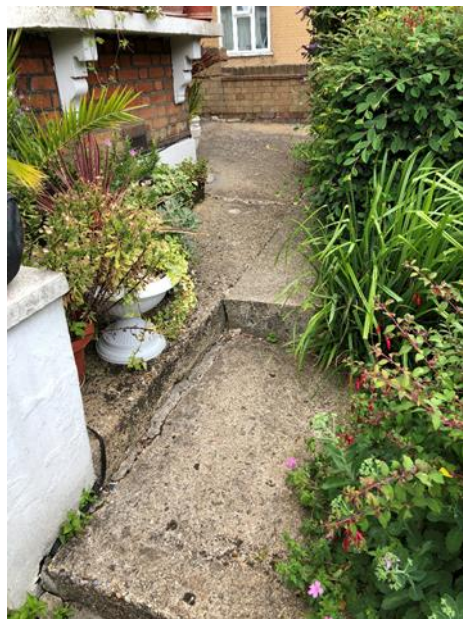
Front external pathway and garden has cracking to concrete slabs, which has opened up significantly over the past 20 years, but no repairs have been undertaken.

Photo 66: Overview of paved front garden

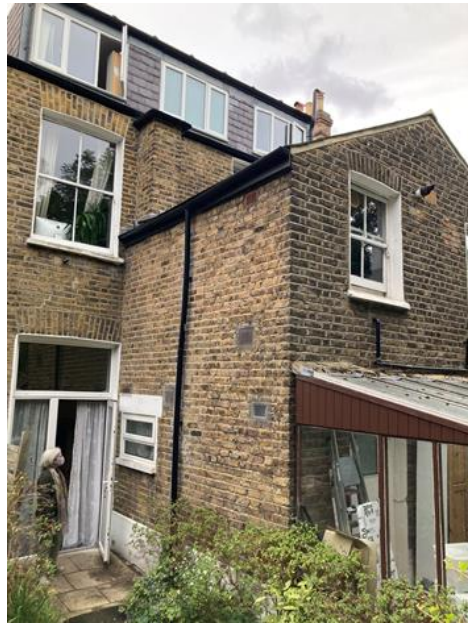
Photo 76: Rear elevation

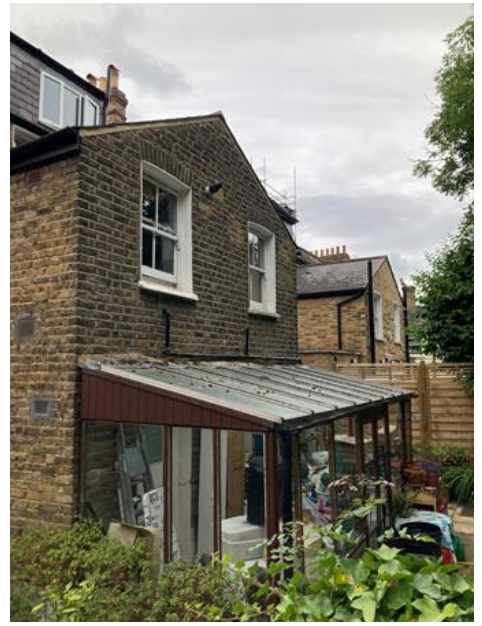
Photo 77: Lean-to
