# Basement Impact Assessment

**69 Grove Avenue, N10 2AL**

**8 December 2023**

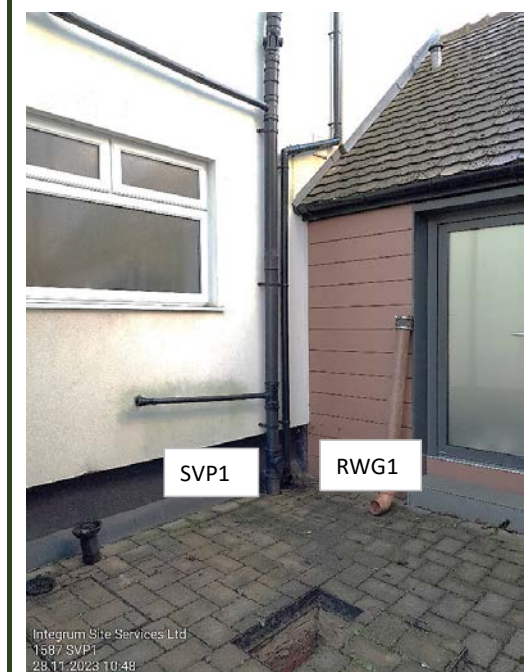
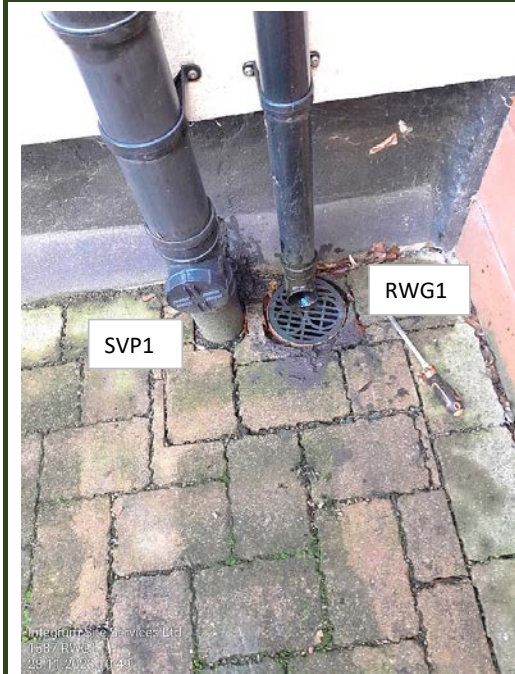
4. RWG1 & SVP1

Despite there being separate systems it should be noted that the rainwater gullies RWG1 and RWG2 have been connected incorrectly into the foul network.

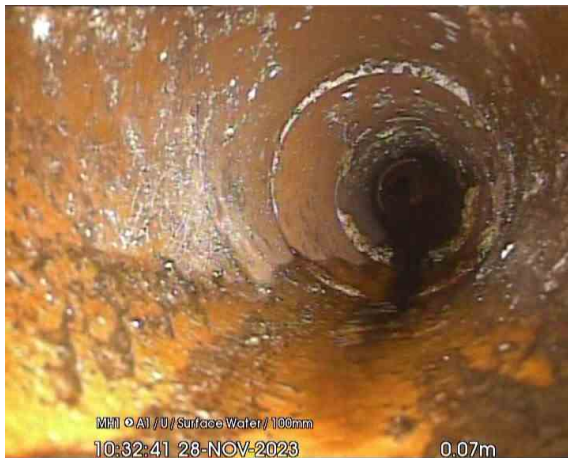
| Item No. | Inspection Direction | PLR | Client's Job Ref | Contractor's Job Ref |
|---|---|---|---|---|
| 1 | Upstream | RWG1X | TBC | 1587 |

1-1-3A, 00:00:03, 0.07 m  
Line deviates right, Slight deviation right

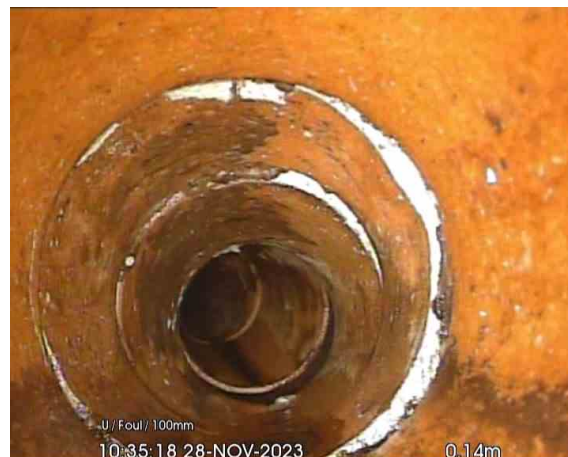
2-1-3A, 00:00:08, 0.14 m  
Joint displaced, medium

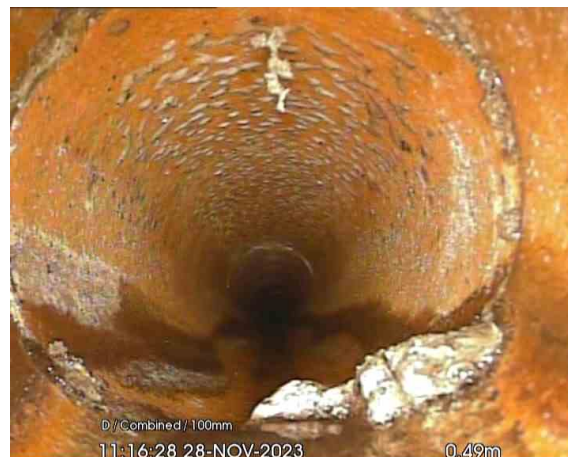
5-1-3A, 00:00:11, 0.49 m  
Attached deposits, other at joint from 4 o'clock to 6 o'clock,  
10% cross-sectional area loss, Jointing intrusions

| Recommendations: | High Pressure Water Jet | | | | |

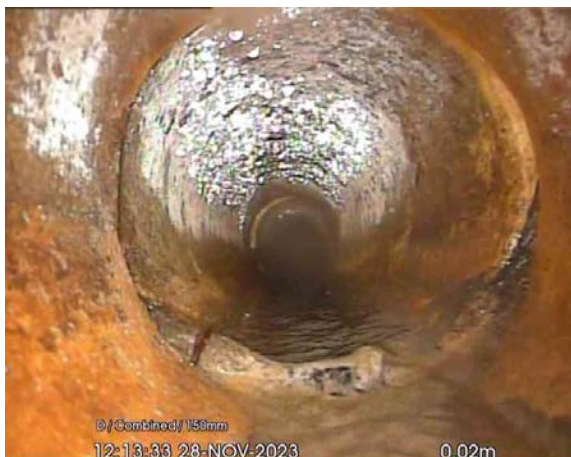
6-1-3A, 00:00:03, 0.02 m

Attached deposits, other at joint from 4 o'clock to 8 o'clock, 5% cross-sectional area loss, Jointing intrusions

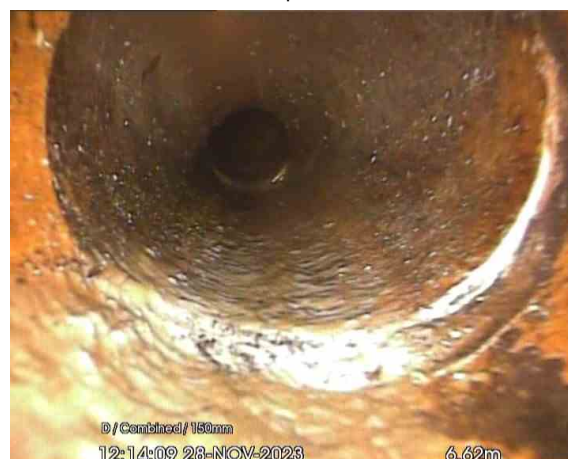
Joint displaced, medium

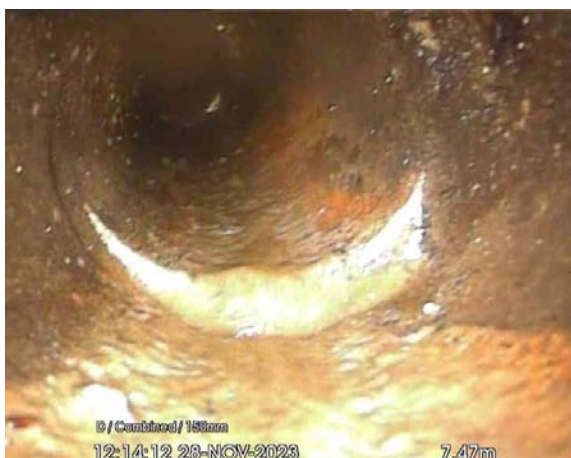
6-1-8A, 00:00:43, 7.47 m

Joint displaced, medium

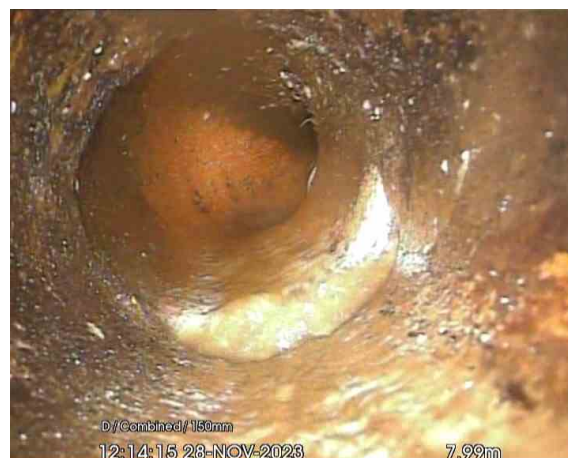
6-1-9A, 00:00:46, 7.99 m

Joint displaced, medium

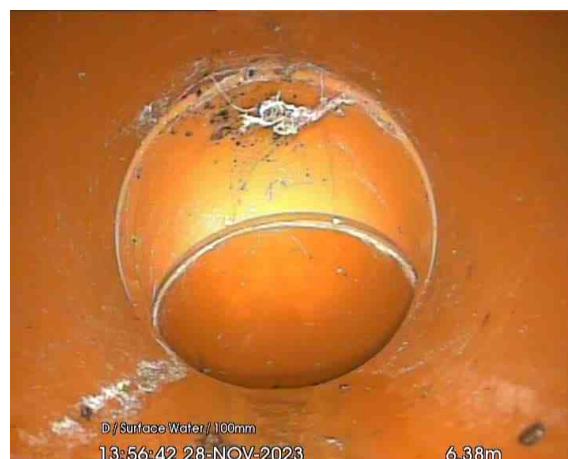
7-1-5A, 00:01:11, 6.38 m  
Line deviates down

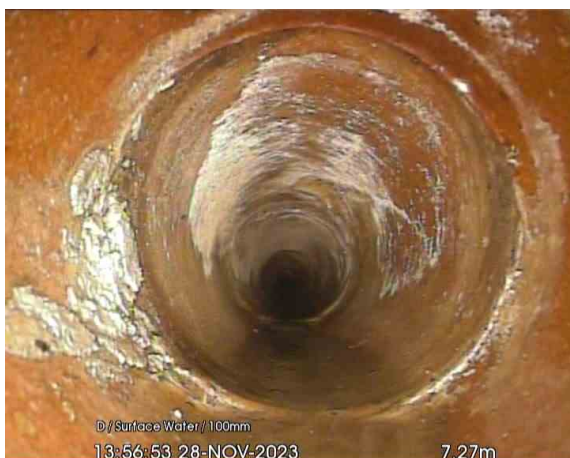
7-1-7A, 00:01:18, 7.27 m  
Pipe material changes to vitrified clay at this point

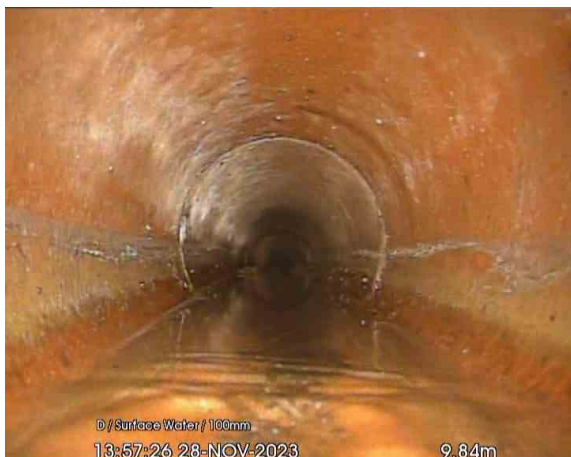
7-1-10A, 00:01:47, 9.84 m  
Water level, 20% of the vertical dimension

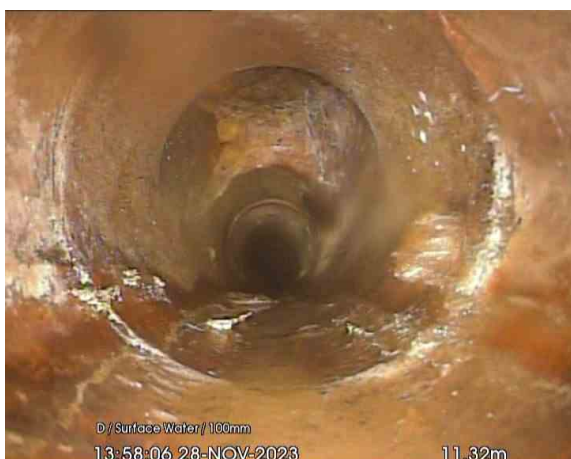
7-1-13A, 00:02:13, 11.46 m  
General remark, At access point concealed in MH1 benching

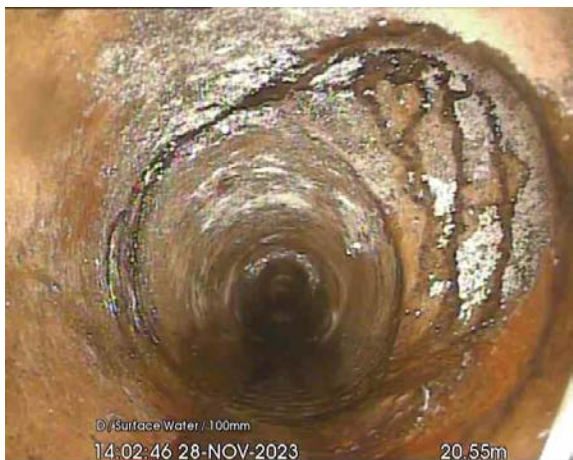
7-1-19A, 00:03:46, 20.55 m  
 Finish node, other special chamber, reference: A1, Junction  
 from RWG3

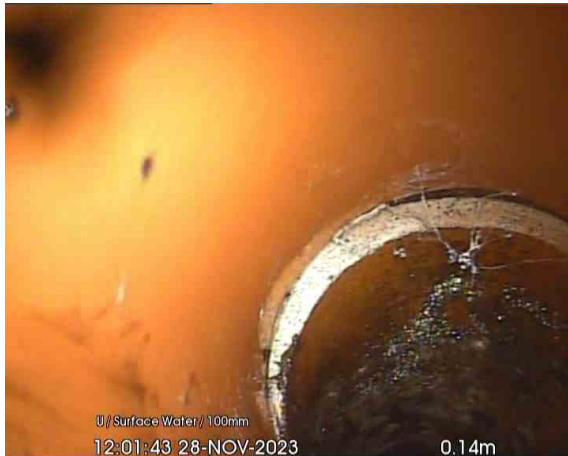
8-1-2A, 00:00:05, 0.14 m  
Joint displaced, medium

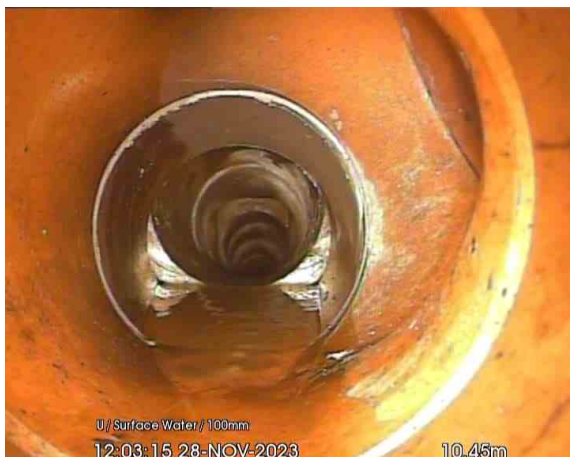
8-1-12A, 00:01:28, 10.45 m  
Junction at 2 o'clock, 100mm dia, from RWG4

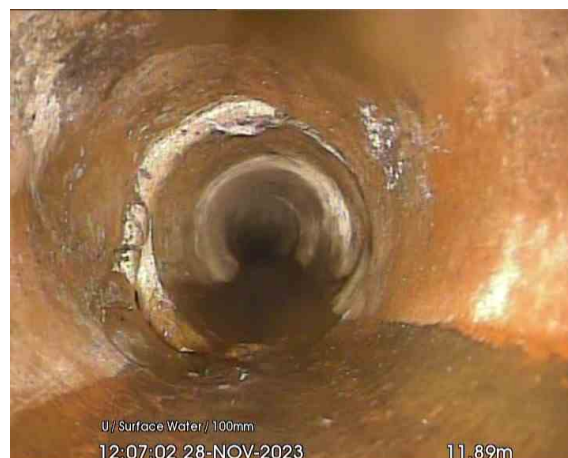
8-1-24A, 00:02:02, 11.89 m  
Attached deposits, other at joint from 6 o'clock to 1 o'clock,  
10% cross-sectional area loss, Jointing intrusions/scale
