Section Pictures - 17/10/2023 - RE

TSA-23-2537 Channing School for Girls CCTV Report\_303\_Issue01

Section Inspection - 17/10/2023 - MH21 X

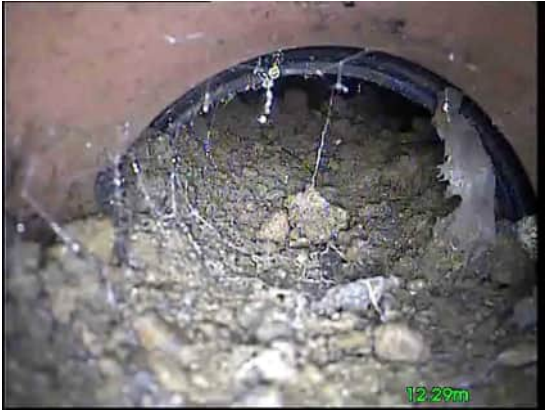
9, 00:00:53, 12.29 m  
Settled deposits, coarse, 75% cross-sectional area loss, change

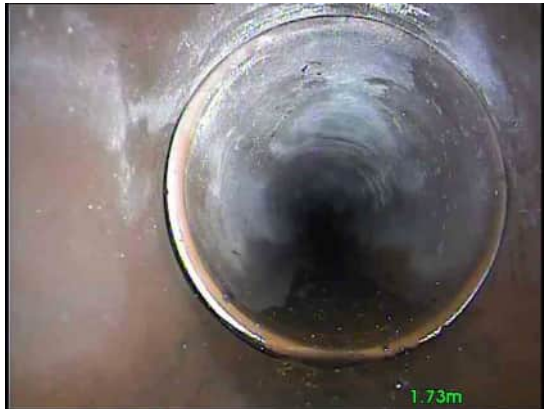
2, 00:00:12, 1.73 m

Joint displaced, medium

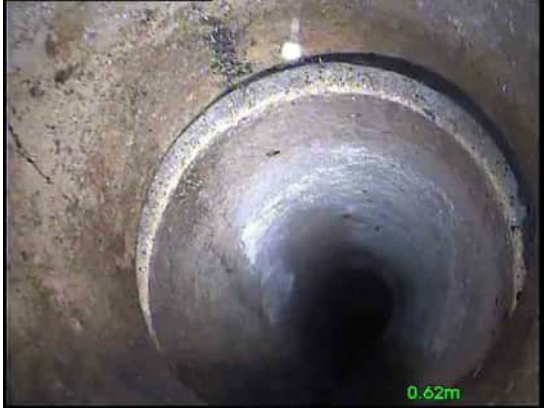
4, 00:00:12, 0.62 m  
Joint displaced, medium

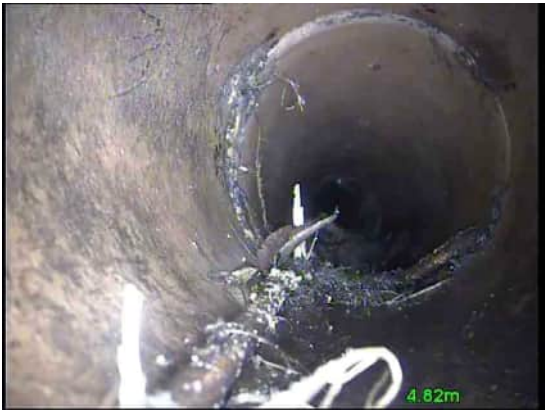
8, 00:00:45, 4.82 m  
Roots, mass, 20% cross-sectional area loss, start

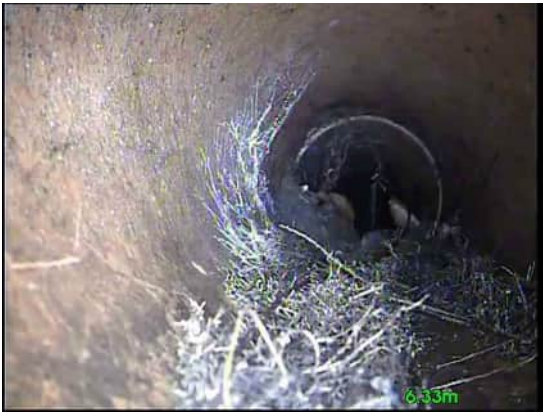
9, 00:00:55, 6.33 m  
Roots, mass, 35% cross-sectional area loss, change

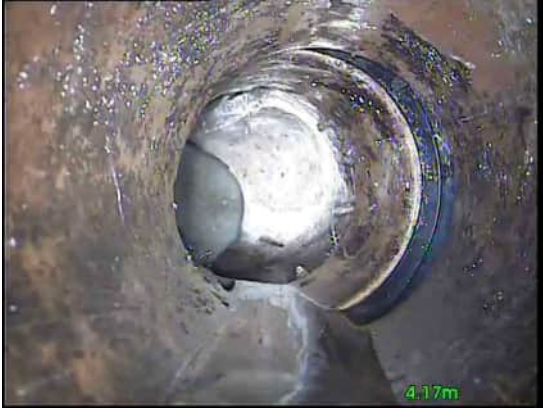
3, 00:00:21, 4.17 m  
Joint displaced, large

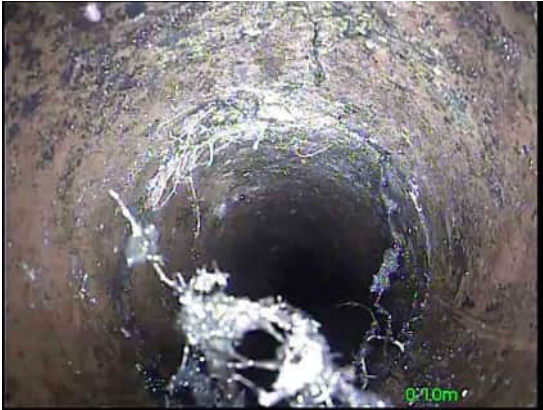
1, 00:00:05, 0.10 m  
Roots, fine at joint

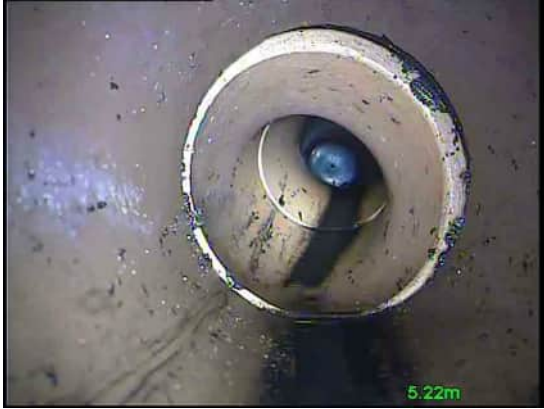
4, 00:00:30, 5.22 m  
Joint displaced, medium

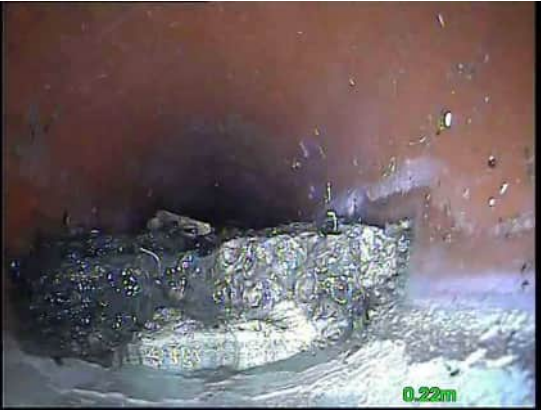
1, 00:00:05, 0.22 m  
Settled deposits, fine, 35% cross-sectional area loss

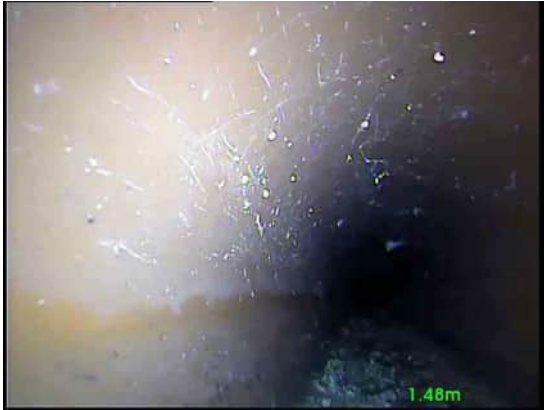
2, 00:00:05, 1.48 m  
Settled deposits, coarse, 5% cross-sectional area loss

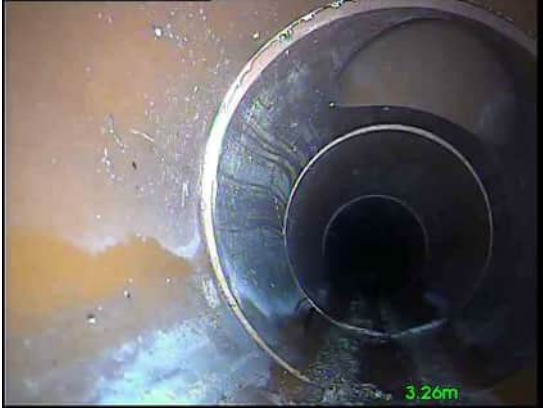
3, 00:00:14, 3.26 m  
Junction at 1 o'clock, 100mm dia

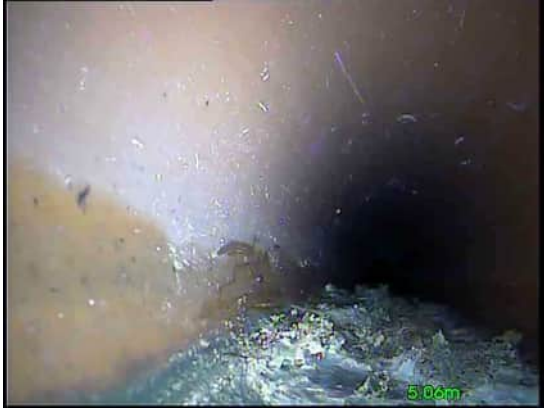
4, 00:00:23, 5.06 m  
Settled deposits, fine, 10% cross-sectional area loss, start

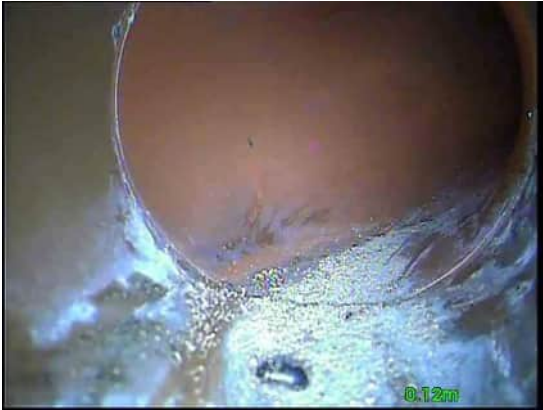
1, 00:00:03, 0.12 m  
Line deviates right

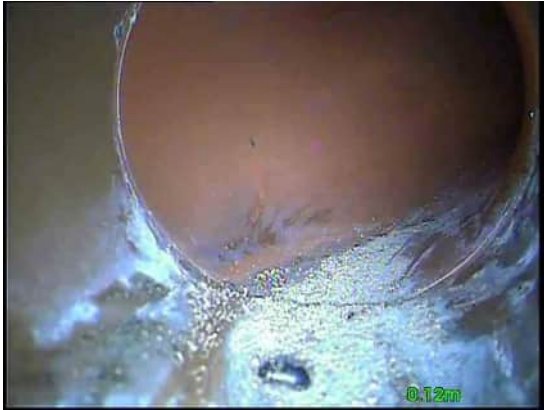
2, 00:00:03, 0.12 m  
Line deviates up

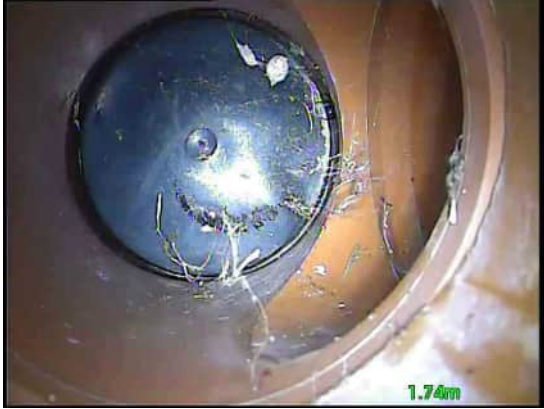
4, 00:00:22, 1.74 m  
Junction at 3 o'clock, 100mm dia

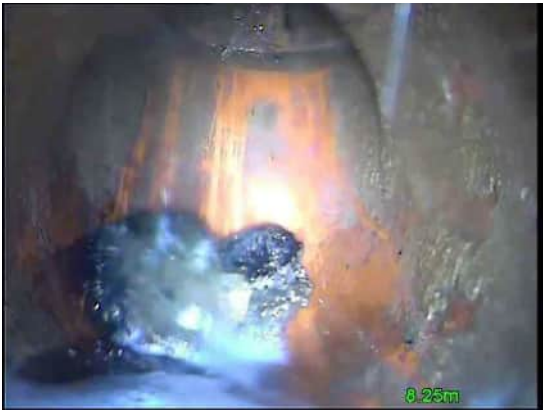
7, 00:01:18, 8.25 m  
Settled deposits, coarse, 5% cross-sectional area loss, At rest bend of internal downpipe

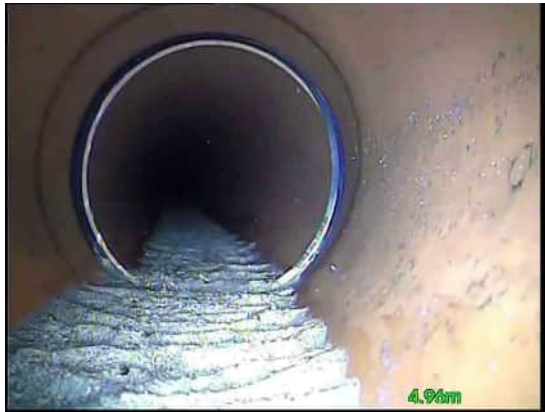
5, 00:00:27, 4.96 m  
Open joint, medium

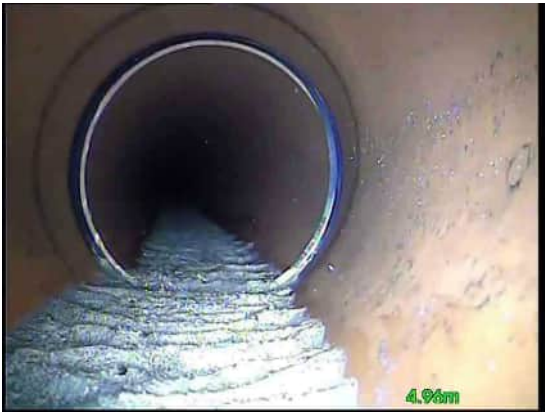
6, 00:00:27, 4.96 m  
Line deviates left

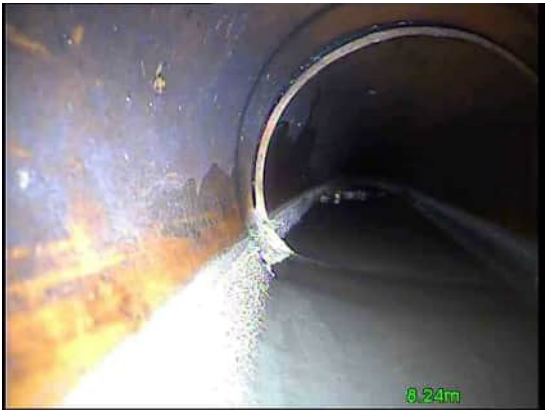
8, 00:00:40, 8.24 m  
Water level, 25% of the vertical dimension, Water standing in sewer at this point

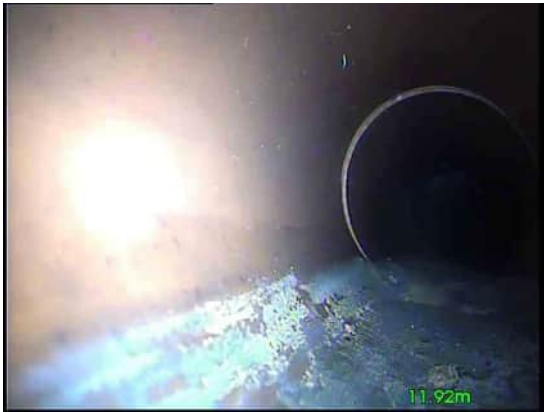
10, 00:00:57, 11.92 m  
Settled deposits, fine, 10% cross-sectional area loss, finish

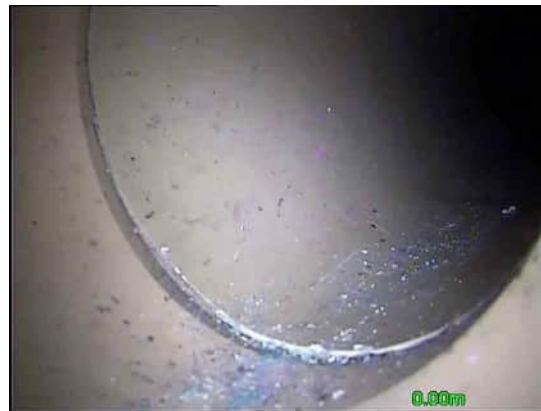
1, 00:00:01, 0.00 m  
Line deviates right

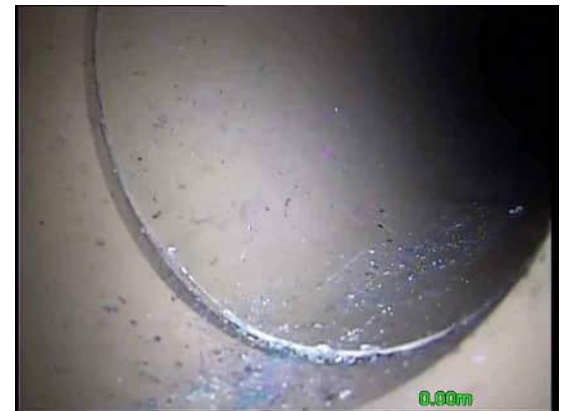
2, 00:00:01, 0.00 m  
Line deviates up

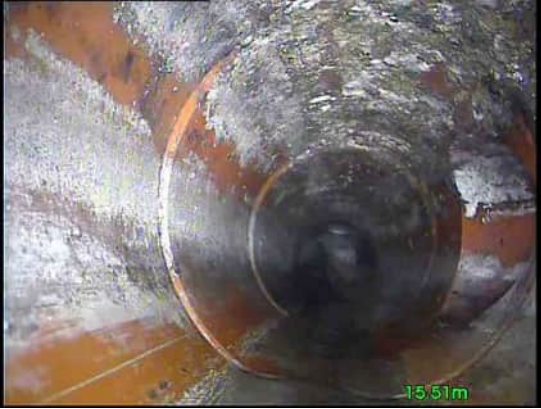
4, 00:00:48, 15.51 m  
Junction at 3 o'clock, 100mm dia, from MH34 X

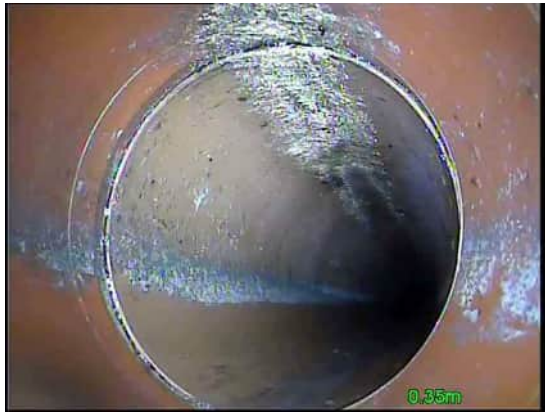
1, 00:00:05, 0.35 m  
Line deviates right

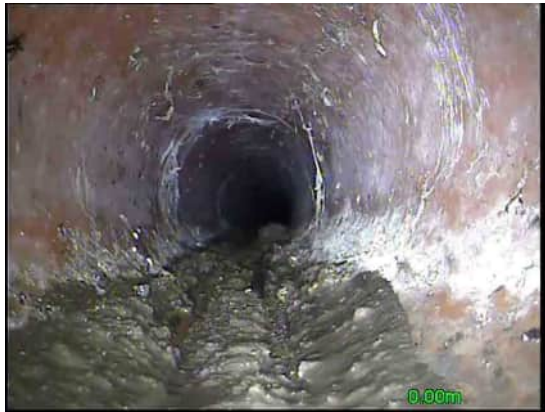
1, 00:00:01, 0.00 m  
Settled deposits, fine, 10% cross-sectional area loss, start

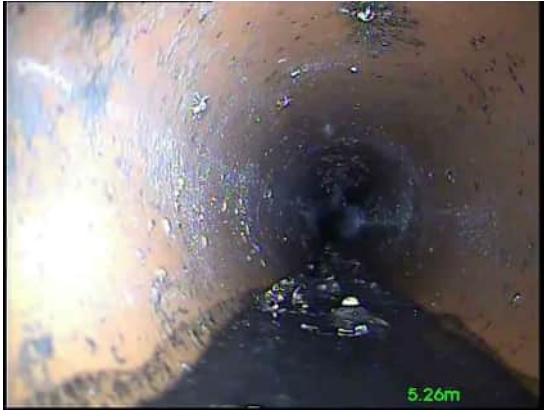
2, 00:00:30, 5.26 m  
Settled deposits, coarse, 5% cross-sectional area loss

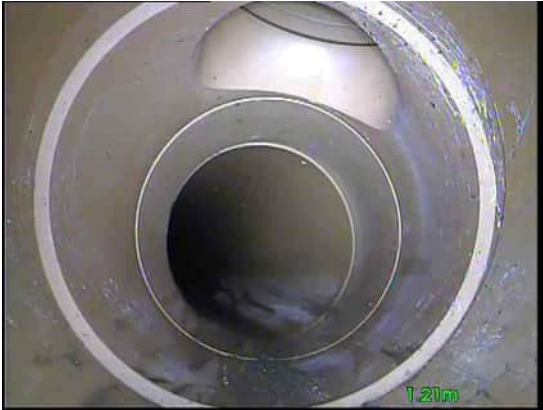
1, 00:00:04, 1.21 m  
Junction at 1 o'clock, 100mm dia

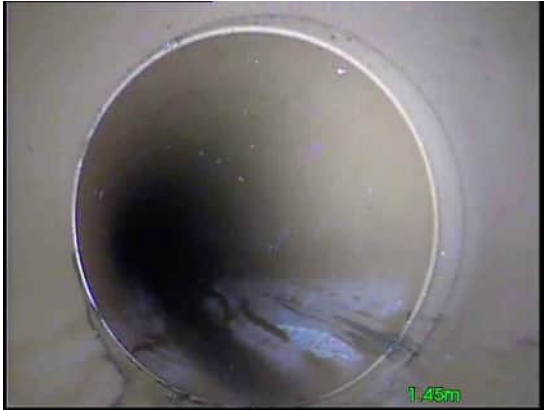
2, 00:00:09, 1.45 m  
Line deviates left

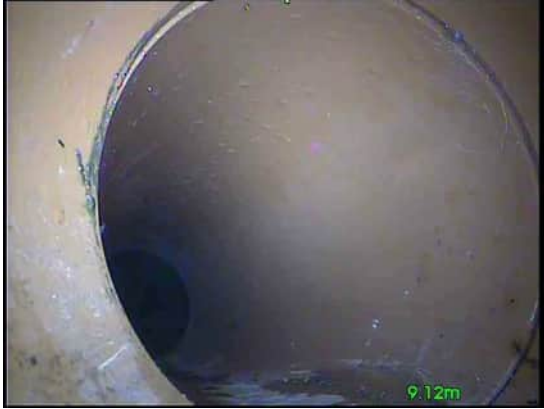
4, 00:00:33, 9.12 m  
Line deviates left

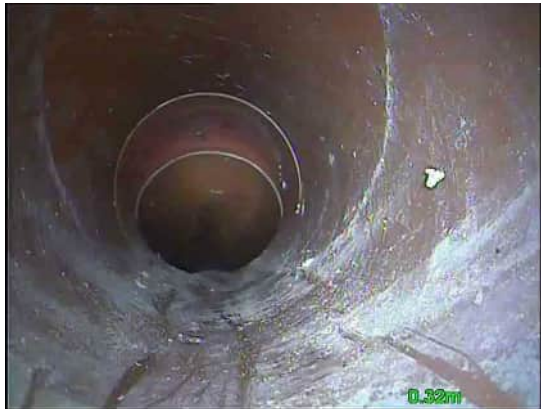
1, 00:00:07, 0.32 m  
Line deviates up

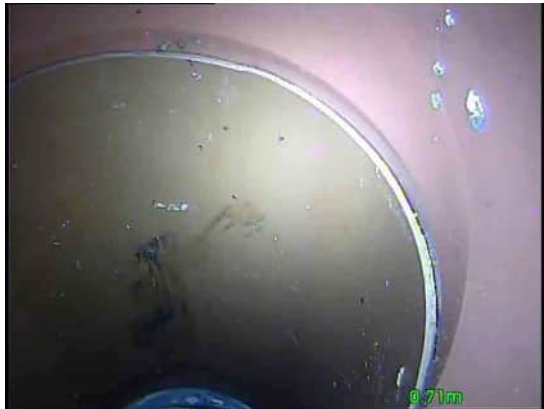
2, 00:00:13, 0.71 m  
General remark, Sewer levels out at this point

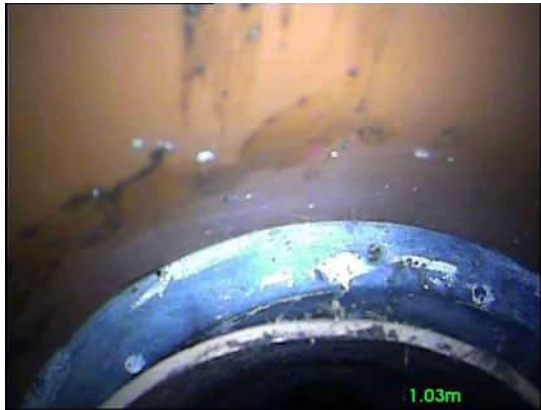
3, 00:00:18, 1.03 m  
Joint displaced, large

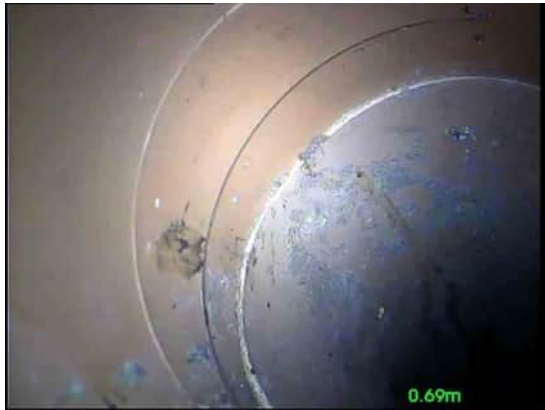
3, 00:00:13, 0.69 m  
Line deviates right

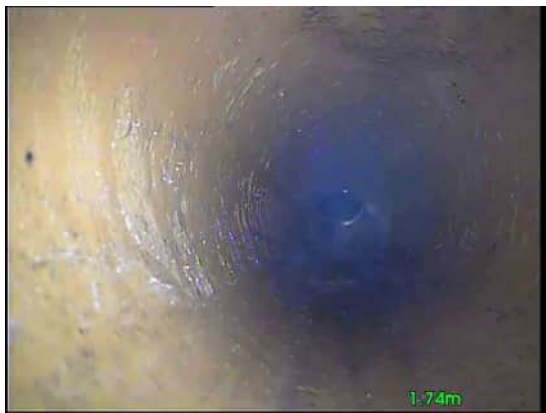
3, 00:00:16, 1.74 m  
General photograph taken at this point

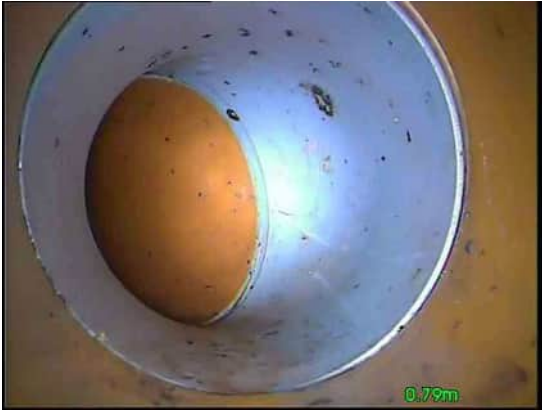
1, 00:00:04, 0.79 m  
Line deviates left

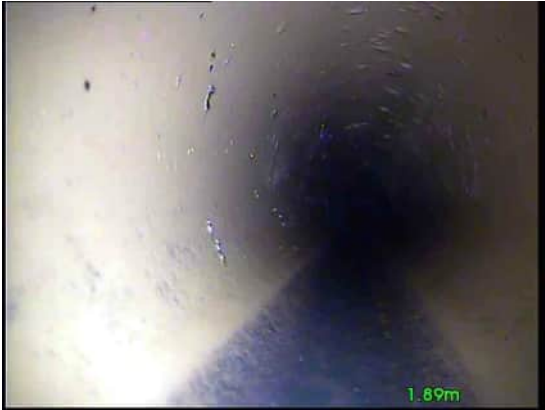
2, 00:00:22, 1.89 m  
General photograph taken at this point

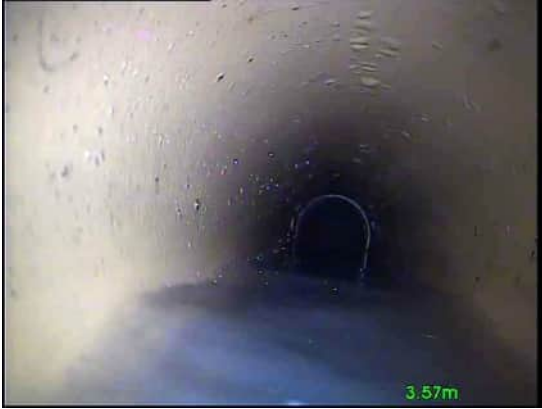
3, 00:00:30, 3.57 m  
Water level, 25% of the vertical dimension, Water standing in sewer at this point

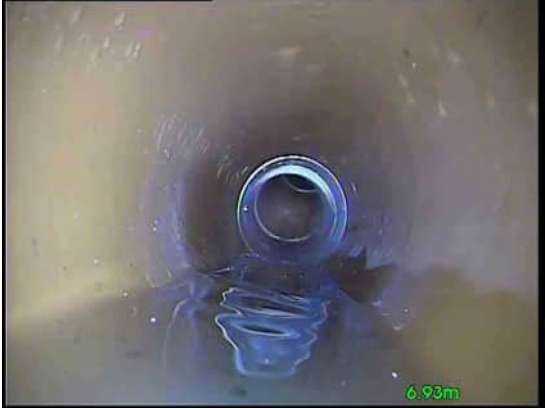
4, 00:00:57, 6.93 m  
Water level, 5% of the vertical dimension

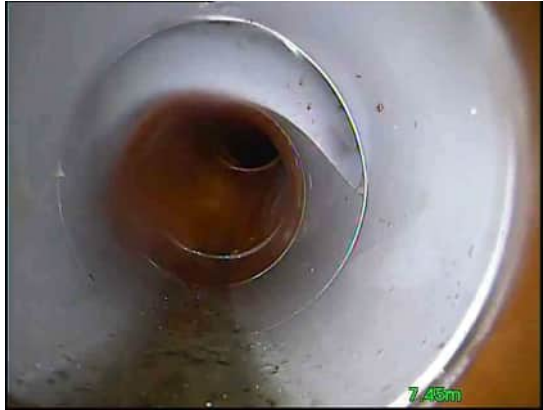
5, 00:01:02, 7.45 m  
Junction at 12 o'clock, 100mm dia, from RE

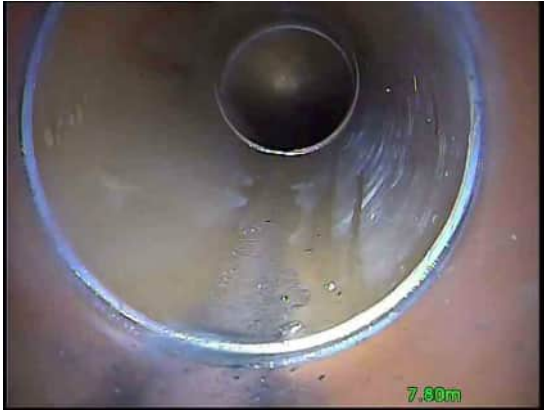
6, 00:01:12, 7.80 m  
Line deviates up

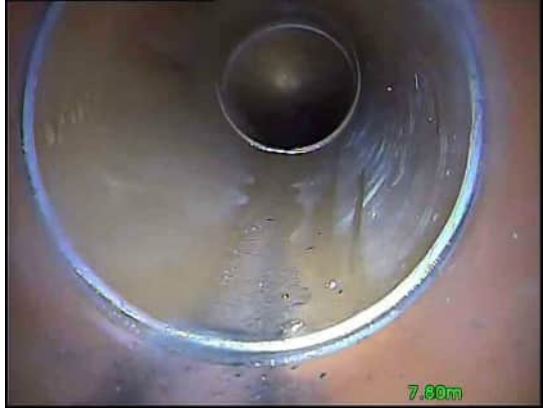
7, 00:01:12, 7.80 m  
Line deviates right

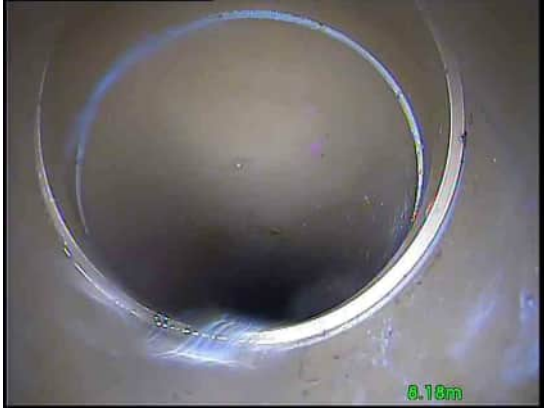
8, 00:01:16, 8.18 m  
General remark, Sewer levels out at this point

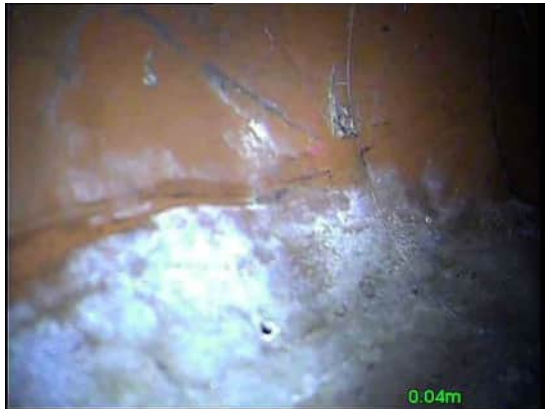
1, 00:00:03, 0.04 m  
Line deviates right

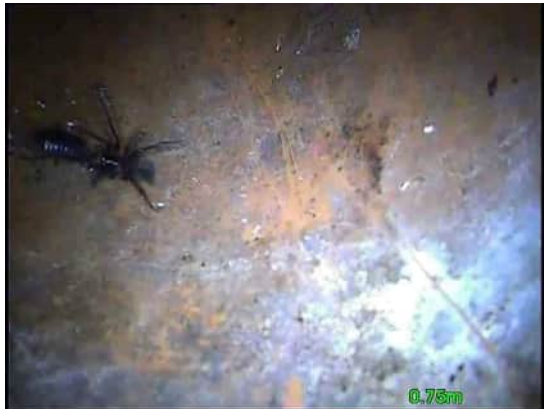
2, 00:00:11, 0.75 m  
Line deviates up

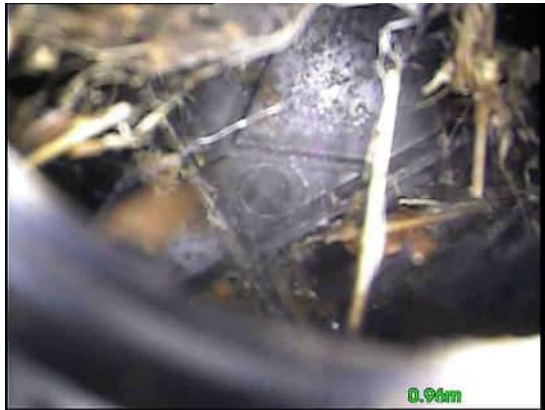
3, 00:00:18, 0.96 m  
Finish node, gully, reference: SGY reached

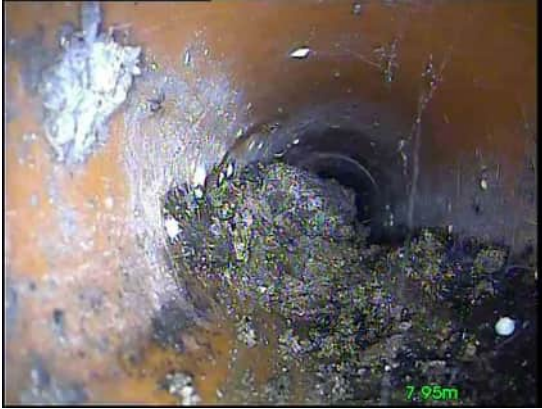
3, 00:00:24, 7.95 m  
Settled deposits, fine, 60% cross-sectional area loss

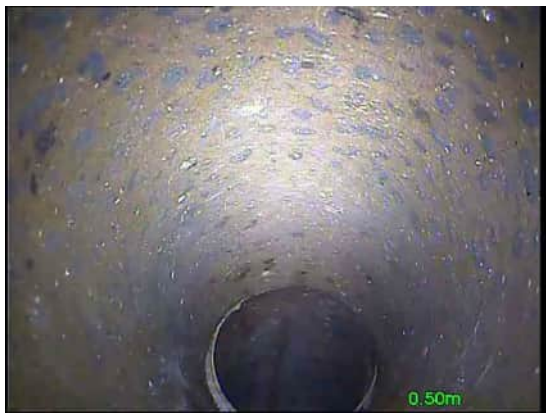
3, 00:00:11, 0.50 m  
General remark, Sewer levels out at this point

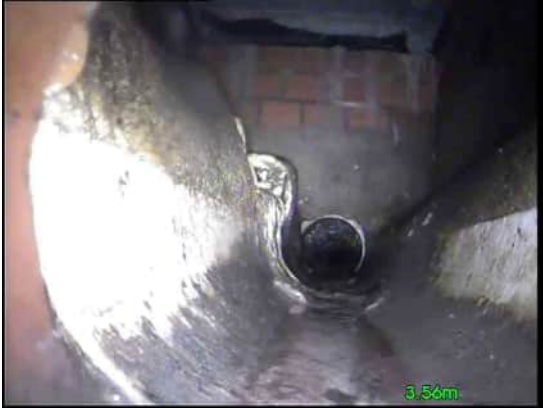
3, 00:00:17, 3.56 m  
Finish node, manhole, reference: MH45 UTL reached

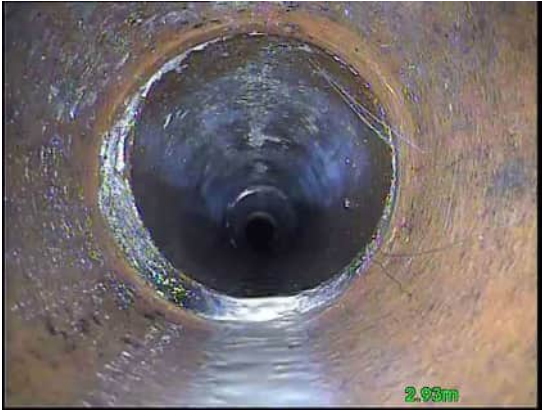
5, 00:00:29, 2.93 m  
General photograph taken at this point

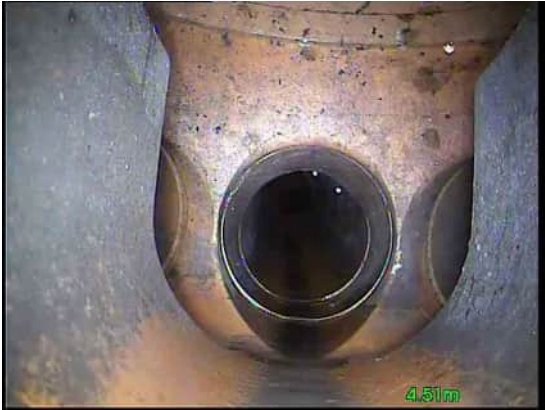
6, 00:00:41, 4.51 m  
Finish node, manhole, reference: MH19 UTL reached

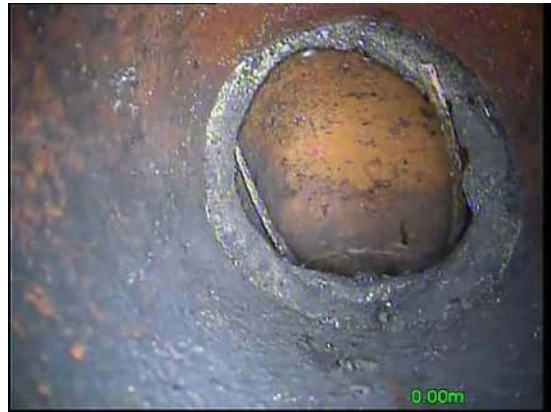
1, 00:00:01, 0.00 m  
General photograph taken at this point

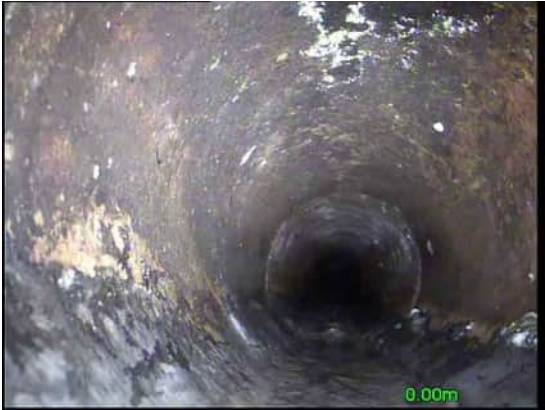
1, 00:00:01, 0.00 m  
General photograph taken at this point

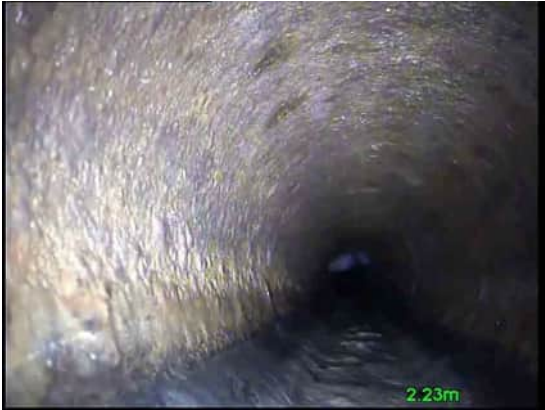
2, 00:00:09, 2.23 m  
General photograph taken at this point

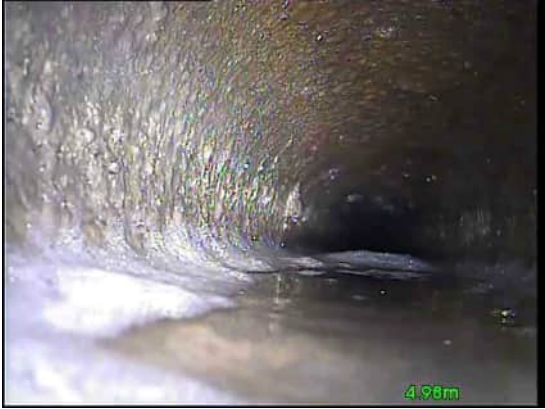
3, 00:00:21, 4.98 m  
Water level, 50% of the vertical dimension, Water in sewer due to water standing in MH42 downstream

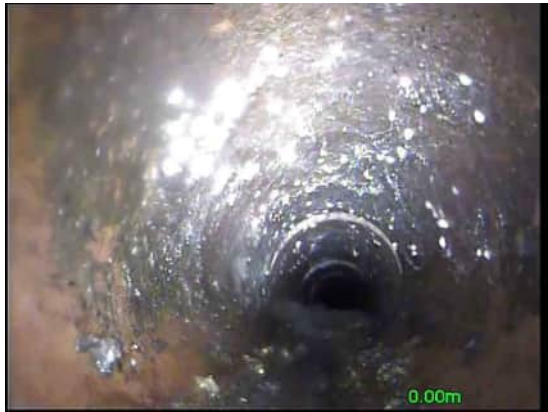
1, 00:00:02, 0.00 m  
General photograph taken at this point
