Tower Surveys Associates

Section Inspection - 17/10/2023 - RE?

TSA-23-2537 Channing School for Girls CCTV Report\_303\_Issue01

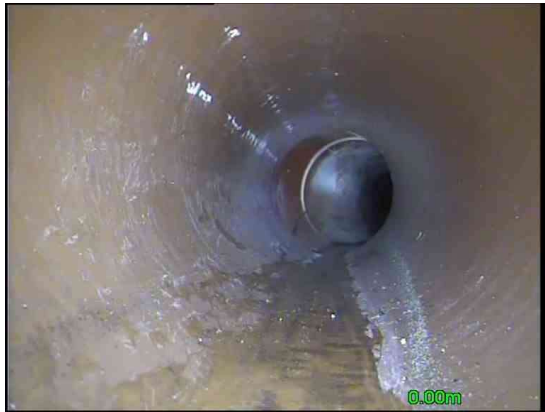
1, 00:00:02, 0.00 m  
General photograph taken at this point

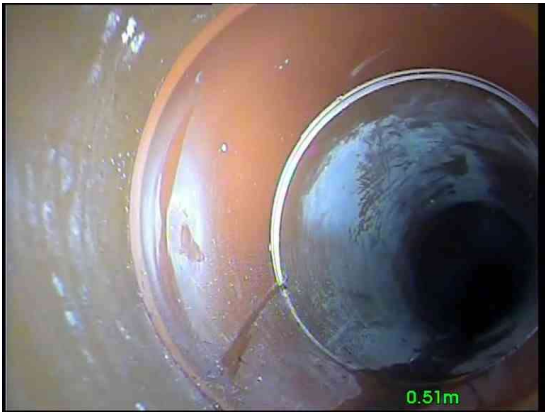
2, 00:00:06, 0.51 m  
Line deviates right

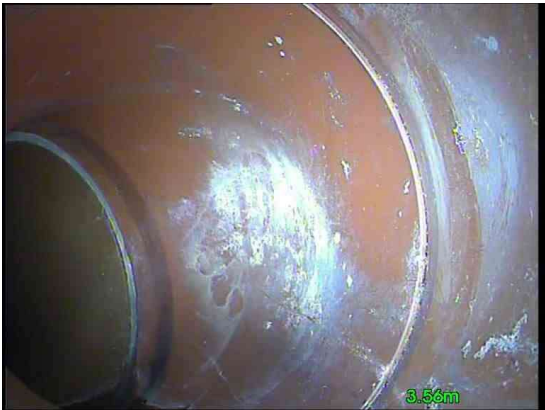
4, 00:00:17, 3.56 m  
Line deviates left

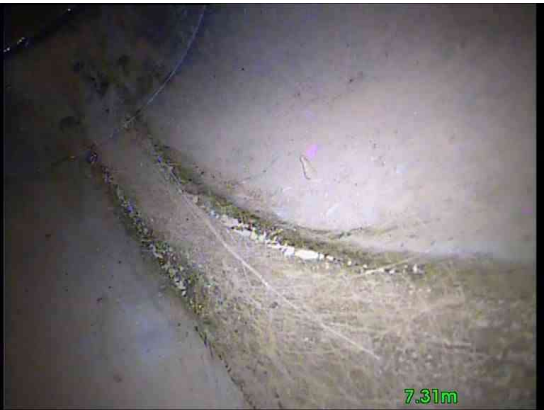
8, 00:00:39, 7.31 m  
General remark, Sewer levels out at this point

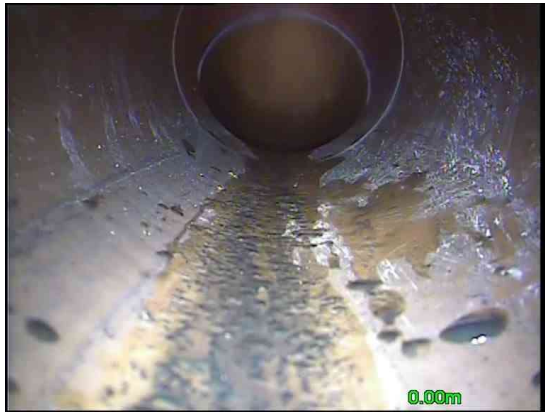
1, 00:00:02, 0.00 m  
Line deviates up

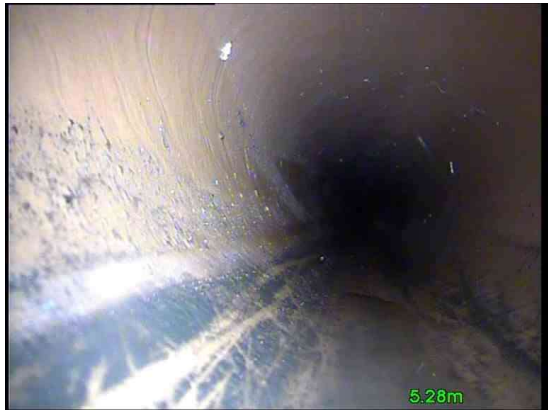
4, 00:00:32, 5.28 m  
General photograph taken at this point

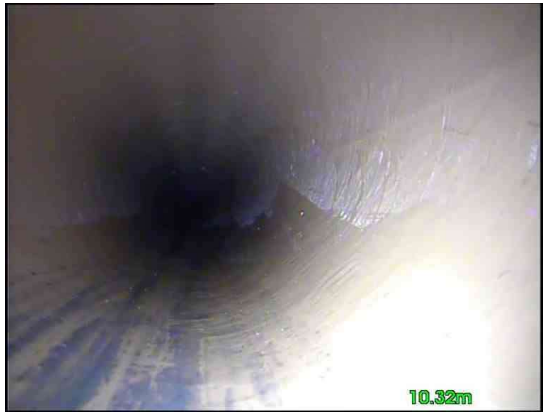
5, 00:00:45, 10.32 m  
General photograph taken at this point

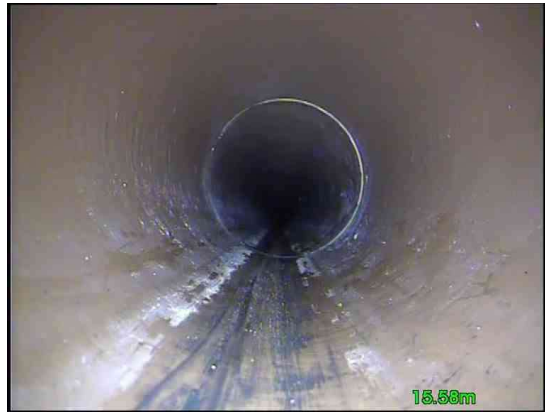
6, 00:00:59, 15.58 m  
General photograph taken at this point

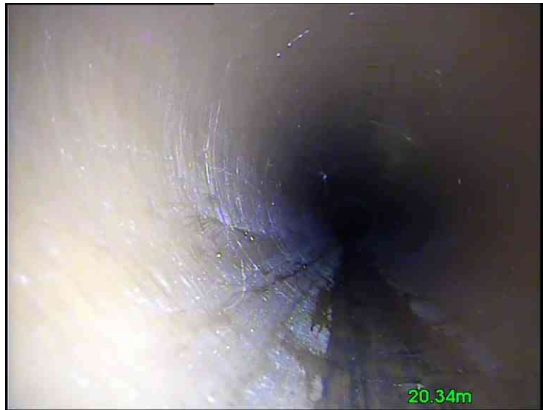
7, 00:01:14, 20.34 m  
General photograph taken at this point

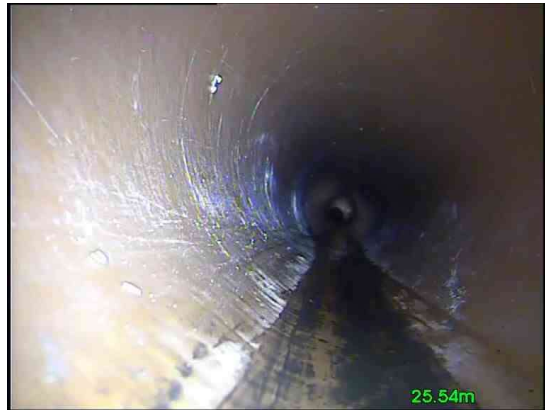
8, 00:01:26, 25.54 m  
General photograph taken at this point

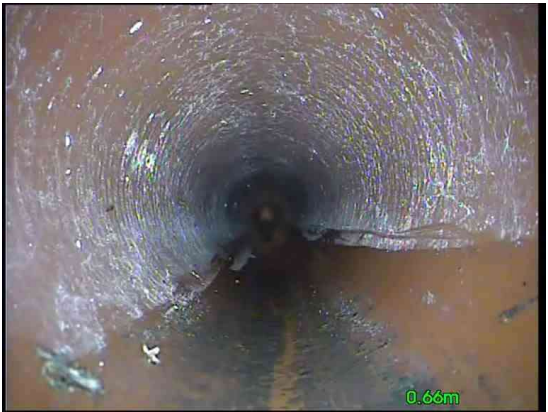
2, 00:00:13, 0.66 m  
General photograph taken at this point

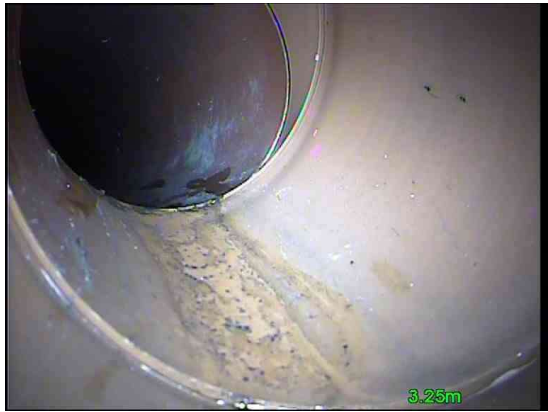
3, 00:00:24, 3.25 m  
Line deviates left

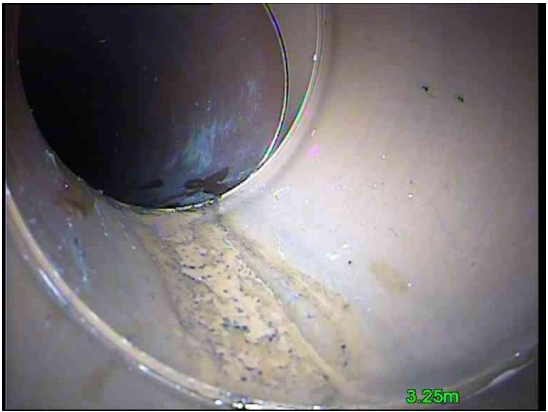
4, 00:00:24, 3.25 m  
Line deviates up

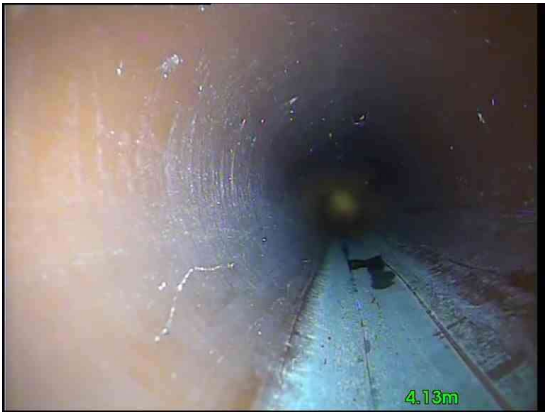
5, 00:00:30, 4.13 m  
General photograph taken at this point

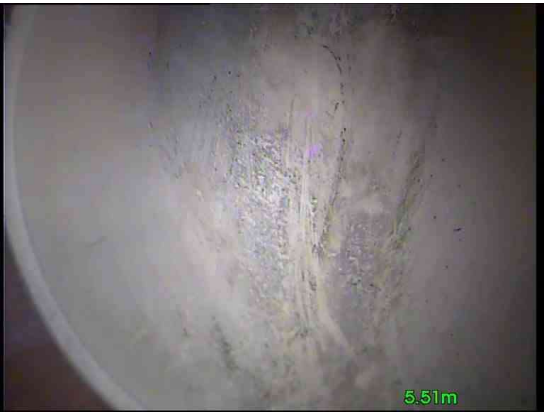
6, 00:00:36, 5.51 m  
Finish node, other special chamber, reference: RWP, RWP reached

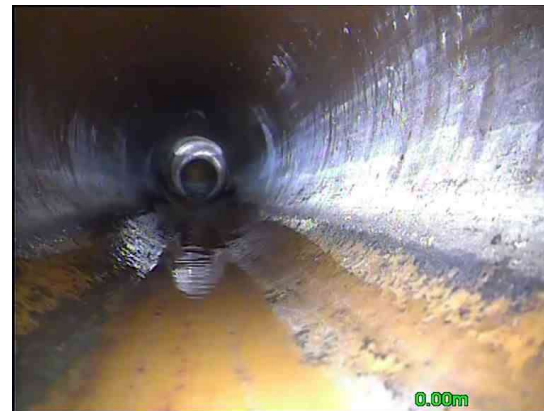
1, 00:00:01, 0.00 m  
General photograph taken at this point

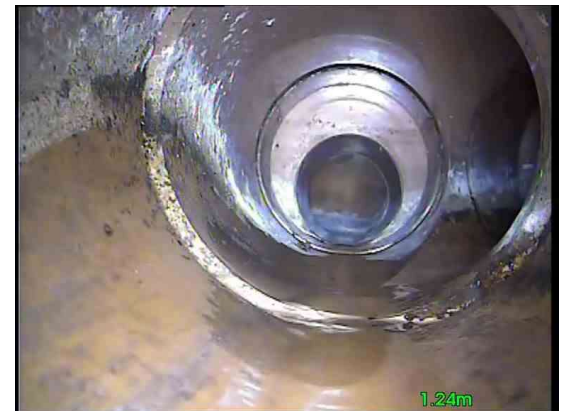
2, 00:00:07, 1.24 m  
Junction at 3 o'clock, 150mm dia

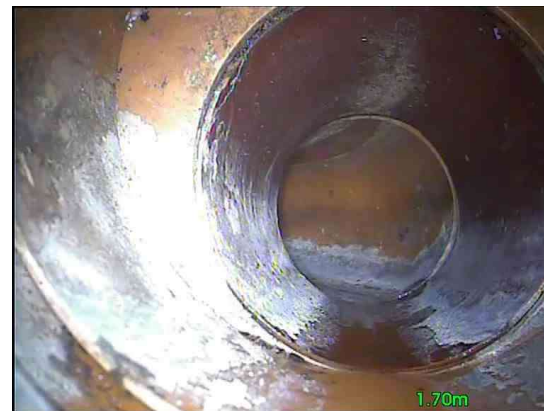
3, 00:00:13, 1.70 m  
Pipe size changes, new size(s), 100mm high

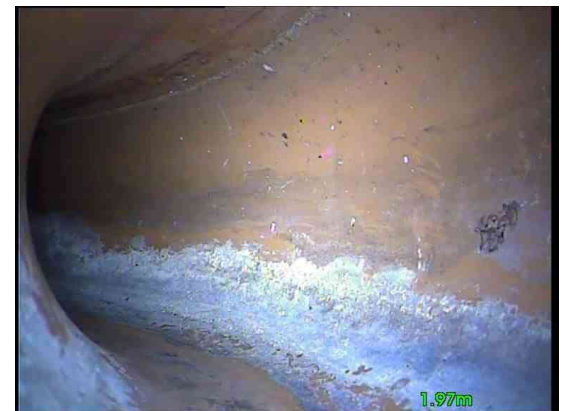
4, 00:00:15, 1.97 m  
Line deviates left

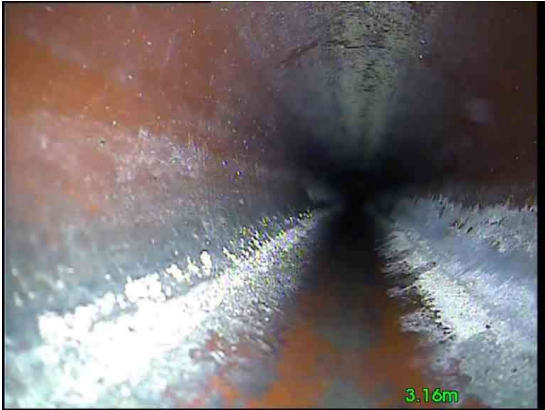
5, 00:00:23, 3.16 m  
General photograph taken at this point

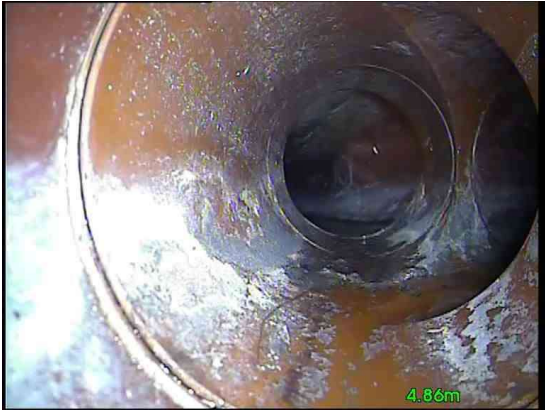
6, 00:00:30, 4.86 m  
Junction at 3 o'clock, 100mm dia

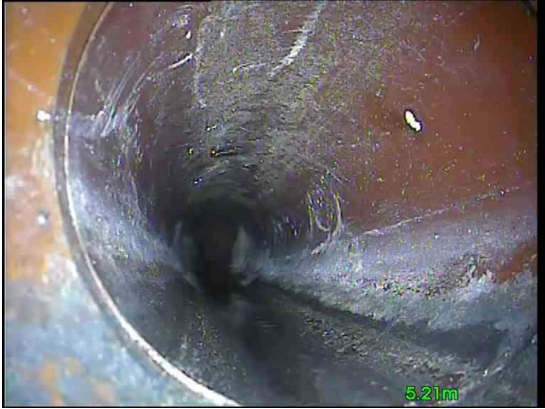
7, 00:00:34, 5.21 m  
Line deviates left

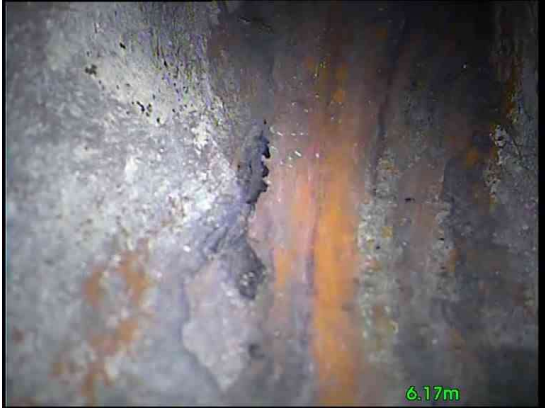
8, 00:00:45, 6.17 m  
Finish node, other special chamber, reference: Downpipe, Internal downpipe reached

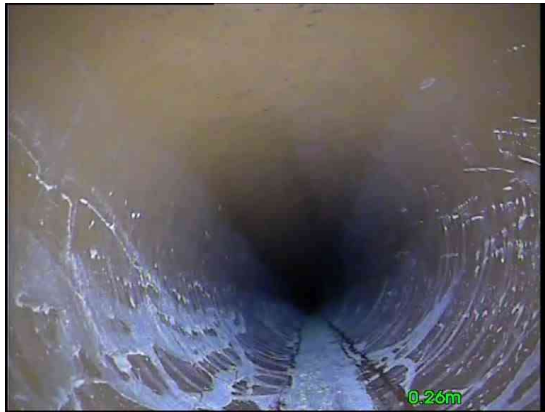
1, 00:00:04, 0.26 m  
General photograph taken at this point

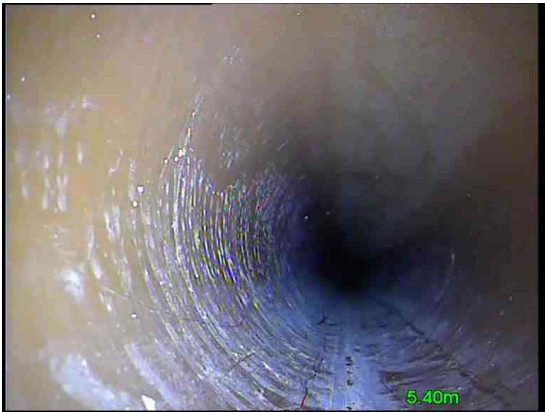
2, 00:00:16, 5.40 m  
General photograph taken at this point

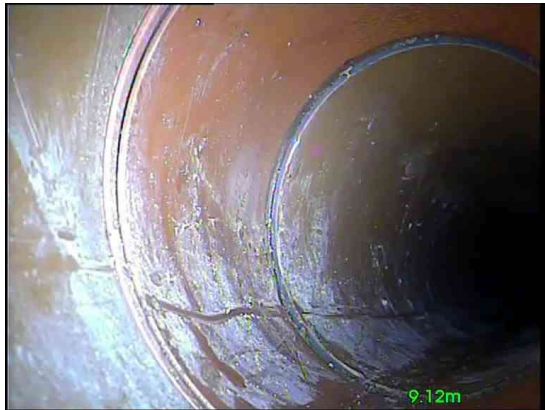
3, 00:00:26, 9.12 m  
Line deviates right

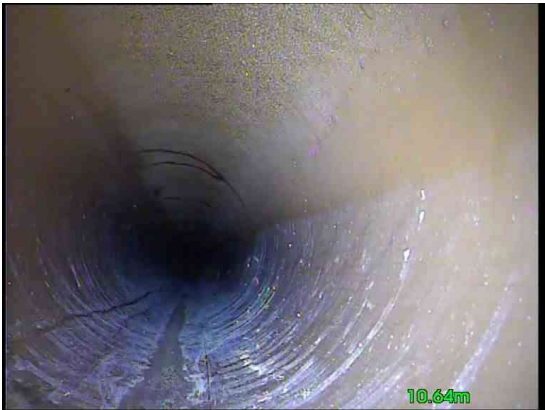
4, 00:00:32, 10.64 m  
General photograph taken at this point

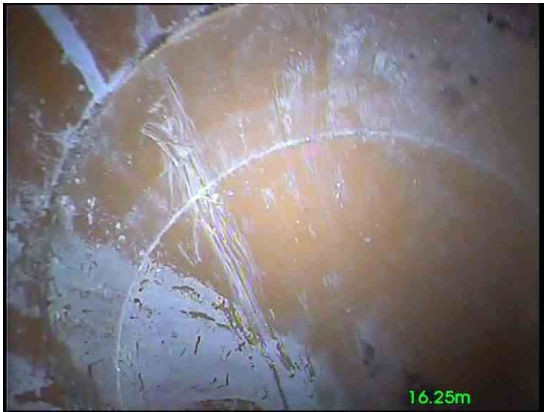
6, 00:00:47, 16.25 m  
General remark, Sewer levels out at this point

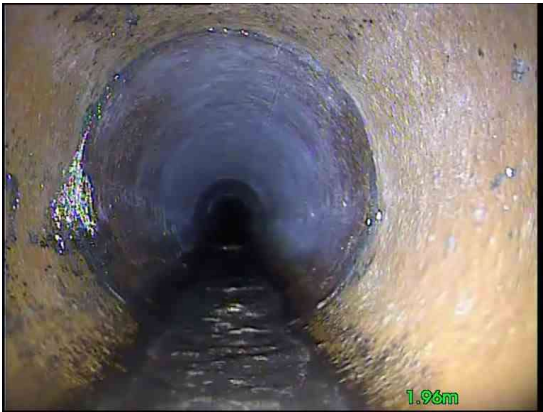
5, 00:00:15, 1.96 m  
General photograph taken at this point

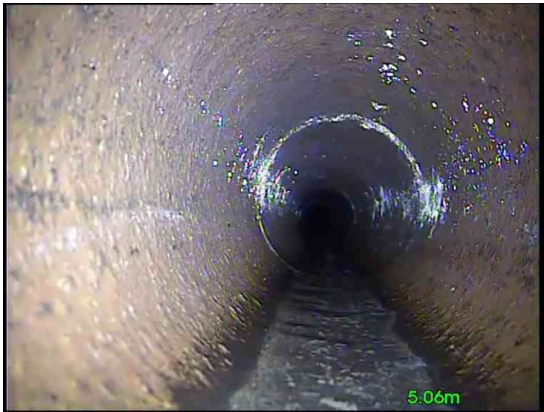
6, 00:00:29, 5.06 m  
General photograph taken at this point

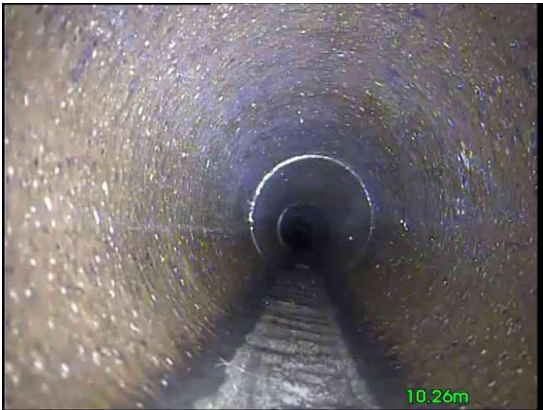
7, 00:00:49, 10.26 m  
General photograph taken at this point

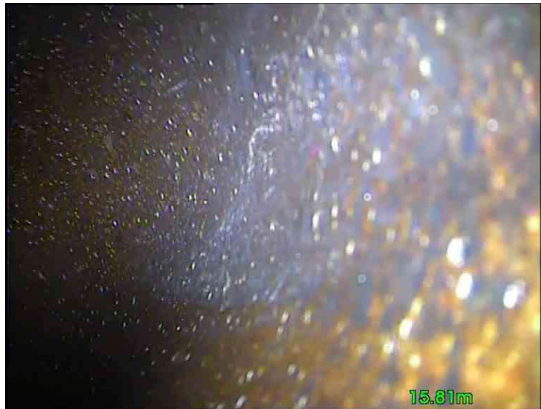
17, 00:01:47, 15.81 m  
Line deviates down

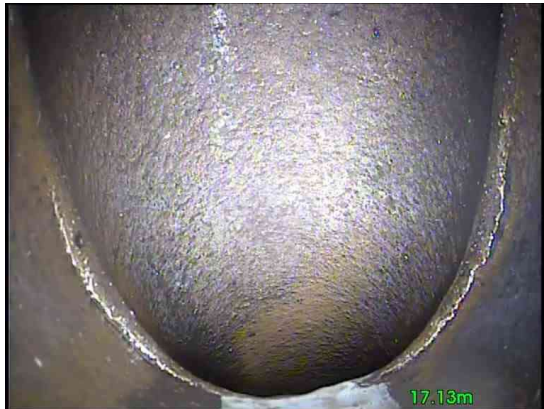
18, 00:02:11, 17.13 m  
Finish node, manhole, reference: MH9 reached

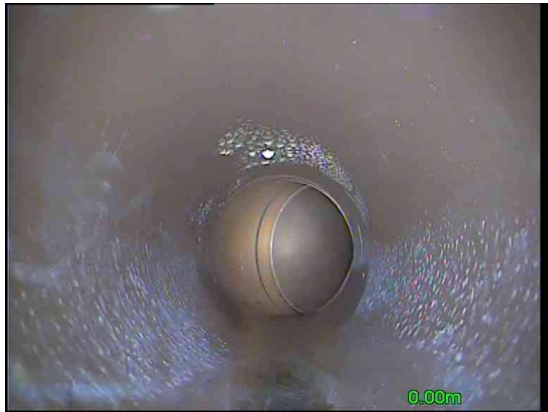
1, 00:00:03, 0.00 m  
General photograph taken at this point

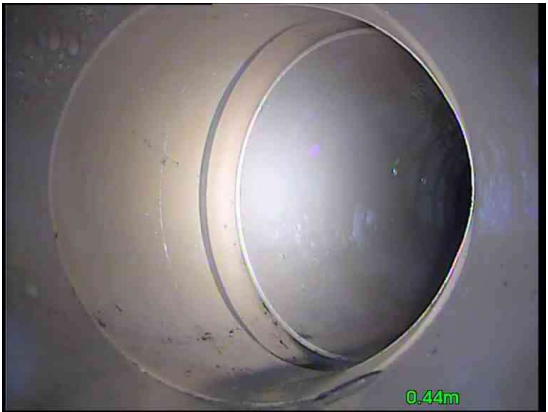
2, 00:00:06, 0.44 m  
Line deviates right

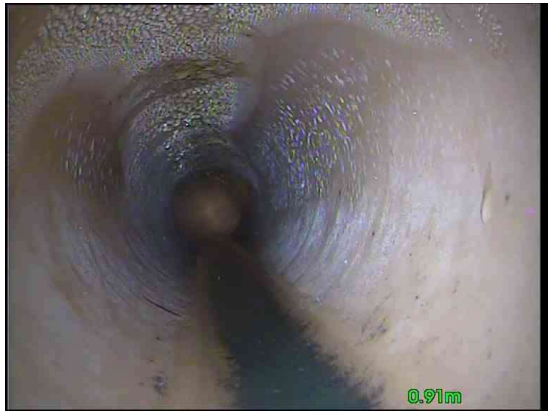
3, 00:00:12, 0.91 m  
General photograph taken at this point

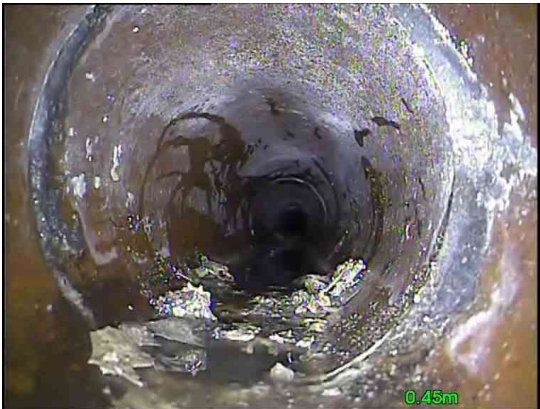
1, 00:00:07, 0.45 m

Settled deposits, coarse, 5% cross-sectional area loss

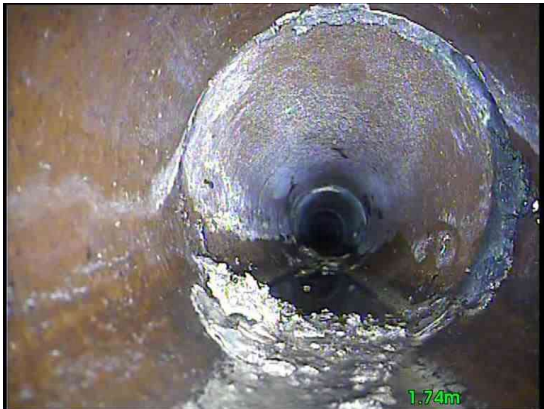
2, 00:00:16, 1.74 m

Settled deposits, hard or compacted at joint, 5% cross-sectional area loss

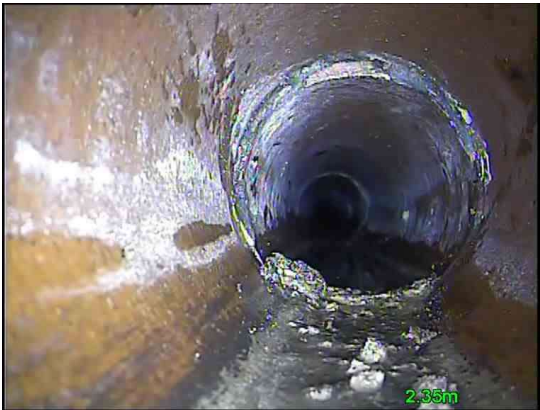
3, 00:00:19, 2.35 m

Settled deposits, hard or compacted at joint, 5% cross-sectional area loss

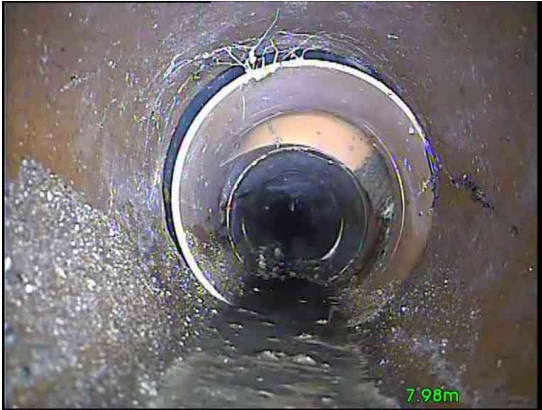
5, 00:00:48, 7.98 m  
Pipe material changes to polyvinyl chloride at this point

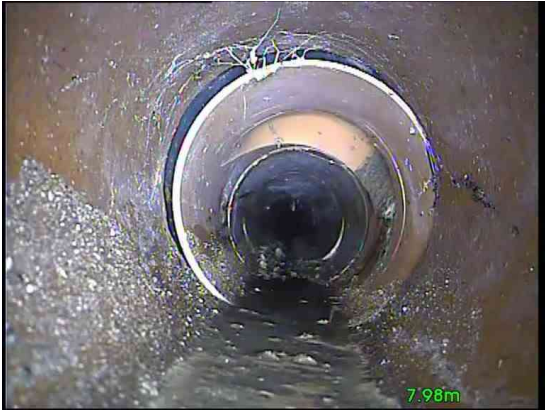
6, 00:00:48, 7.98 m  
Joint displaced, medium

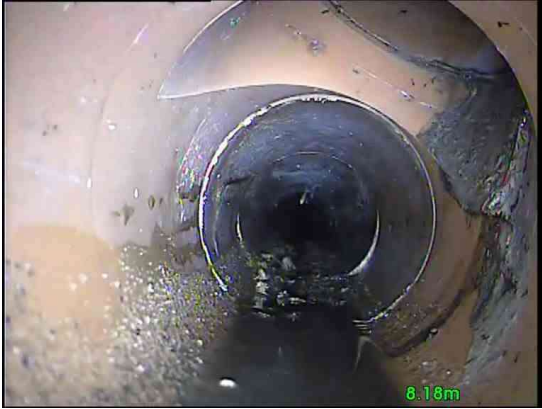
7, 00:00:54, 8.18 m  
Junction at 2 o'clock, 100mm dia

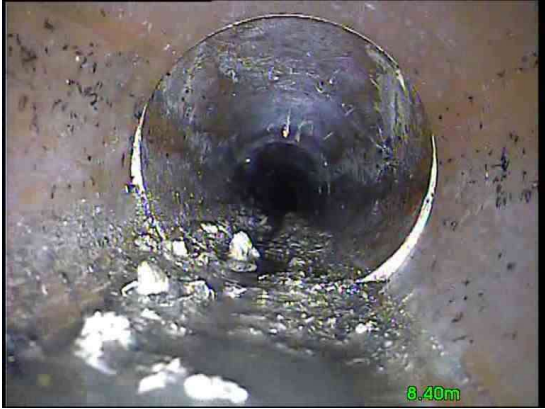
8, 00:00:56, 8.40 m  
Settled deposits, coarse, 5% cross-sectional area loss, start

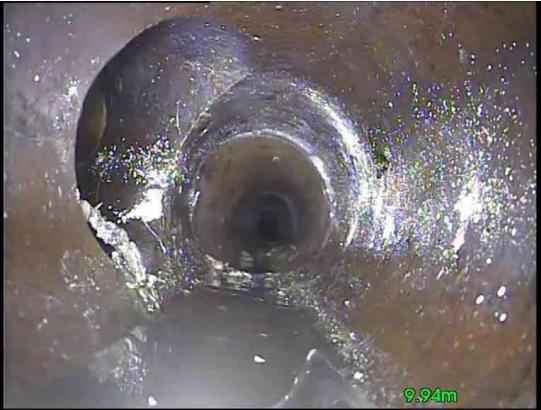
10, 00:01:09, 9.94 m  
Junction at 10 o'clock, 100mm dia

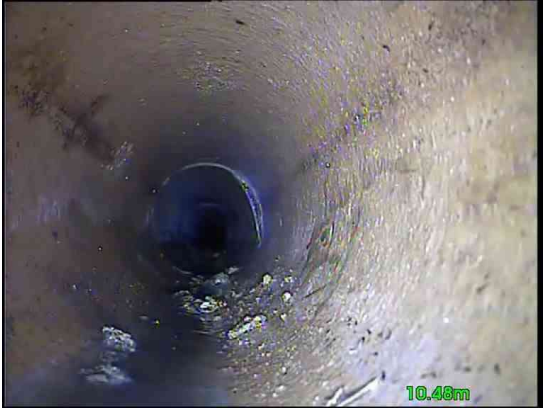
11, 00:01:16, 10.48 m  
Settled deposits, coarse, 5% cross-sectional area loss, start

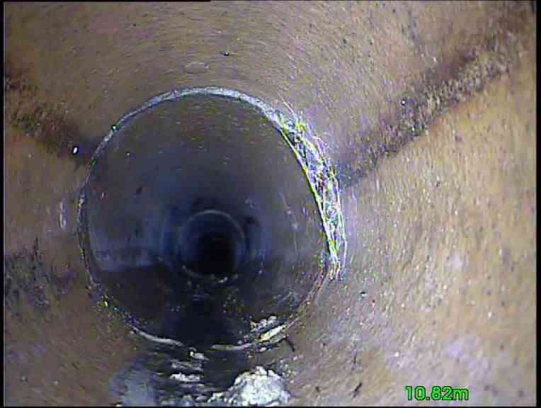
12, 00:01:18, 10.82 m  
General photograph taken at this point

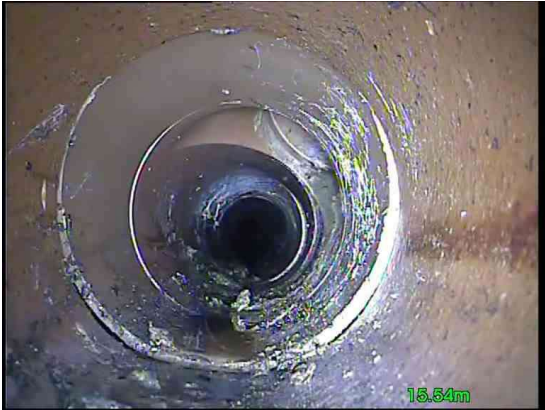
14, 00:01:50, 15.54 m  
Pipe material changes to polyvinyl chloride at this point

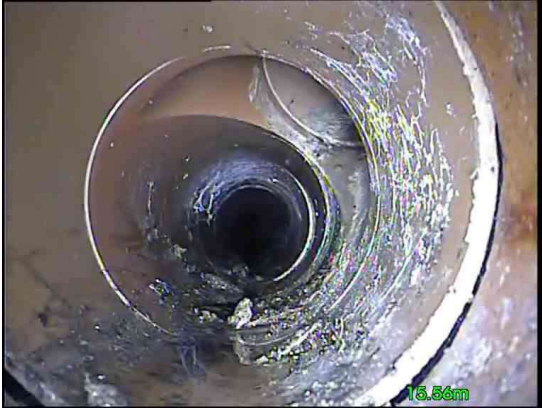
15, 00:01:52, 15.56 m  
Junction at 2 o'clock, 100mm dia

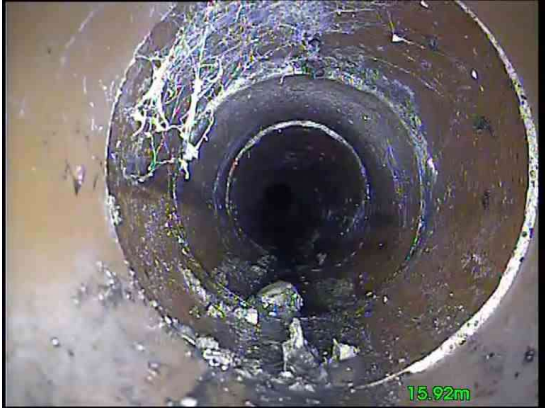
16, 00:01:55, 15.92 m  
Pipe material changes to vitrified clay at this point

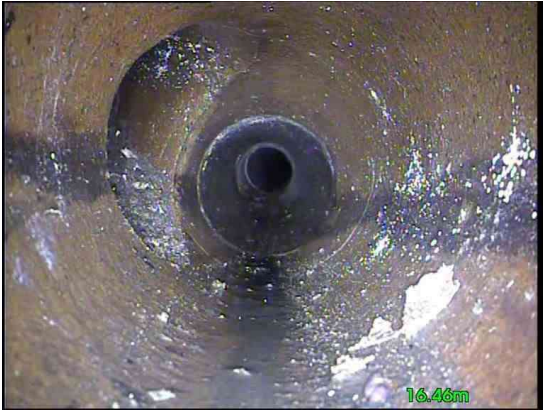
17, 00:02:00, 16.46 m  
Junction at 10 o'clock, 100mm dia

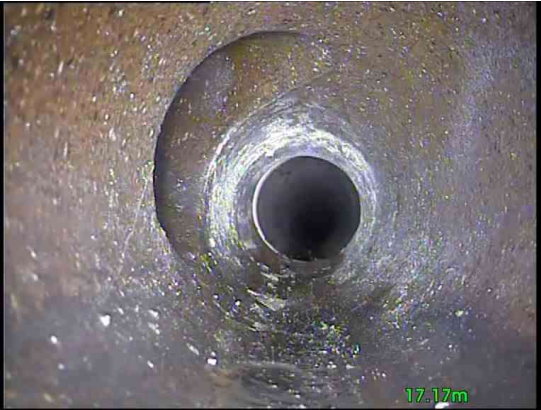
18, 00:02:06, 17.17 m  
Junction at 10 o'clock, 100mm dia

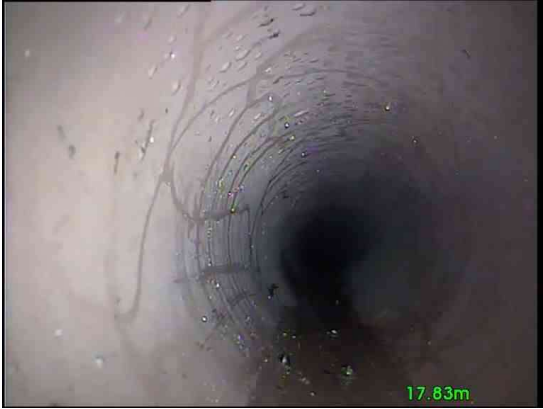
19, 00:02:08, 17.83 m  
Pipe material changes to polyvinyl chloride at this point

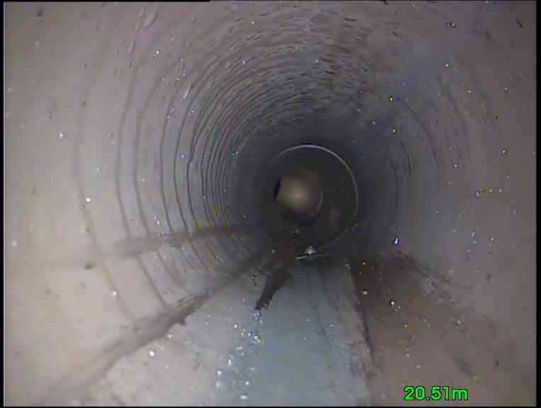
20, 00:02:17, 20.51 m  
General photograph taken at this point

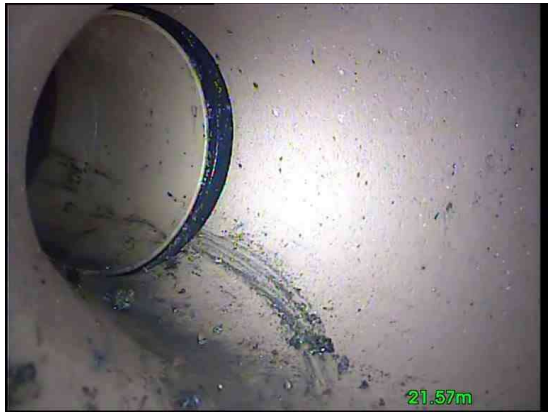
21, 00:02:27, 21.57 m  
Line deviates left

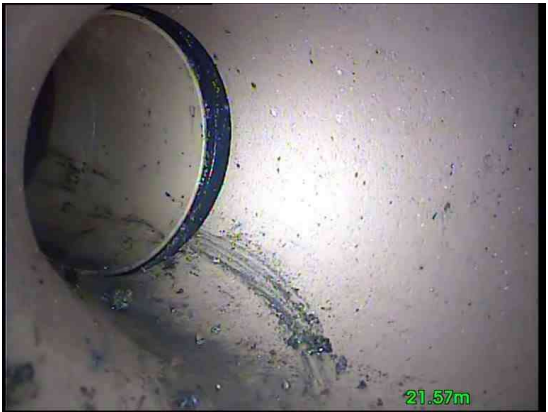
22, 00:02:27, 21.57 m  
Line deviates up

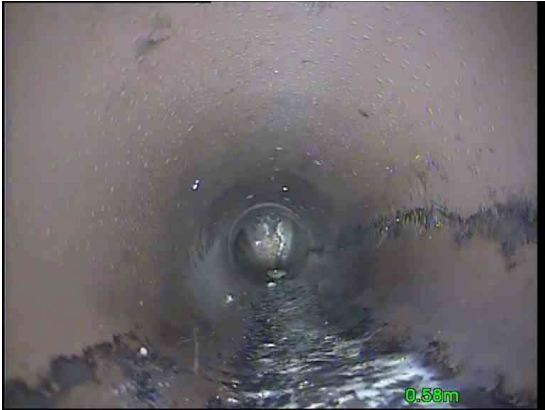
1, 00:00:05, 0.58 m  
General photograph taken at this point

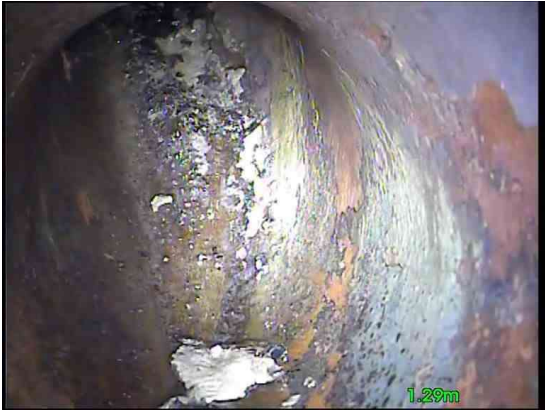
2, 00:00:13, 1.29 m  
Finish node, other special chamber, reference: Downpipe, Internal downpipe reached

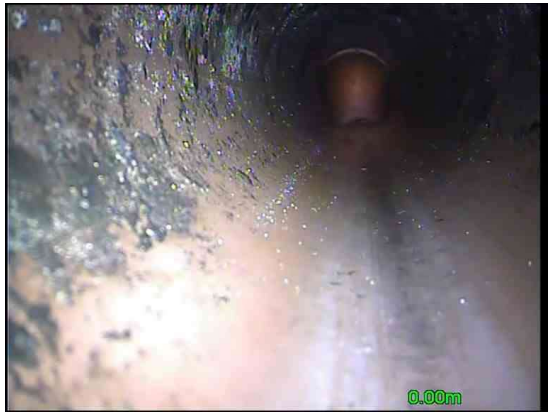
1, 00:00:01, 0.00 m  
Line deviates up

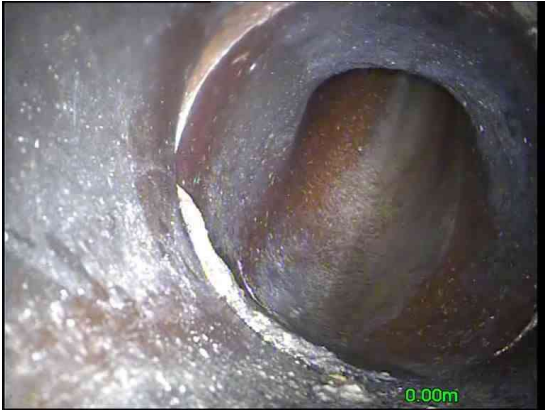
1, 00:00:02, 0.00 m  
General photograph taken at this point

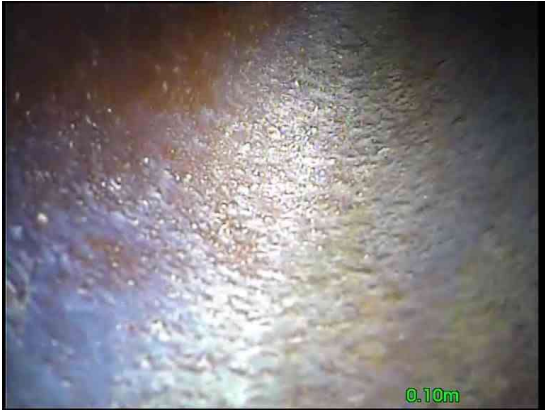
2, 00:00:05, 0.10 m  
Line deviates up

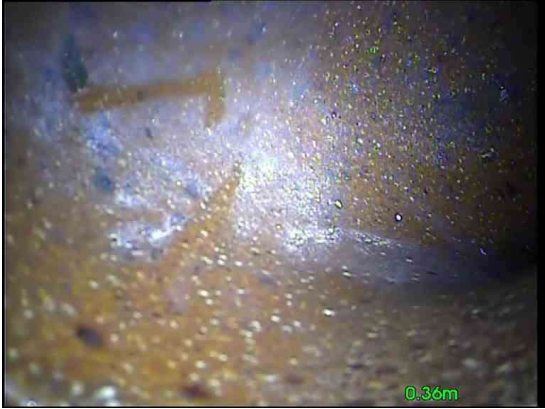
3, 00:00:10, 0.36 m  
Line deviates right

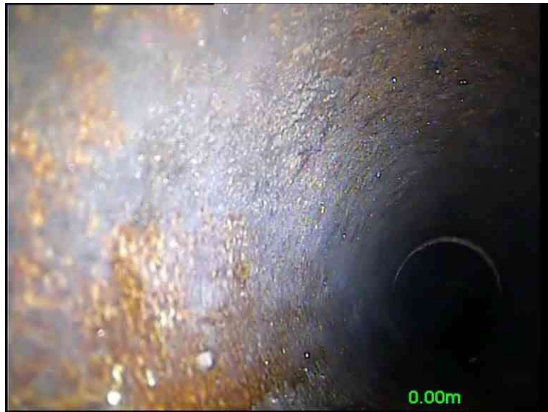
1, 00:00:01, 0.00 m

Line deviates right

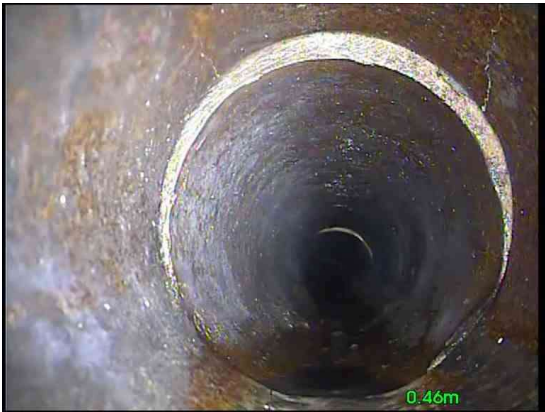
2, 00:00:11, 0.46 m

General photograph taken at this point

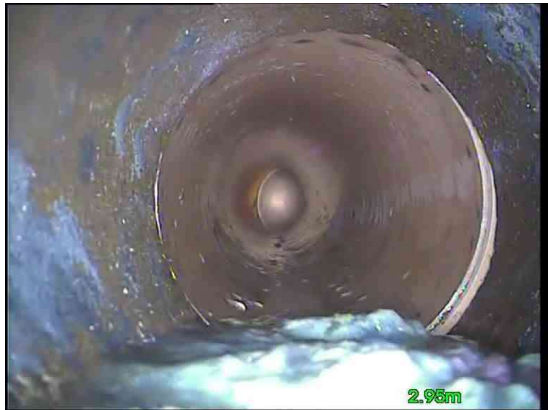
3, 00:00:26, 2.95 m

Attached deposits, fouling from 5 o'clock to 7 o'clock, 5% cross-sectional area loss

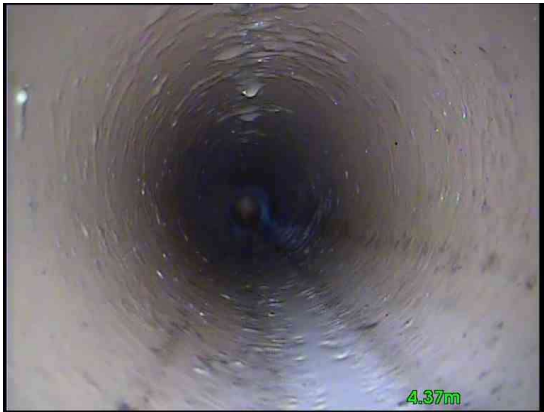
6, 00:00:41, 4.37 m

General photograph taken at this point

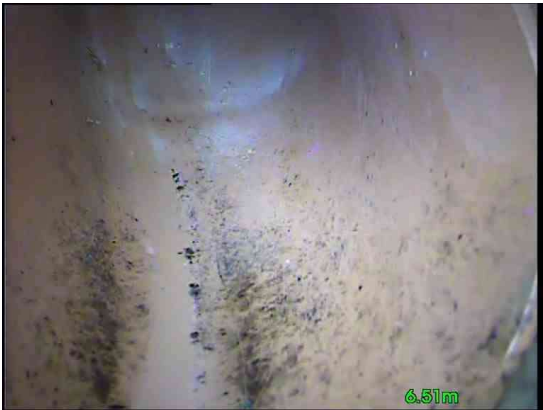
7, 00:00:54, 6.51 m

Finish node, other special chamber, reference: Downpipe, Internal downpipe reached

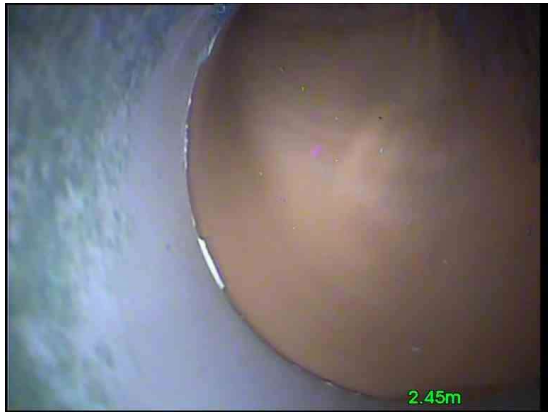
5, 00:00:15, 2.45 m  
Finish node, other special chamber, reference: Downpipe,  
Internal downpipe reached

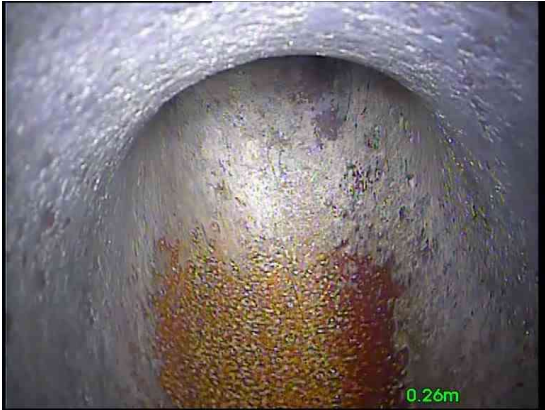
2, 00:00:07, 0.26 m  
Finish node, other special chamber, reference: Downpipe,  
Downpipe reached

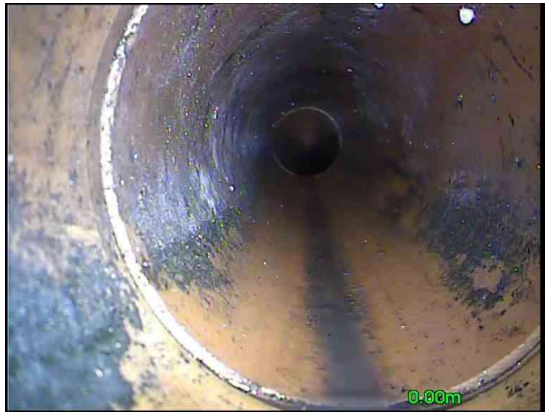
1, 00:00:03, 0.00 m  
Line deviates up

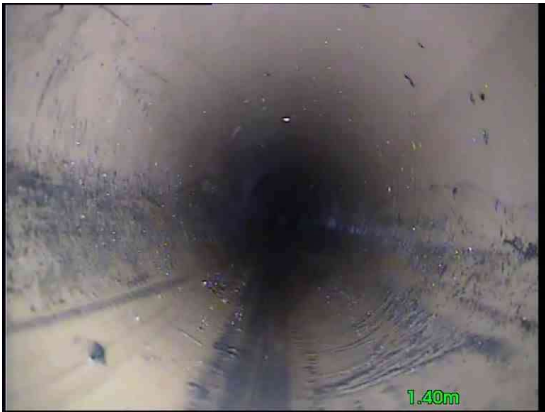
2, 00:00:12, 1.40 m  
General photograph taken at this point

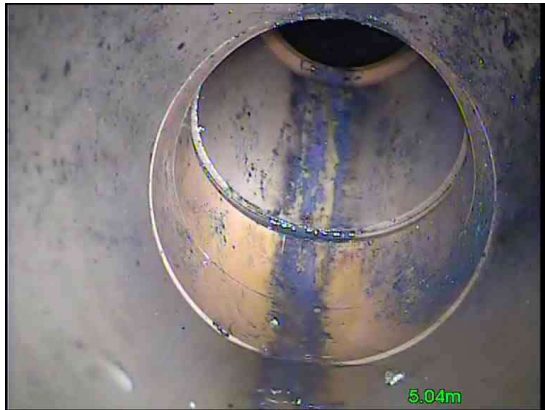
3, 00:00:33, 5.04 m  
Line deviates up

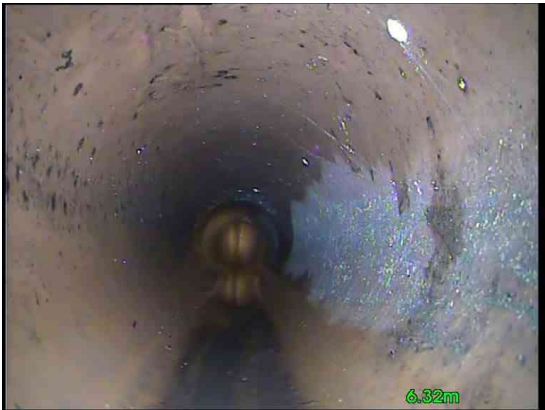
4, 00:00:45, 6.32 m  
General photograph taken at this point

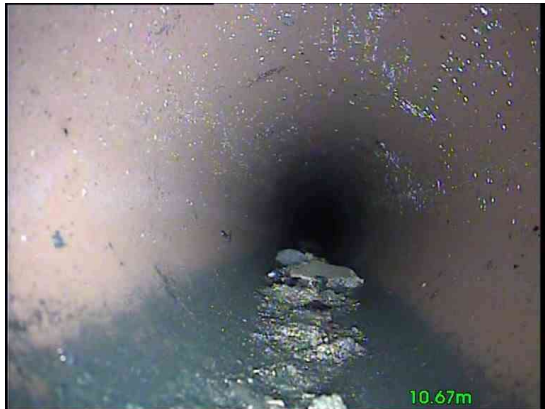
5, 00:00:41, 10.67 m  
Settled deposits, coarse, 10% cross-sectional area loss, start

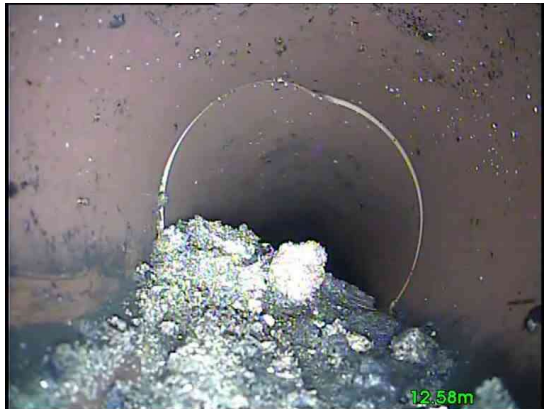
6, 00:00:50, 12.58 m  
Settled deposits, coarse, 35% cross-sectional area loss, change

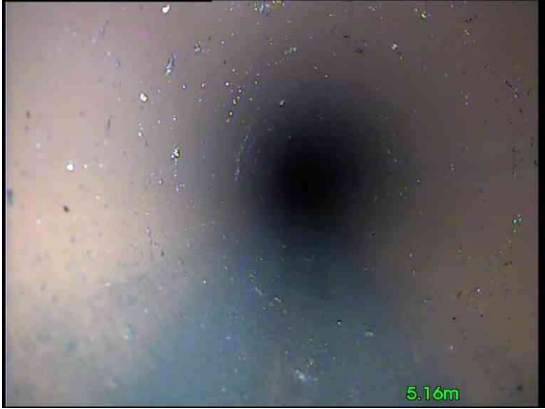
4, 00:00:25, 5.16 m  
Settled deposits, coarse, 20% cross-sectional area loss, finish

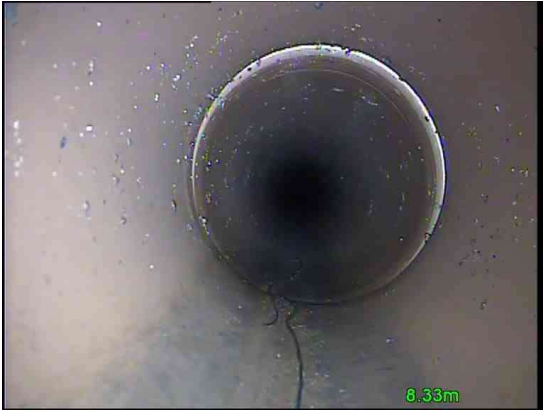
5, 00:00:34, 8.33 m  
Roots, fine, start

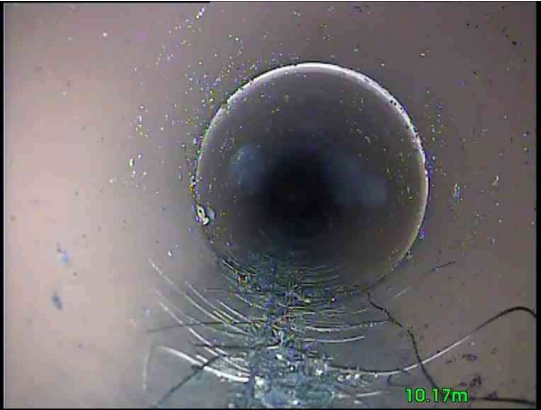
6, 00:00:40, 10.17 m  
General photograph taken at this point

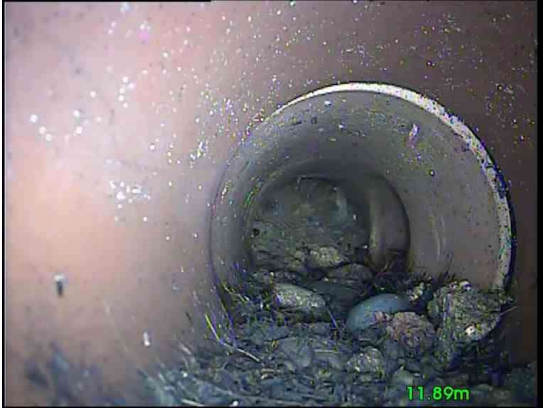
7, 00:00:46, 11.89 m  
Settled deposits, coarse, 25% cross-sectional area loss, start

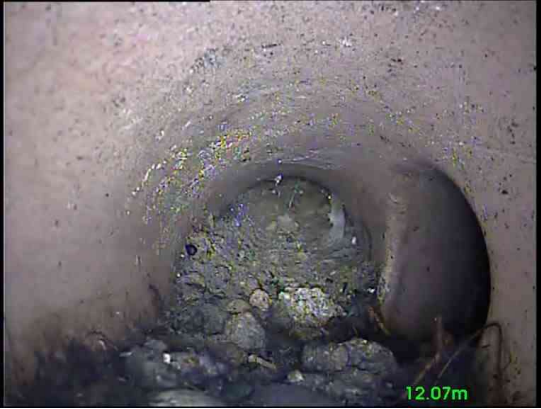
8, 00:00:49, 12.07 m  
Junction at 3 o'clock, 100mm dia

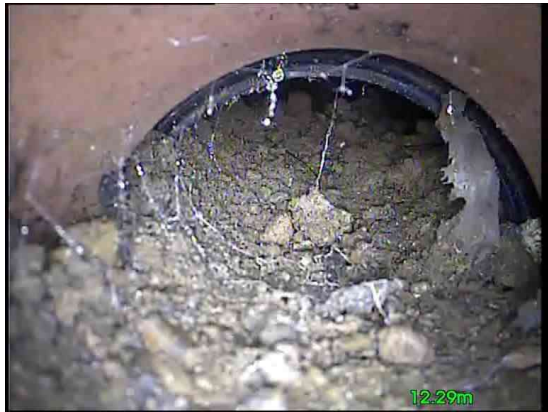
10, 00:00:53, 12.29 m  
Finish node, rodding eye, reference: RE reached

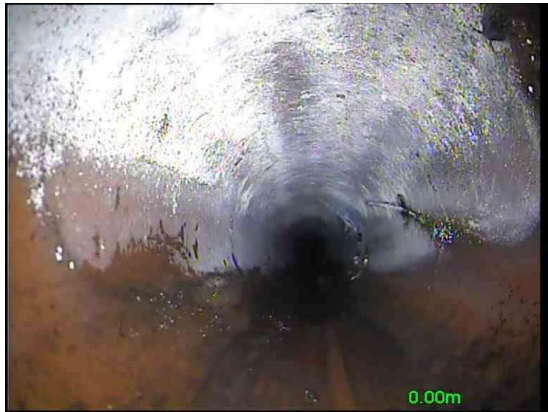
1, 00:00:02, 0.00 m  
General photograph taken at this point

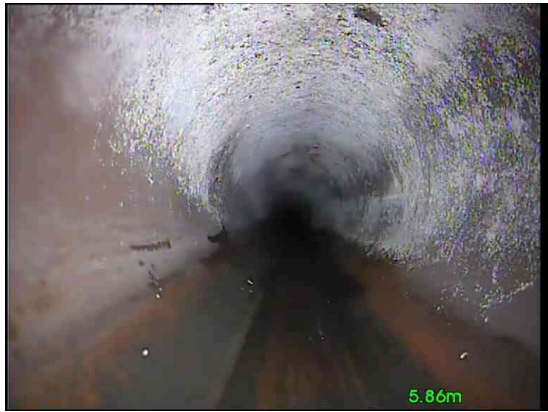
3, 00:00:27, 5.86 m  
General photograph taken at this point

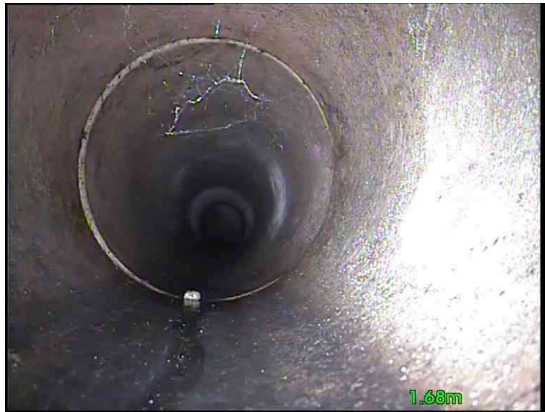
5, 00:00:19, 1.68 m  
General photograph taken at this point

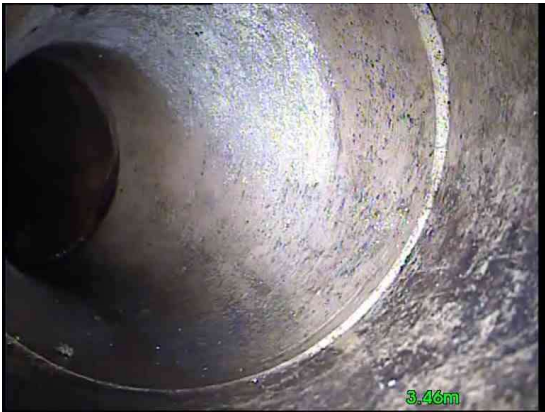
6, 00:00:30, 3.46 m  
Line deviates left

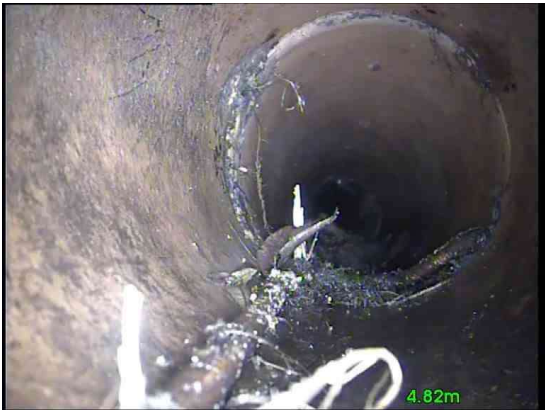
8, 00:00:45, 4.82 m  
Roots, mass, 20% cross-sectional area loss, start

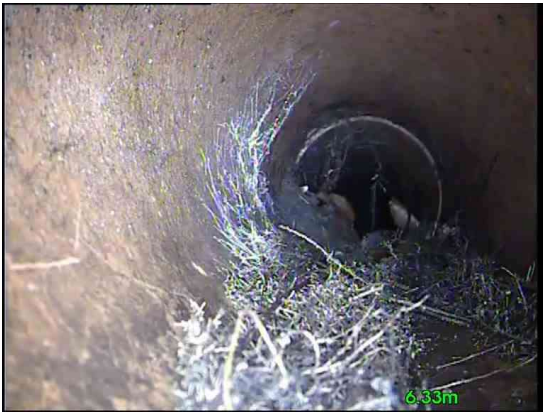
9, 00:00:55, 6.33 m  
Roots, mass, 35% cross-sectional area loss, change

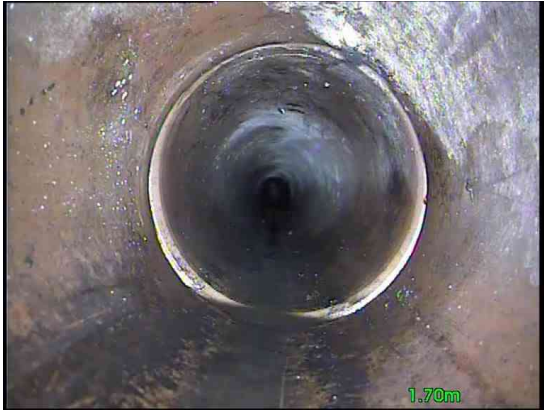
2, 00:00:12, 1.70 m  
General photograph taken at this point

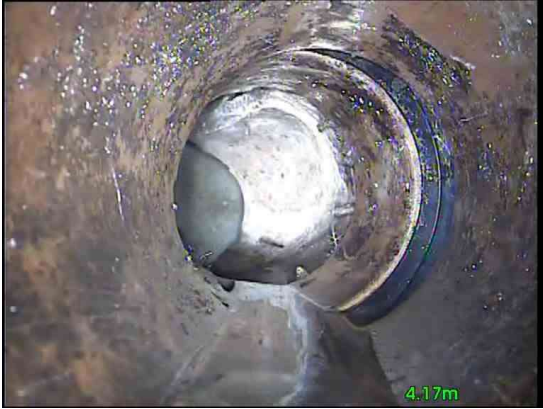
3, 00:00:21, 4.17 m  
Joint displaced, large

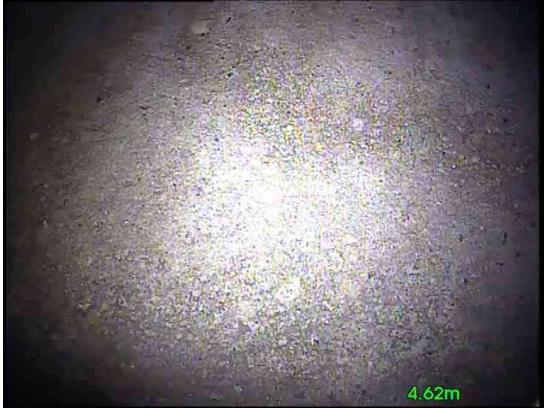
4, 00:00:31, 4.62 m  
Finish node, manhole, reference: MH22 UTL reached

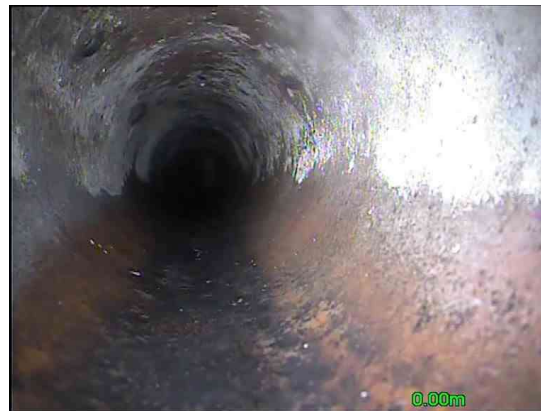
1, 00:00:02, 0.00 m  
General photograph taken at this point

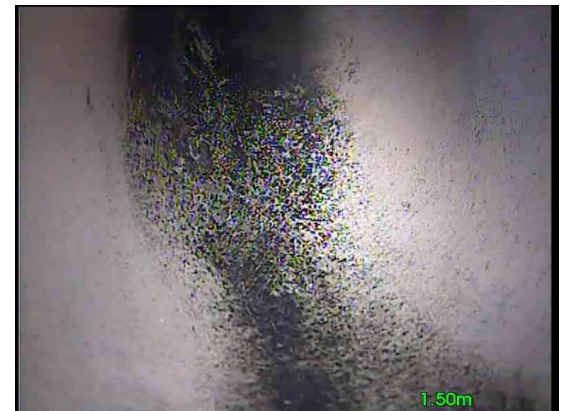
2, 00:00:12, 1.50 m  
Line deviates up

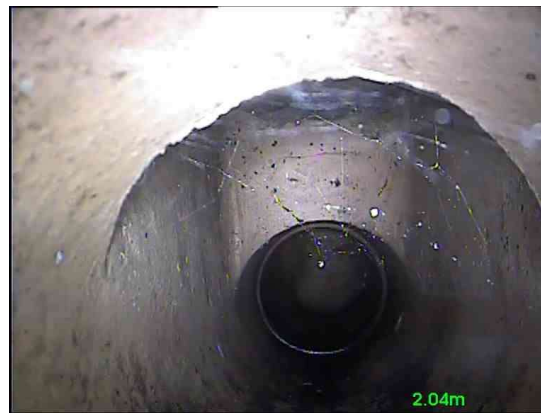
3, 00:00:20, 2.04 m  
Finish node, rodding eye, reference: RWP reached

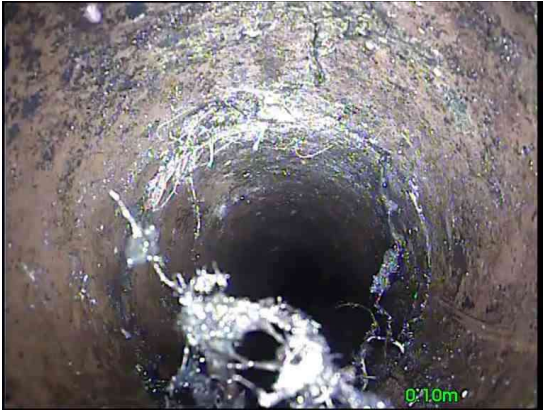
1, 00:00:05, 0.10 m  
Roots, fine at joint

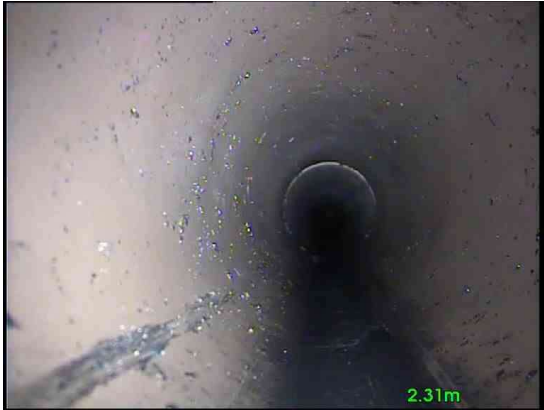
2, 00:00:17, 2.31 m  
General photograph taken at this point

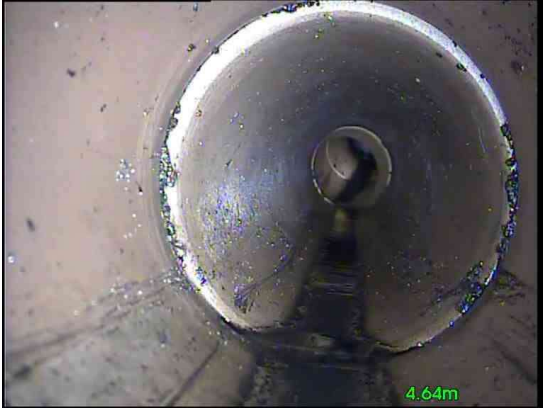
3, 00:00:26, 4.64 m  
Line deviates up

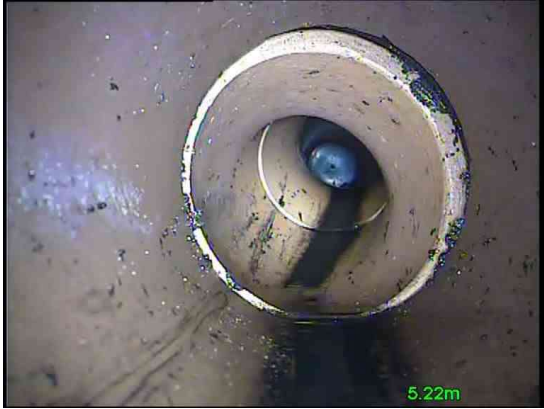
4, 00:00:30, 5.22 m  
Joint displaced, medium
