Tower Surveys Associates

Section Inspection - 17/10/2023 - RE?

TSA-23-2537 Channing School for Girls CCTV Report\_303\_Issue01

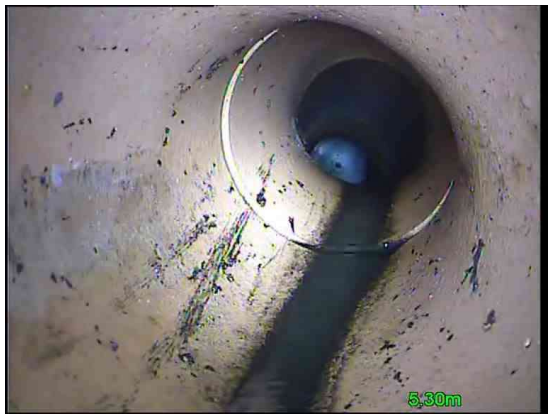
5, 00:00:33, 5.30 m  
Line deviates up

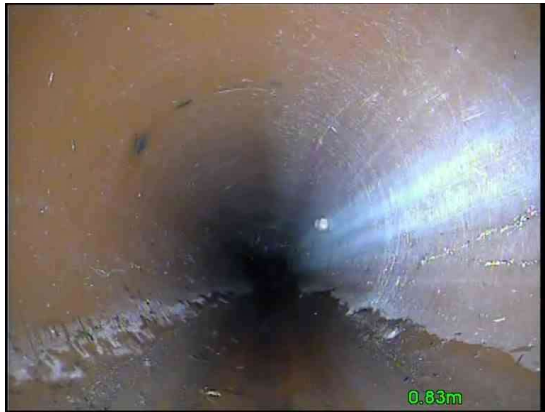
1, 00:00:04, 0.83 m  
General photograph taken at this point

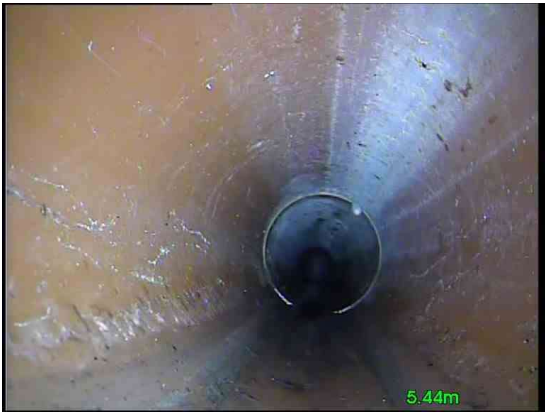
2, 00:00:17, 5.44 m  
General photograph taken at this point

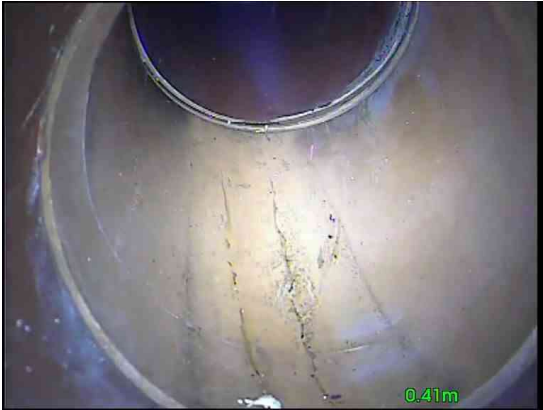
1, 00:00:04, 0.41 m  
Line deviates up

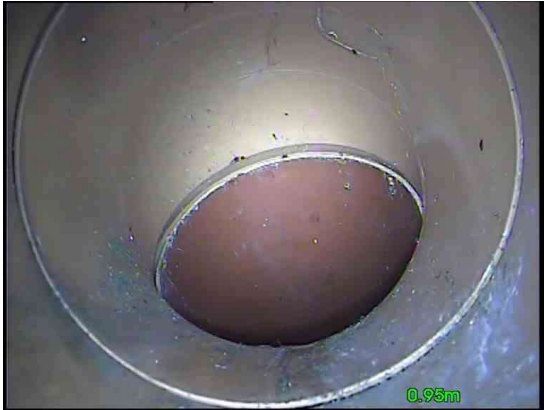
2, 00:00:09, 0.95 m  
General remark, Sewer levels out at this point

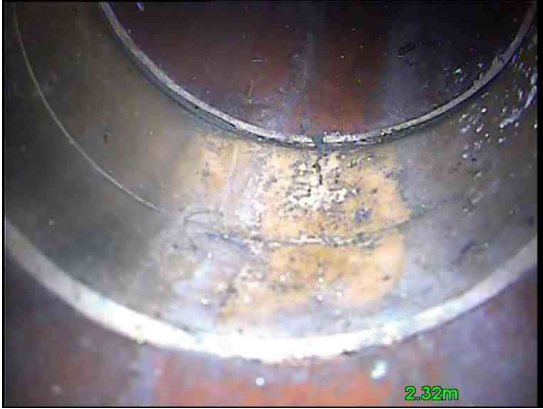
3, 00:00:17, 2.32 m  
Line deviates up

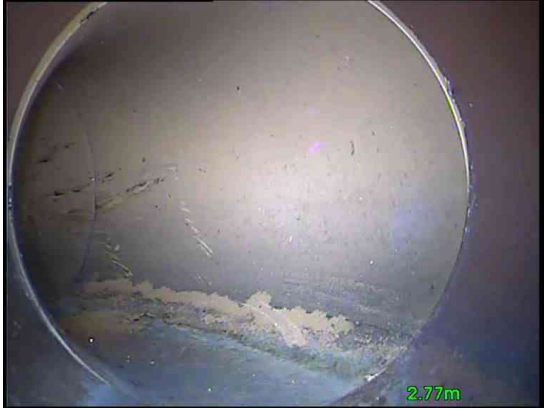
4, 00:00:22, 2.77 m  
Line deviates left

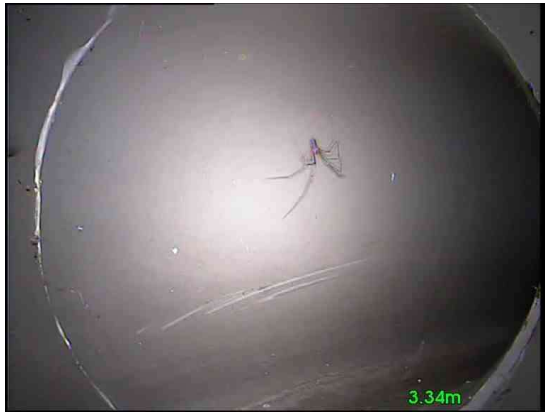
5, 00:00:25, 3.34 m  
Line deviates right

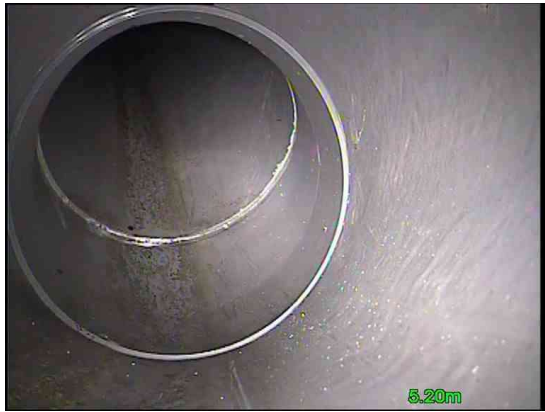
7, 00:00:46, 5.20 m  
Line deviates up

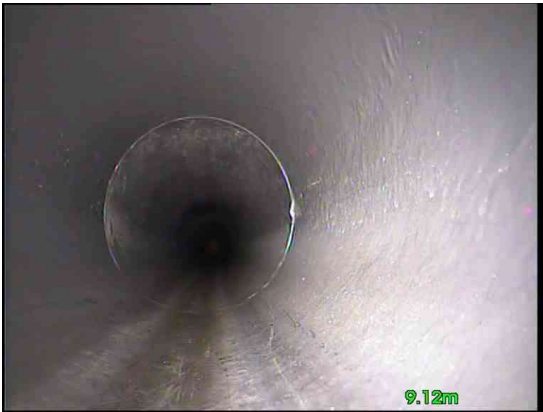
9, 00:01:01, 9.12 m  
General photograph taken at this point

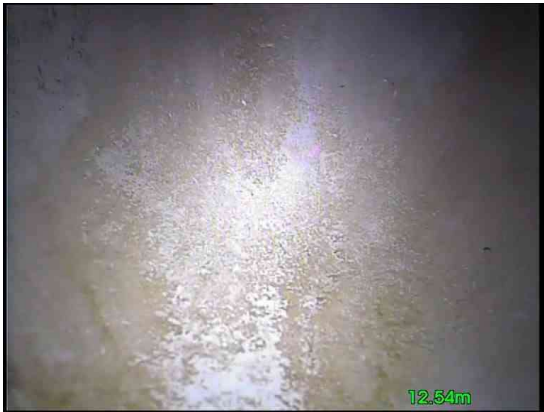
10, 00:01:20, 12.54 m  
Finish node, other special chamber, reference: RWP, Internal RWP reached

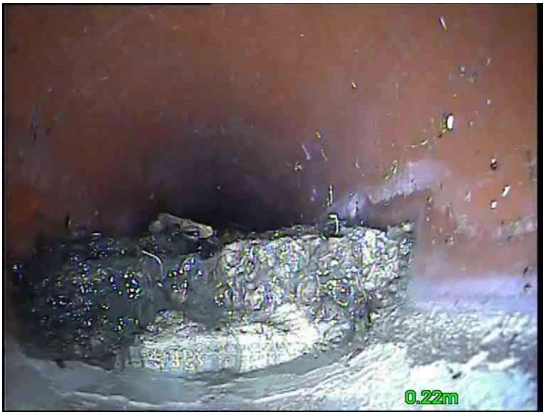
1, 00:00:05, 0.22 m

Settled deposits, fine, 35% cross-sectional area loss

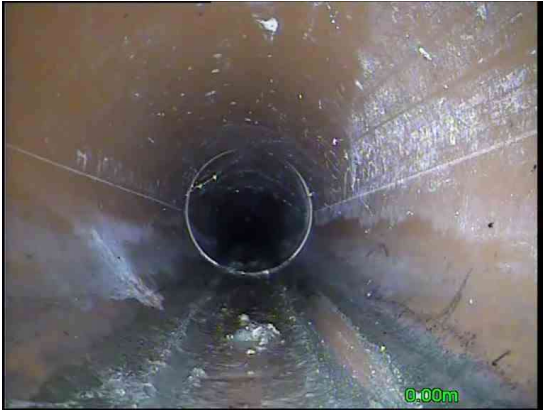
1, 00:00:01, 0.00 m  
General photograph taken at this point

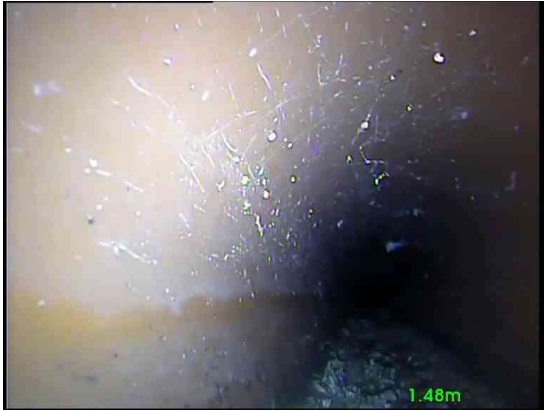
2, 00:00:05, 1.48 m  
Settled deposits, coarse, 5% cross-sectional area loss

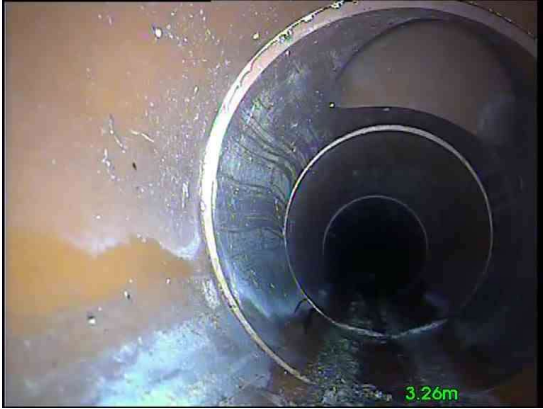
3, 00:00:14, 3.26 m  
Junction at 1 o'clock, 100mm dia

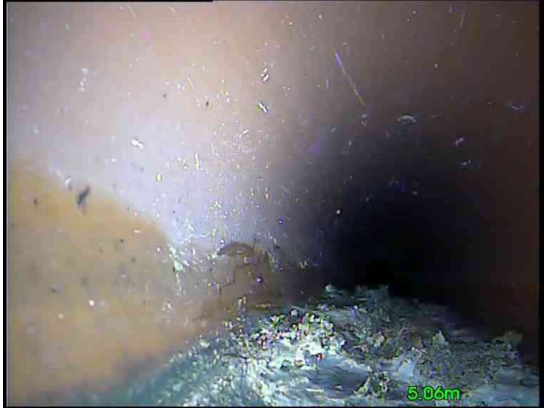
4, 00:00:23, 5.06 m  
Settled deposits, fine, 10% cross-sectional area loss, start

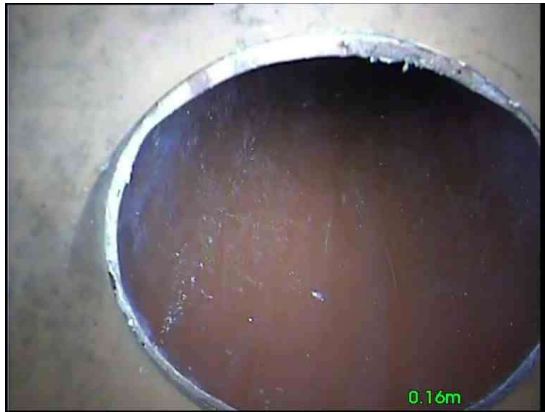
1, 00:00:04, 0.16 m  
Line deviates up

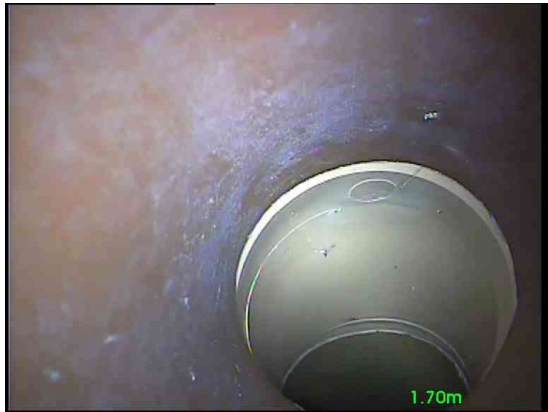
2, 00:00:11, 1.70 m  
General remark, Sewer levels out at this point

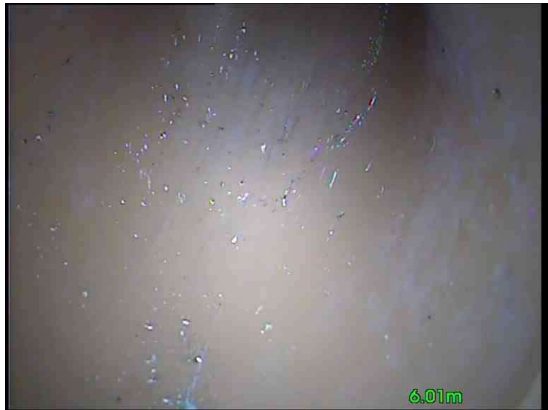
4, 00:00:26, 6.01 m  
Line deviates up

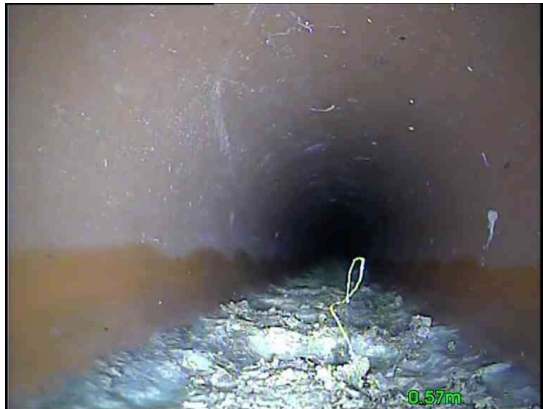
1, 00:00:05, 0.57 m

Settled deposits, fine, 10% cross-sectional area loss, start

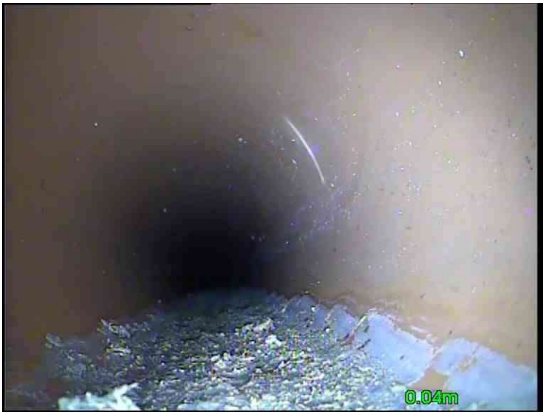
1, 00:00:02, 0.04 m  
Settled deposits, fine, 10% cross-sectional area loss, start

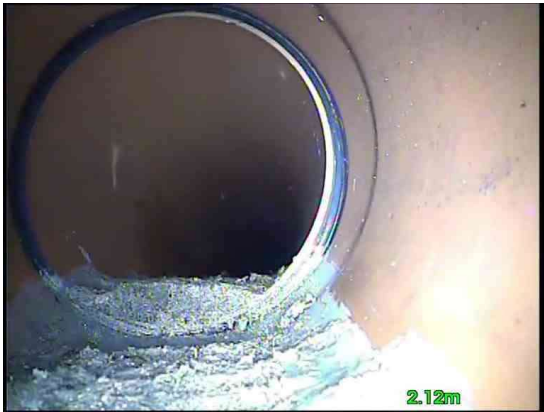
2, 00:00:17, 2.12 m  
Open joint, medium

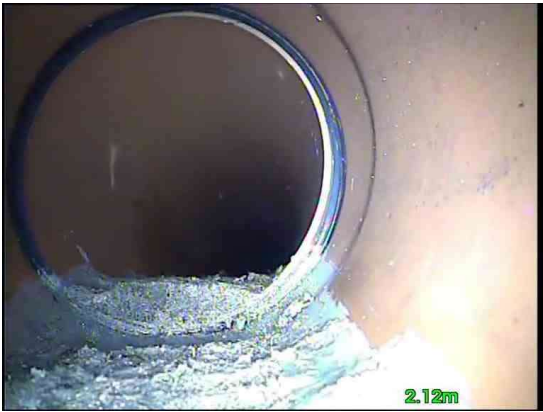
3, 00:00:17, 2.12 m  
Line deviates right

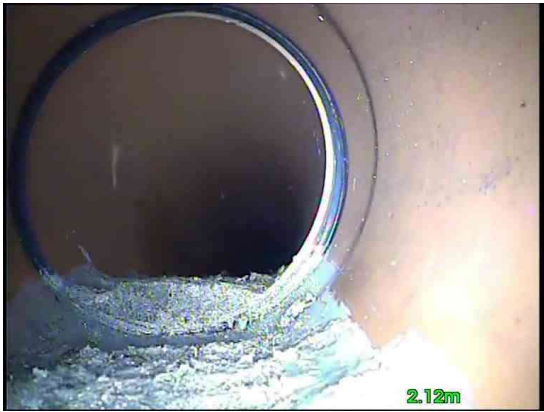
4, 00:00:17, 2.12 m  
Line deviates down

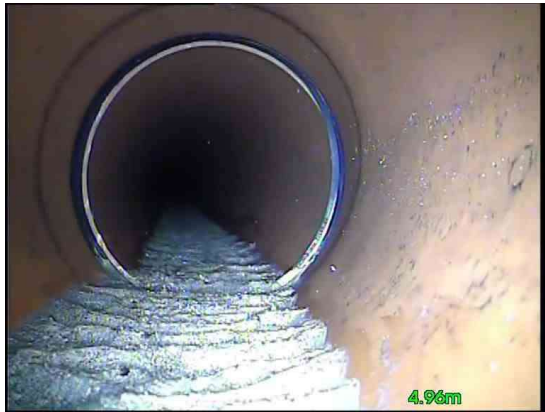
5, 00:00:27, 4.96 m  
Open joint, medium

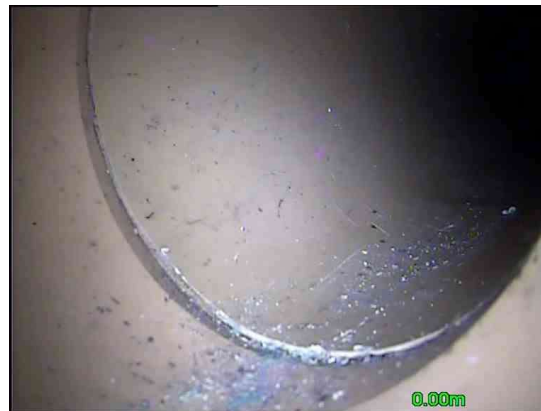
1, 00:00:01, 0.00 m  
Line deviates right

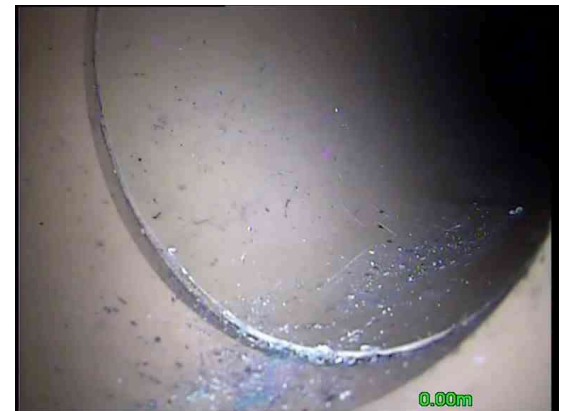
2, 00:00:01, 0.00 m  
Line deviates up

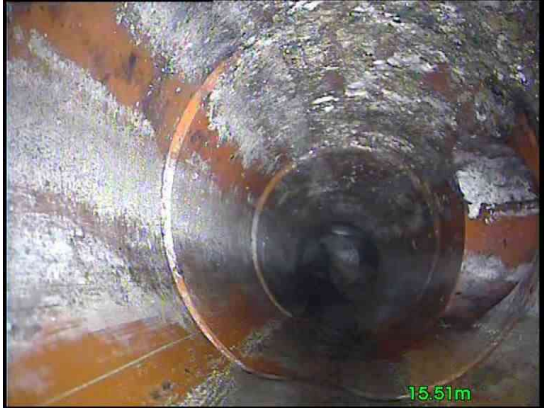
4, 00:00:48, 15.51 m  
Junction at 3 o'clock, 100mm dia, from MH34 X

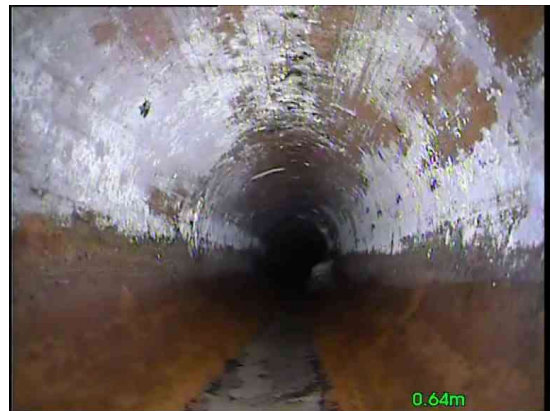
1, 00:00:05, 0.64 m  
General photograph taken at this point

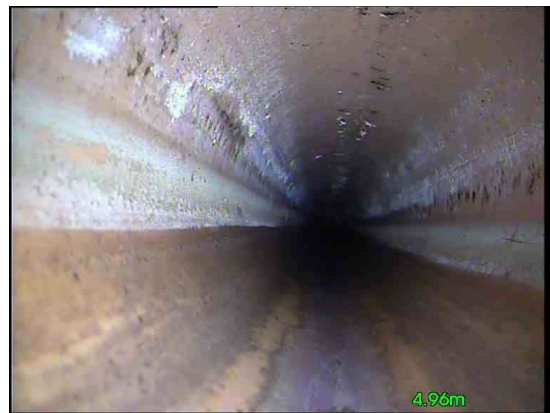
3, 00:00:21, 4.96 m  
General photograph taken at this point

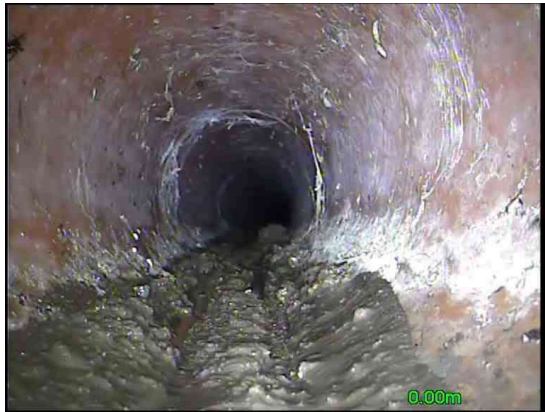
1, 00:00:01, 0.00 m  
Settled deposits, fine, 10% cross-sectional area loss, start

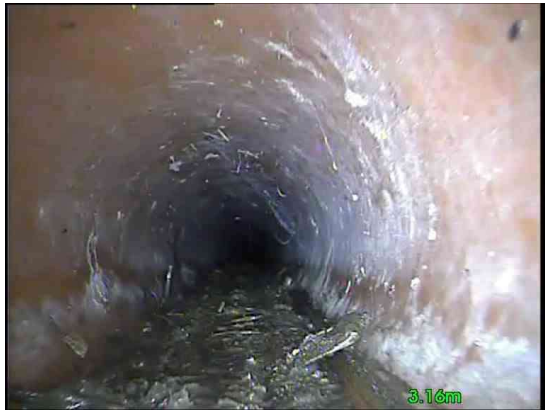
3, 00:00:14, 3.16 m  
Settled deposits, coarse, 10% cross-sectional area loss, start

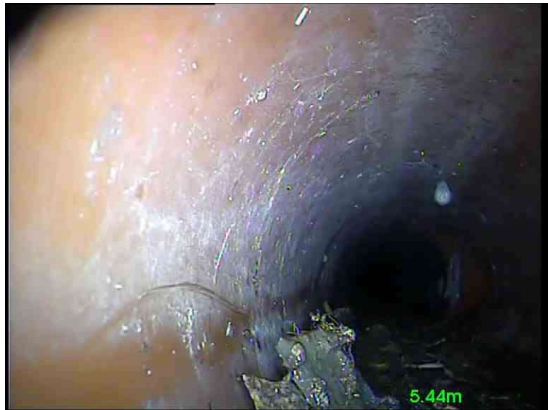
4, 00:00:23, 5.44 m  
General photograph taken at this point

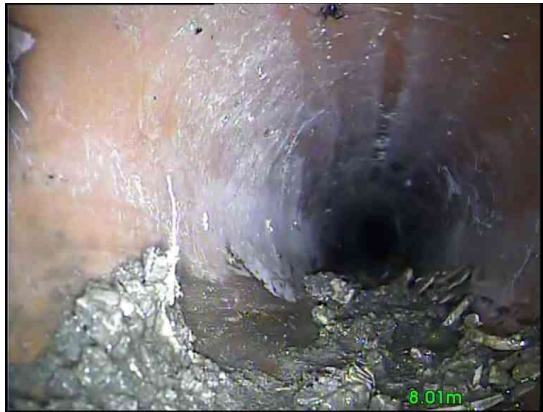
5, 00:00:36, 8.01 m  
General photograph taken at this point

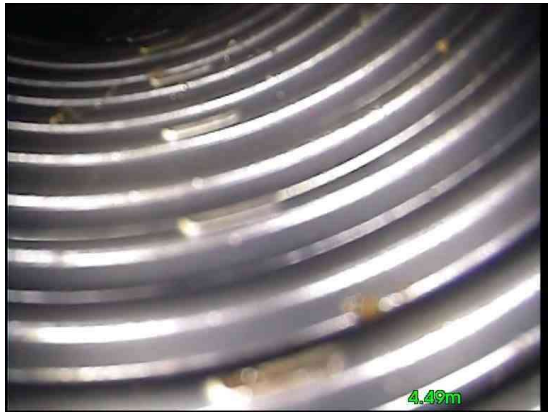
5, 00:00:40, 4.49 m  
Finish node, gully, reference: SGY reached

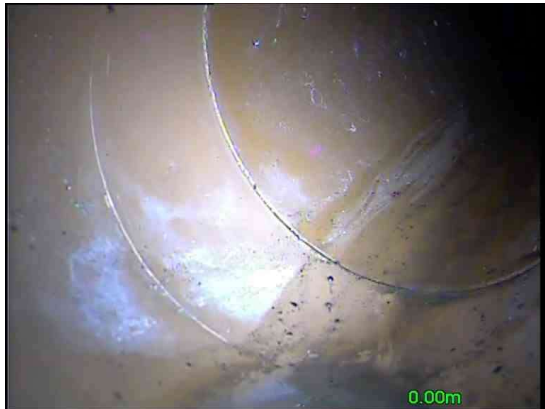
1, 00:00:01, 0.00 m  
Line deviates right

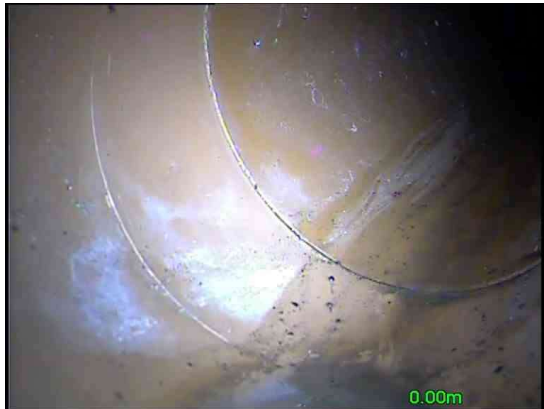
2, 00:00:01, 0.00 m  
Line deviates up

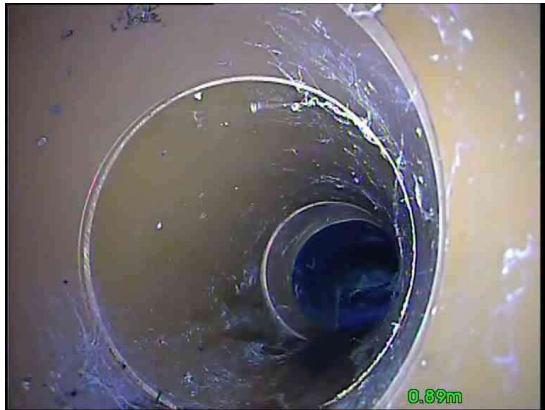
3, 00:00:10, 0.89 m  
Line deviates right

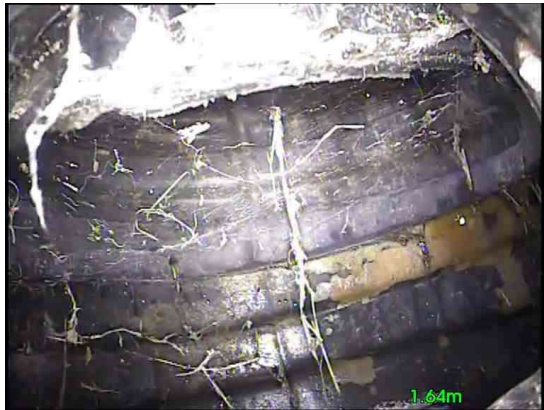
4, 00:00:15, 1.64 m  
Finish node, gully, reference: Gully reached

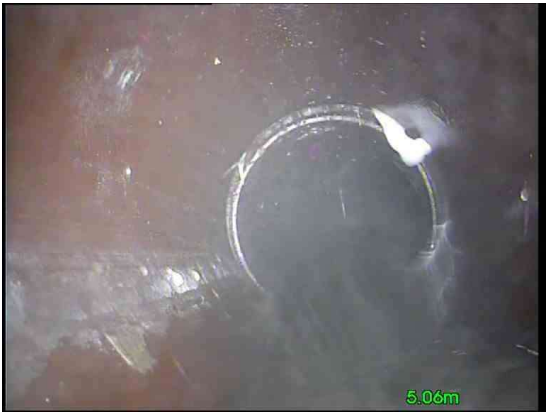
2, 00:02:36, 5.06 m  
General photograph taken at this point

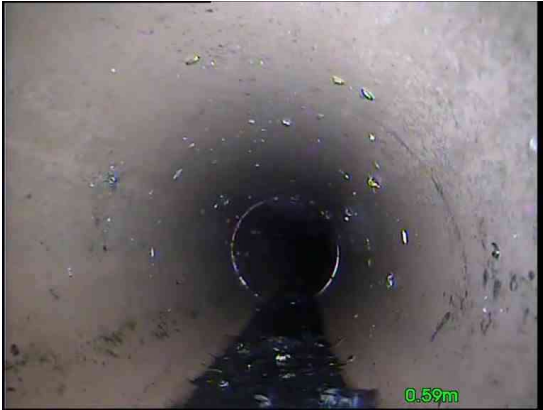
1, 00:00:07, 0.59 m  
General photograph taken at this point

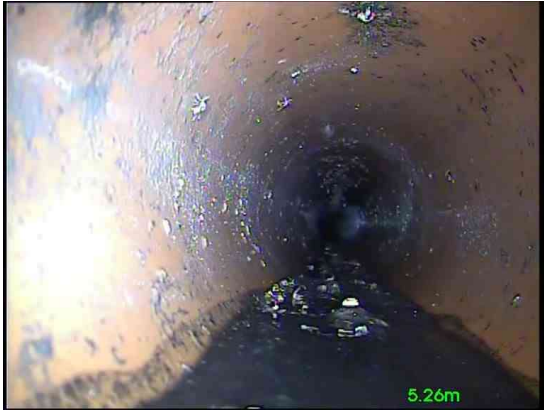
2, 00:00:30, 5.26 m  
Settled deposits, coarse, 5% cross-sectional area loss

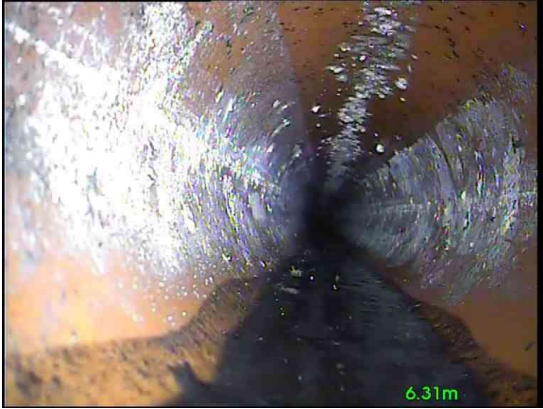
3, 00:00:36, 6.31 m  
General photograph taken at this point

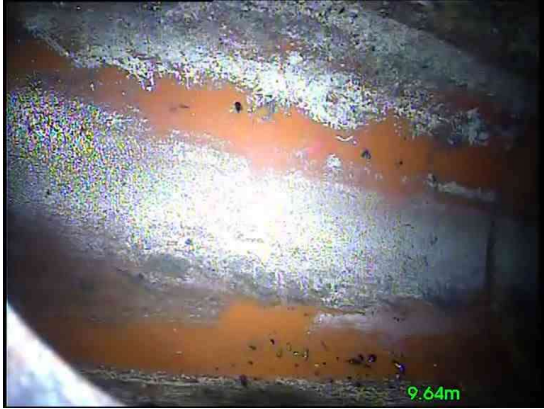
4, 00:00:52, 9.64 m  
Finish node, major connection without manhole, reference: Main sewer reached

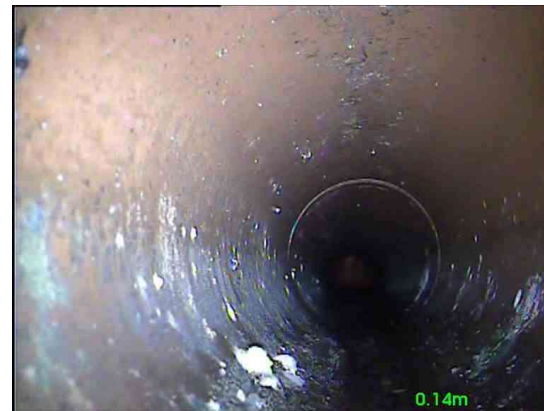
1, 00:00:02, 0.14 m  
General photograph taken at this point

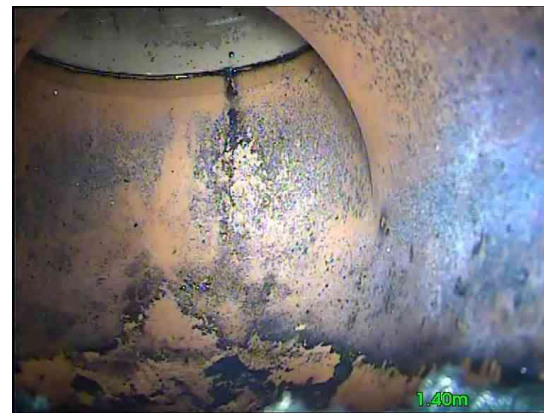
3, 00:00:13, 1.40 m  
Finish node, other special chamber, reference: Downpipe,  
Internal downpipe reached

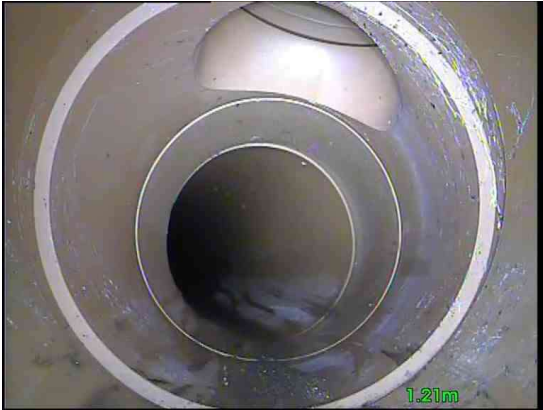
1, 00:00:04, 1.21 m  
Junction at 1 o'clock, 100mm dia

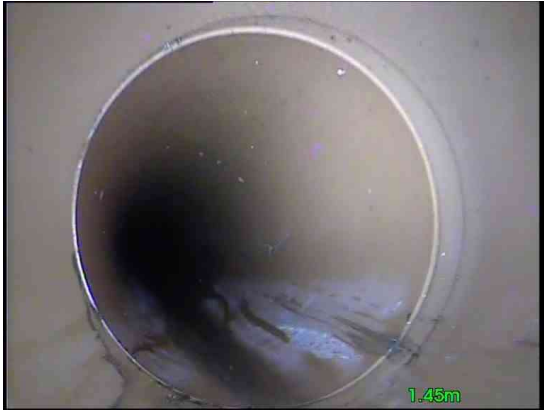
2, 00:00:09, 1.45 m  
Line deviates left

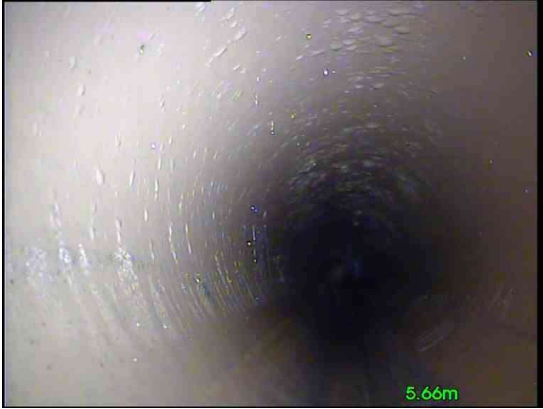
3, 00:00:22, 5.66 m  
General photograph taken at this point

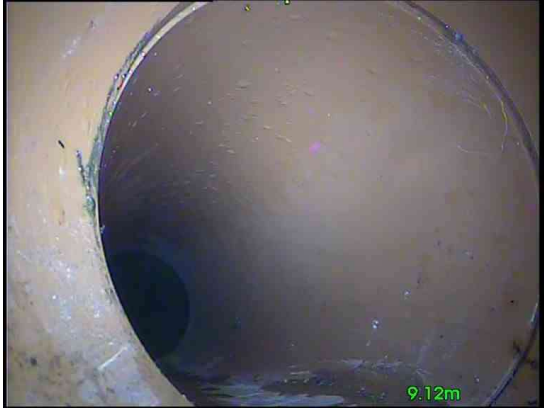
4, 00:00:33, 9.12 m  
Line deviates left

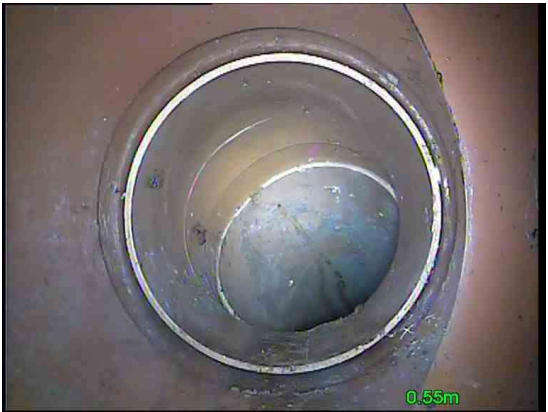
2, 00:00:11, 0.55 m  
Line deviates up

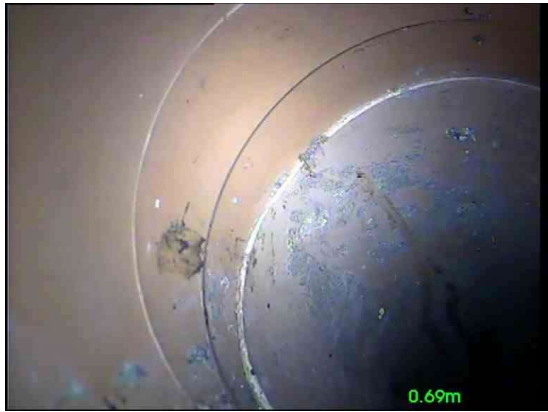
3, 00:00:13, 0.69 m  
Line deviates right

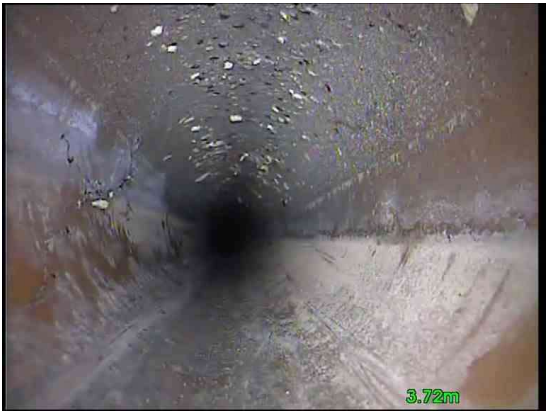
4, 00:00:23, 3.72 m  
General photograph taken at this point

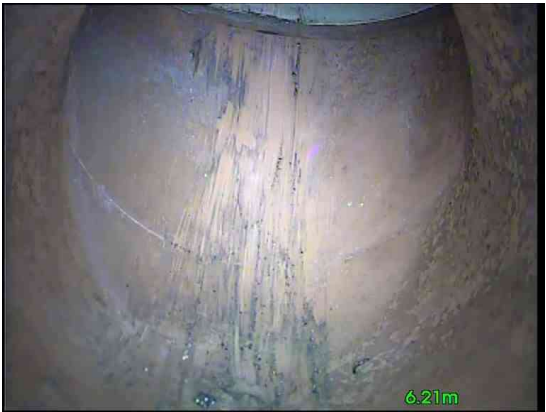
5, 00:00:37, 6.21 m  
Finish node, other special chamber, reference: RWP, Internal RWP reached

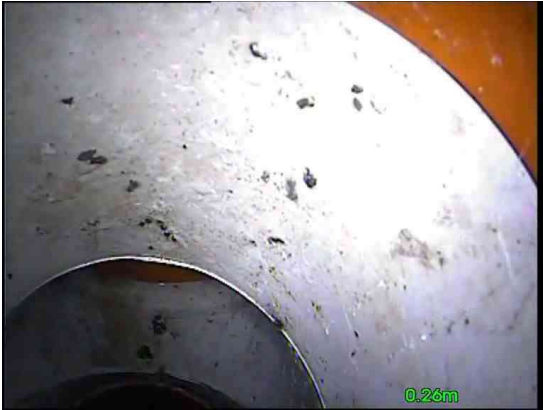
1, 00:00:05, 0.26 m  
Line deviates down

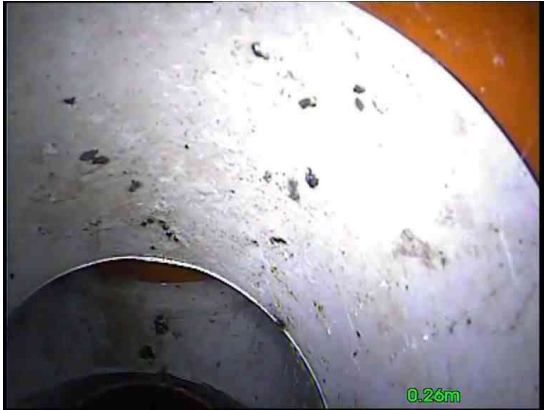
2, 00:00:05, 0.26 m  
Junction at 12 o'clock, 100mm dia

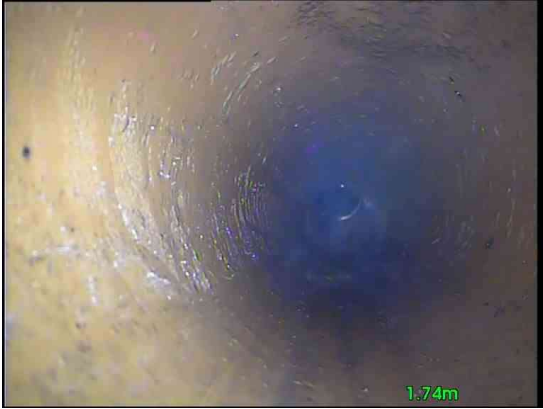
3, 00:00:16, 1.74 m  
General photograph taken at this point

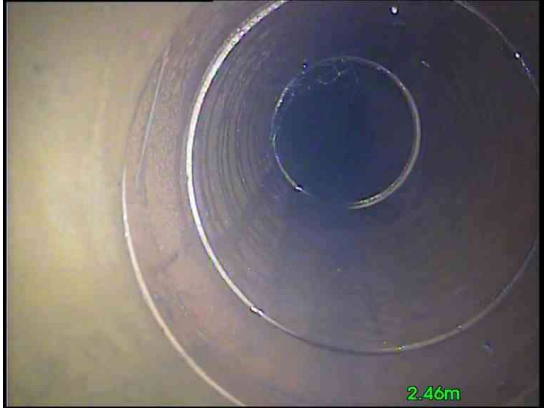
4, 00:00:18, 2.46 m  
General remark, Sewer levels out at this point
