## London Borough of Haringey

## Preliminary Flood Risk Assessment

**Channing School for Girls – Senior School**  
CCTV Condition Report

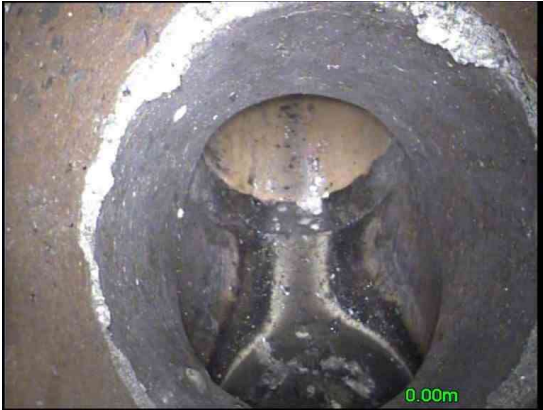
1, 00:00:01, 0.00 m  
General remark, Winsor trap visible

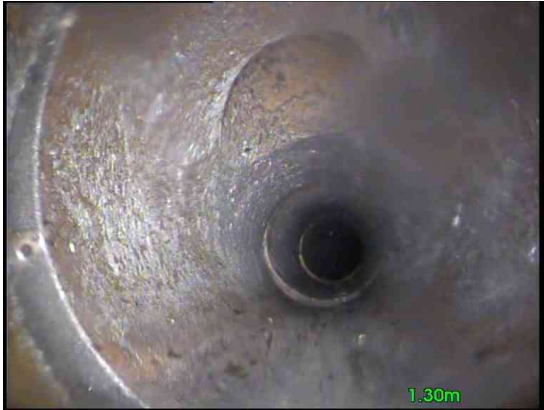
2, 00:00:17, 1.30 m  
Junction at 11 o'clock, 100mm dia

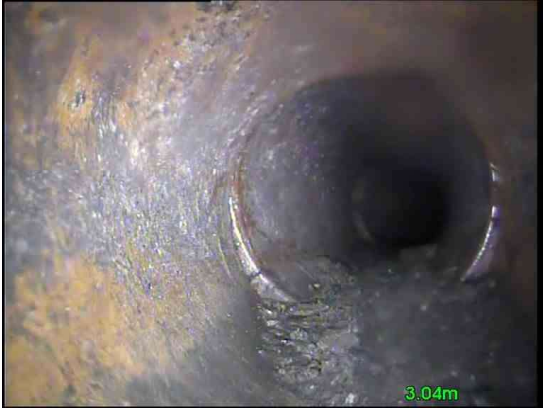
3, 00:00:30, 3.04 m  
Settled deposits, fine, 10% cross-sectional area loss

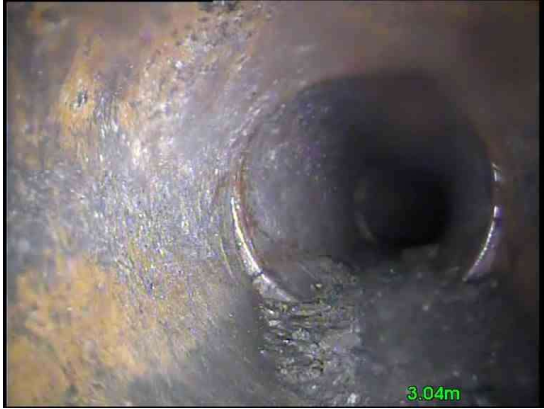
4, 00:00:30, 3.04 m  
Joint displaced, medium

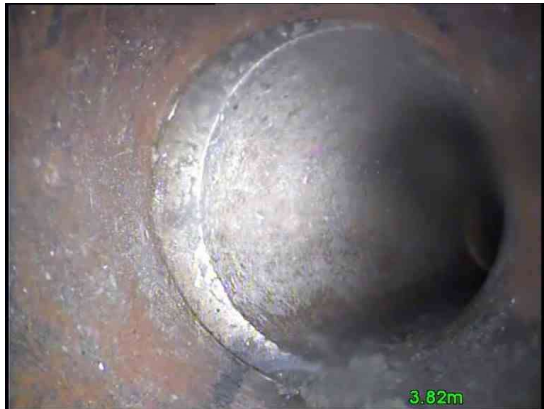
6, 00:00:37, 3.82 m  
Joint displaced, medium

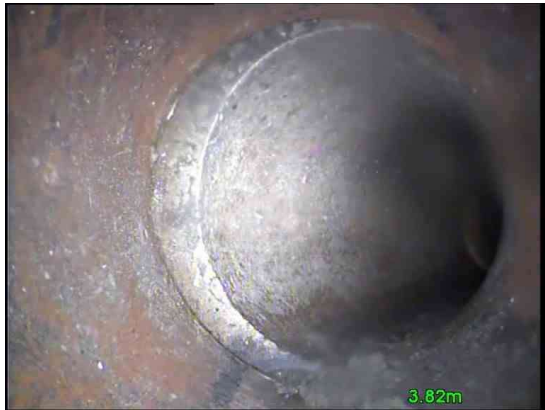
7, 00:00:37, 3.82 m  
Line deviates right

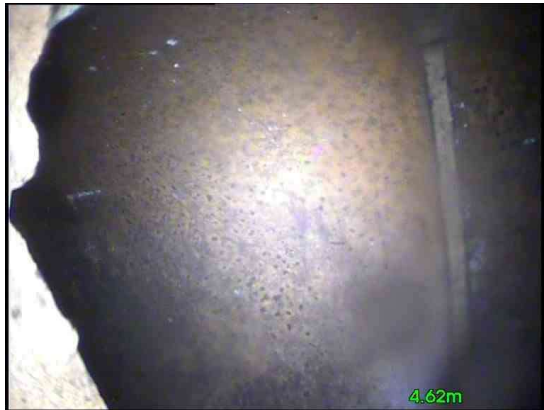
8, 00:00:47, 4.62 m  
Finish node, major connection without manhole, reference:  
Main public sewer reached

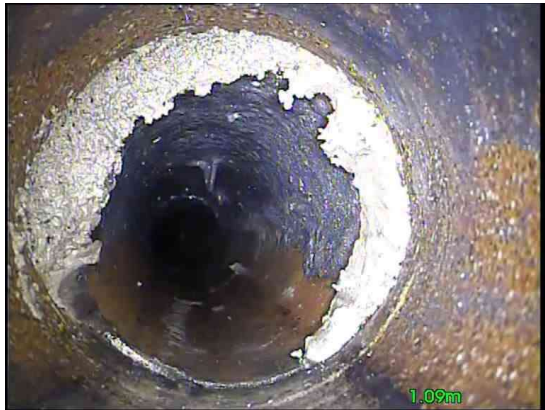
3, 00:00:11, 1.09 m  
Line deviates left

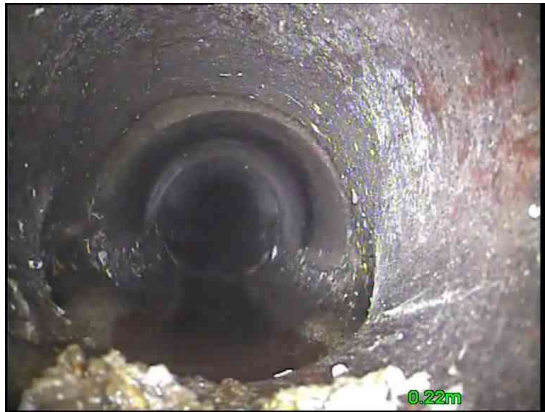
1, 00:00:07, 0.22 m  
General remark, Winser trap visible

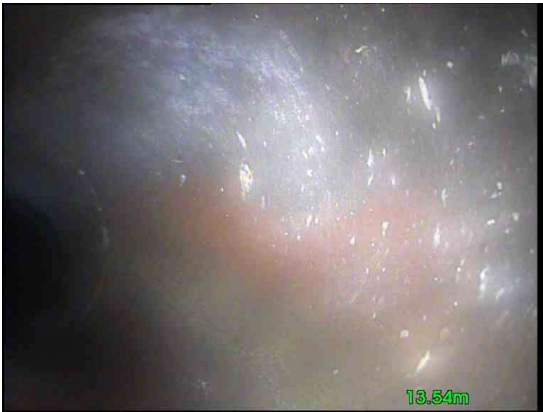
5, 00:00:57, 13.54 m  
Line deviates left

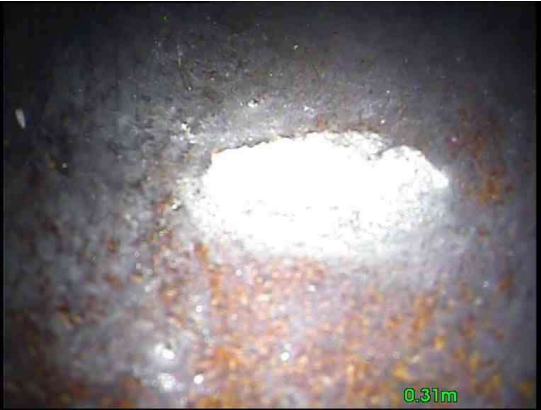
2, 00:00:13, 0.31 m  
Finish node, other special chamber, reference: Vent Pipe, Vent Pipe reached

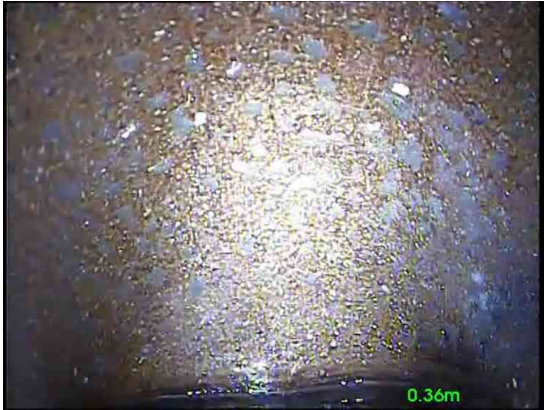
2, 00:00:08, 0.36 m  
Finish node, gully, reference: Gully reached

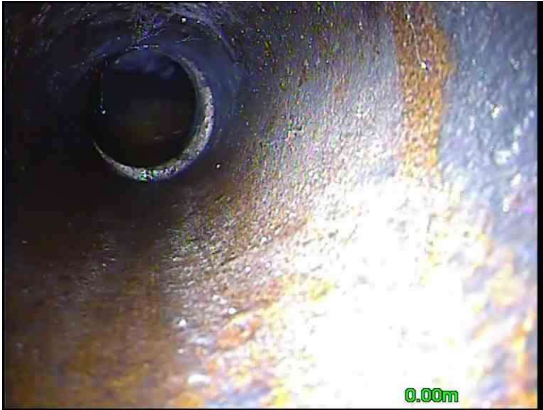
1, 00:00:02, 0.00 m  
Line deviates up

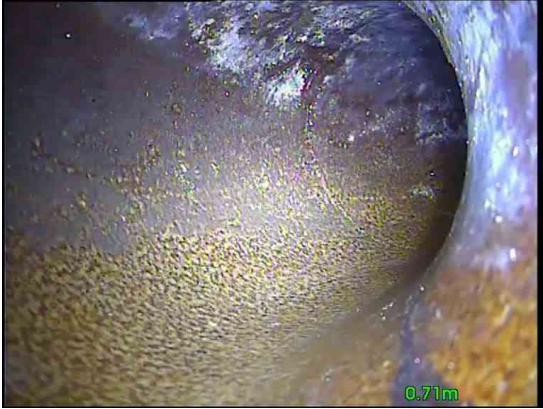
3, 00:00:15, 0.71 m  
Line deviates right

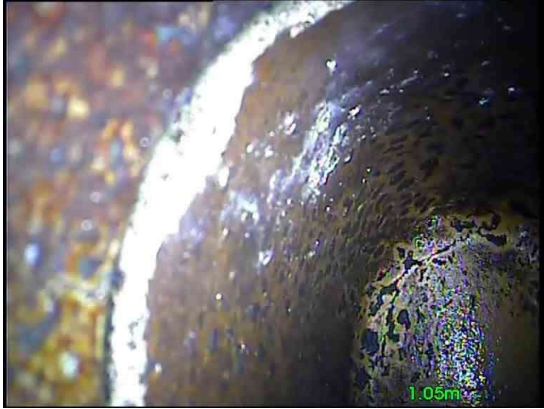
4, 00:00:22, 1.05 m  
Finish node, gully, reference: Gully reached

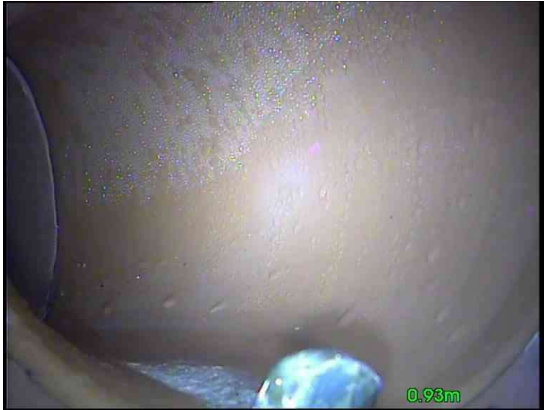
2, 00:00:12, 0.93 m  
Line deviates left

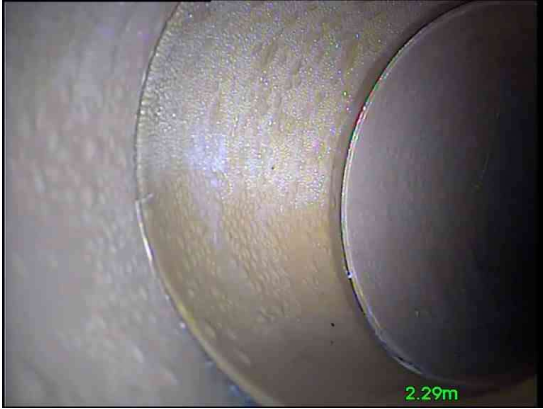
3, 00:00:32, 2.29 m  
Line deviates right

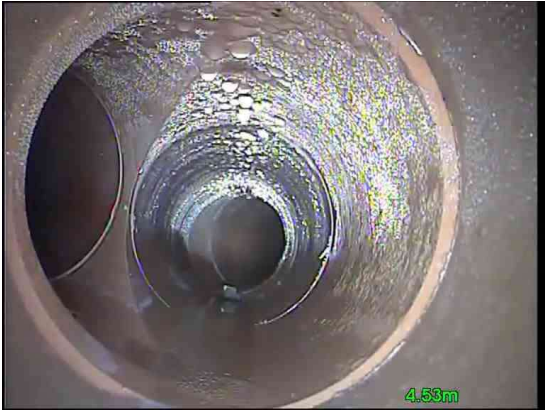
5, 00:00:53, 4.53 m  
Junction at 9 o'clock, 100mm dia

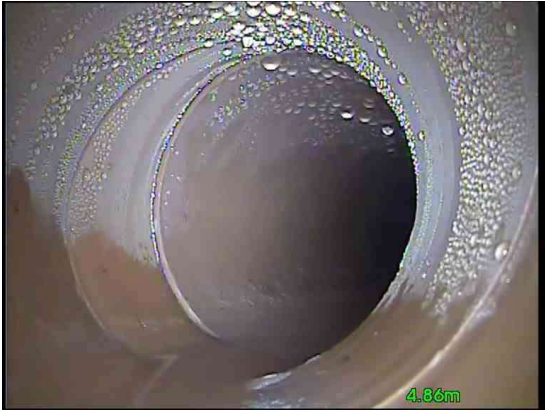
6, 00:00:58, 4.86 m  
Line deviates right

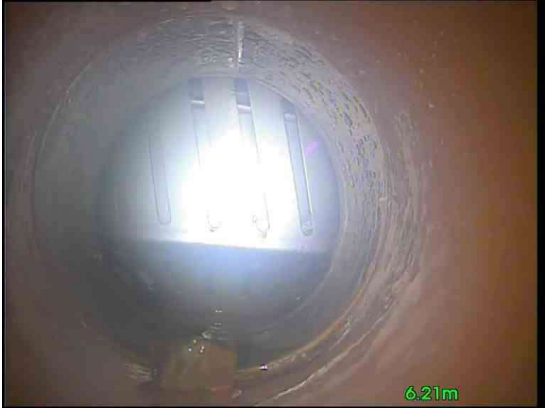
7, 00:01:07, 6.21 m  
Finish node, gully, reference: Internal gully reached

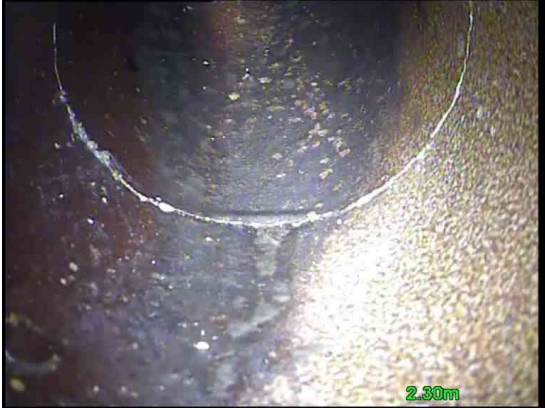
4, 00:00:32, 2.30 m  
Finish node, gully, reference: Gully reached

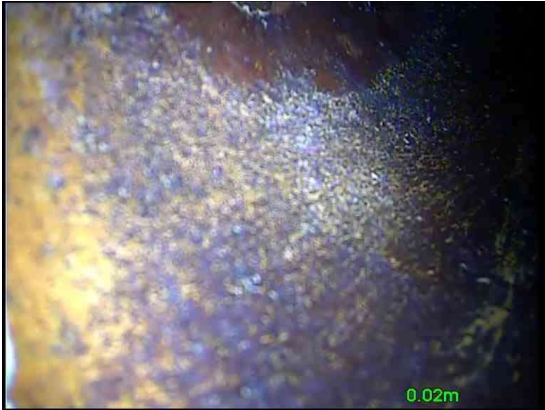
2, 00:00:04, 0.02 m  
Finish node, other special chamber, reference: Downpipe, Downpipe reached

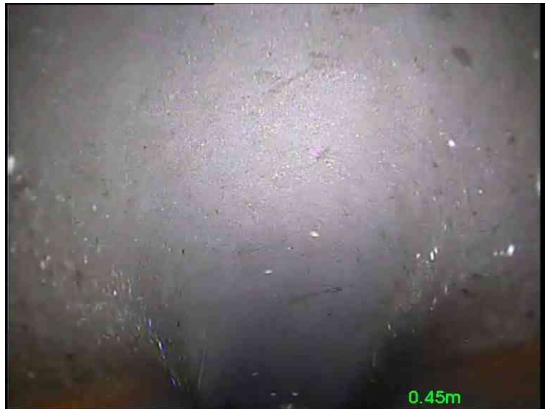
1, 00:00:09, 0.45 m  
Line deviates down

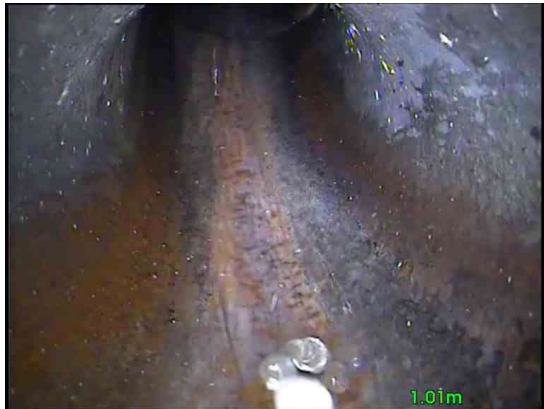
2, 00:00:14, 1.01 m  
General remark, Sewer levels out at this point

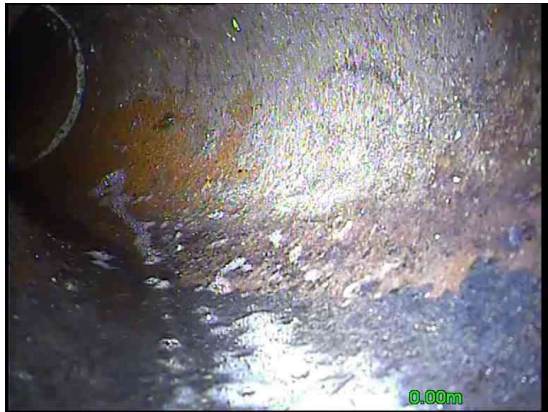
2, 00:00:02, 0.00 m  
Line deviates left

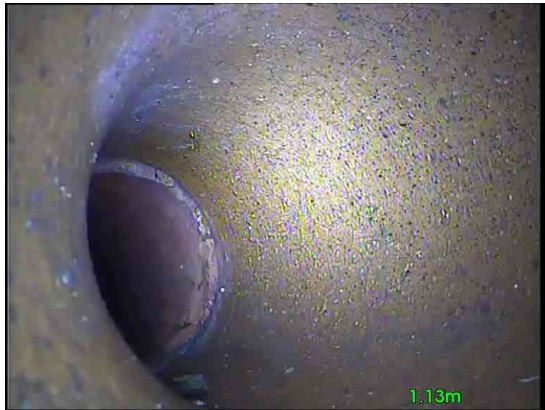
3, 00:00:13, 1.13 m  
Line deviates left

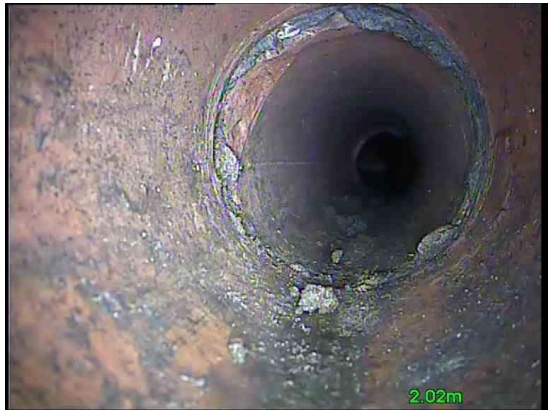
4, 00:00:17, 2.02 m  
Line deviates right

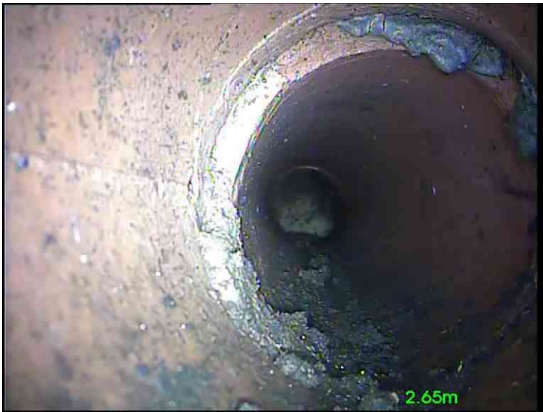
5, 00:00:22, 2.65 m  
Line deviates left

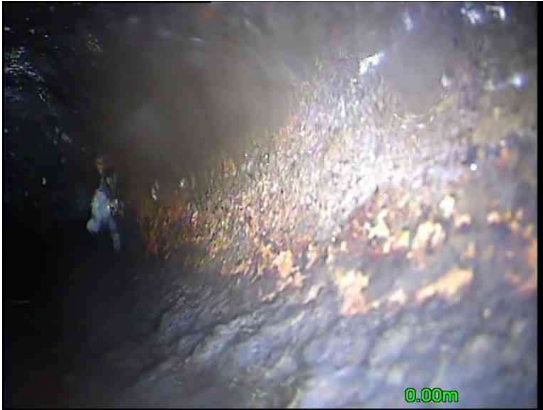
1, 00:00:03, 0.00 m  
Line deviates left

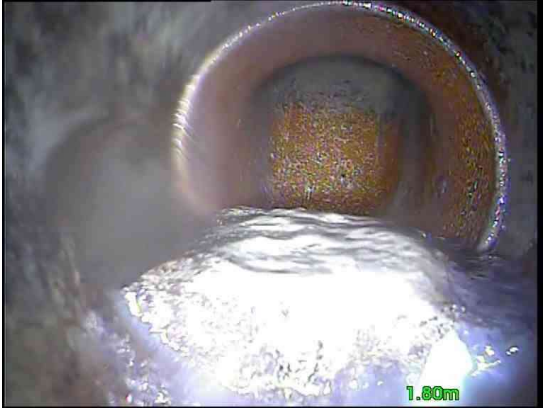
3, 00:00:22, 1.80 m  
Settled deposits, hard or compacted, 20% cross-sectional area loss, At rest bend of downpipe

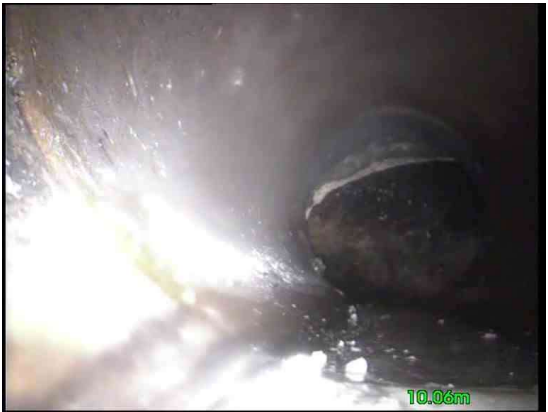
6, 00:01:16, 10.06 m  
Line deviates down

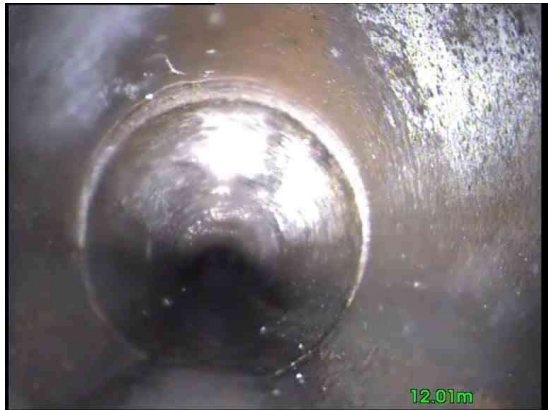
4, 00:02:54, 12.01 m  
Pipe material changes to cast iron at this point

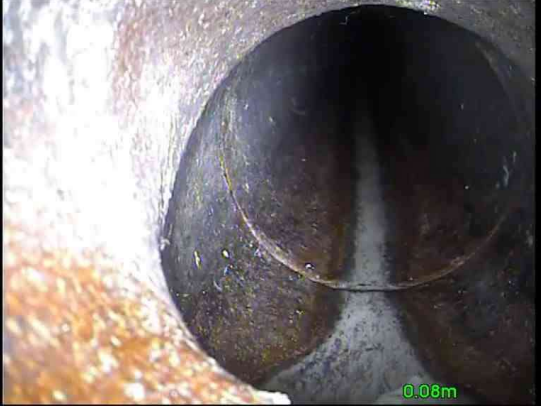
1, 00:00:05, 0.08 m  
General remark, Winsor trap visible

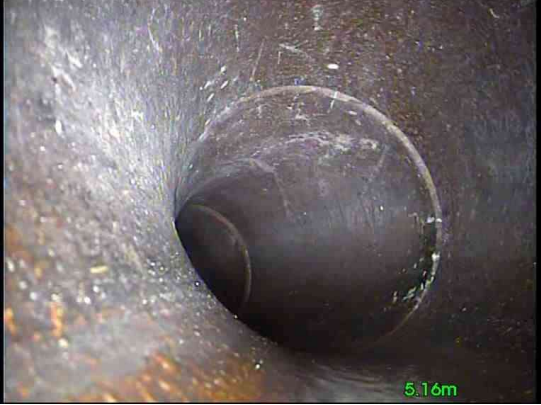
4, 00:00:27, 5.16 m  
Line deviates left

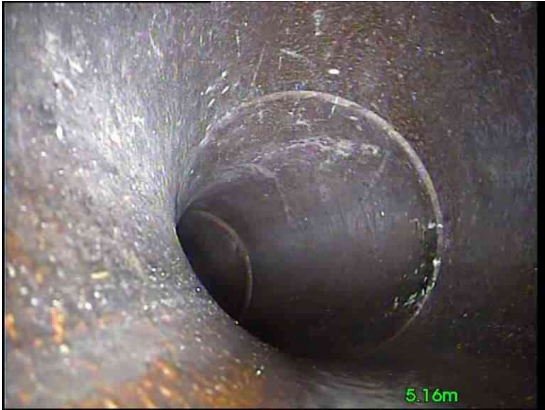
5, 00:00:27, 5.16 m  
Line deviates down

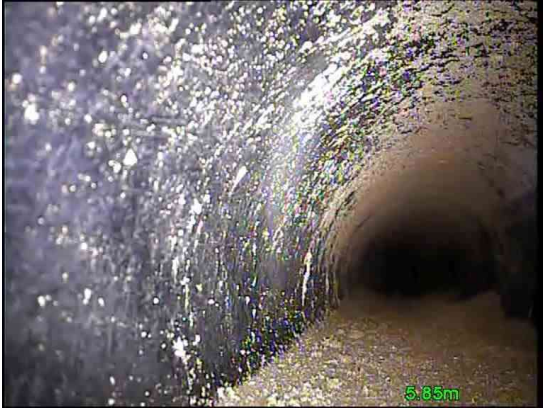
3, 00:00:28, 5.85 m  
Settled deposits, fine, 20% cross-sectional area loss, change

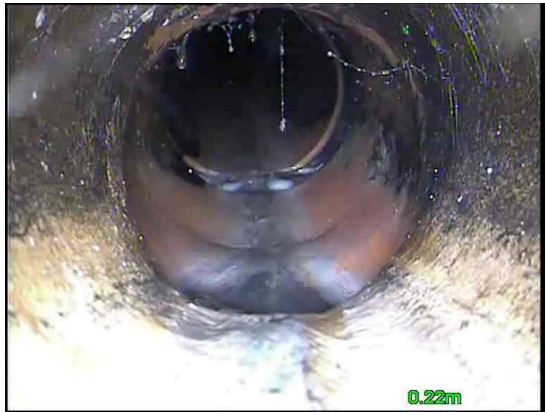
1, 00:00:05, 0.22 m  
General remark, Winsor trap visible

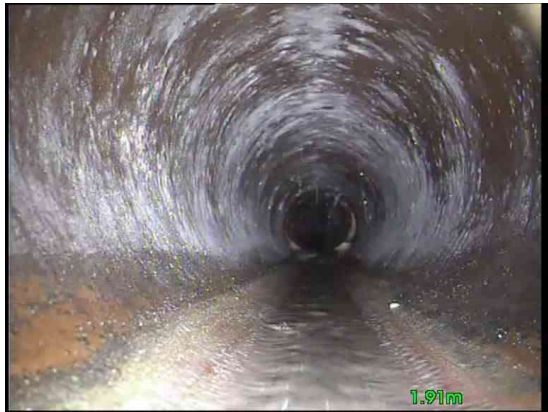
2, 00:00:10, 1.91 m  
General photograph taken at this point

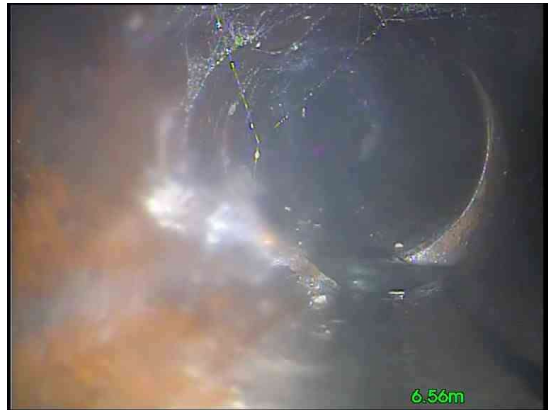
8, 00:05:01, 6.56 m  
Line deviates left

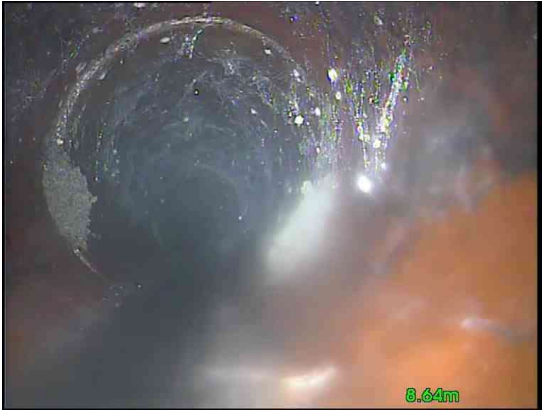
9, 00:05:13, 8.64 m  
Settled deposits, fine at joint, 5% cross-sectional area loss

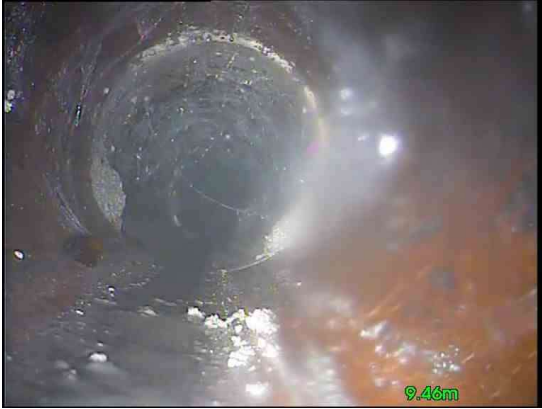
11, 00:05:30, 9.46 m  
Settled deposits, fine at joint, 5% cross-sectional area loss

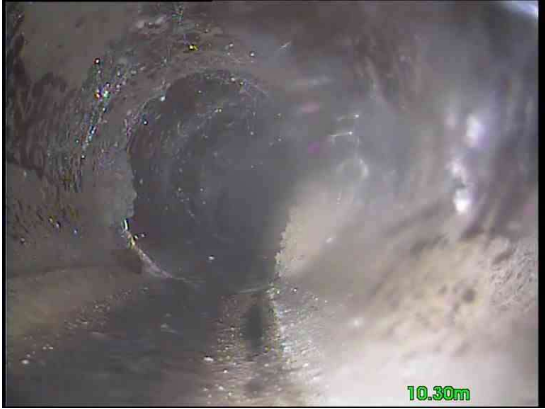
12, 00:05:34, 10.30 m  
Settled deposits, fine at joint, 5% cross-sectional area loss

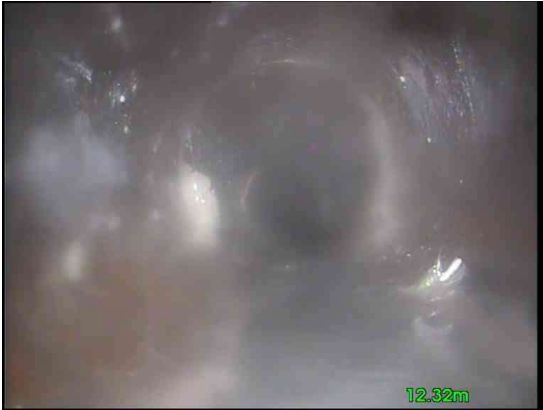
13, 00:09:32, 12.32 m  
Settled deposits, fine at joint, 5% cross-sectional area loss
