HERITAGE STATEMENT FOR 37 NORTH ROAD, HIGHGATE FOR REMEDIATION  
OF DECAYED AND DRY ROT INFECTED TIMBERS AND REPAIRS TO EXTERIOR

JOB NO: 162-58

V.3 REPORT 18 JUNE 2025

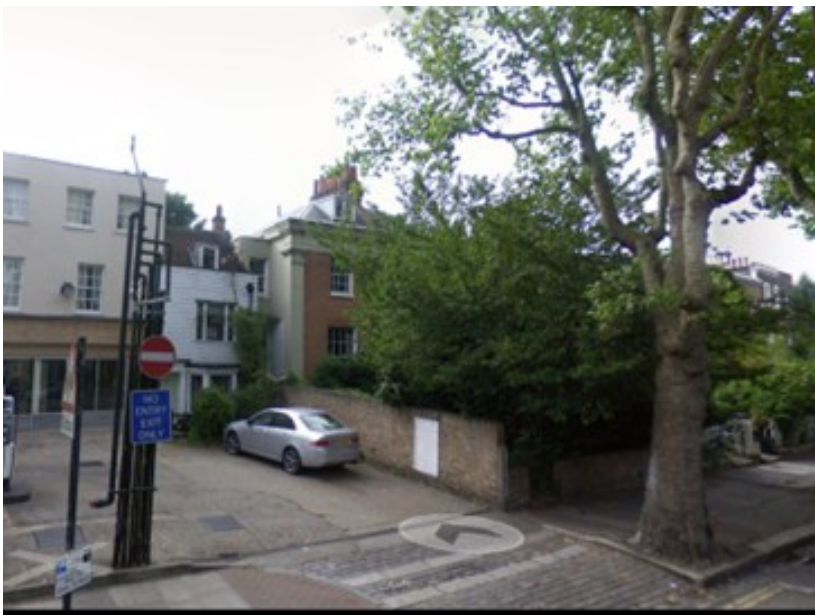
**Fig 8:**

**2008:** Google street view image., showing 37 North Road. The south frontage and south side of the building appear to be in reasonable condition in this image.

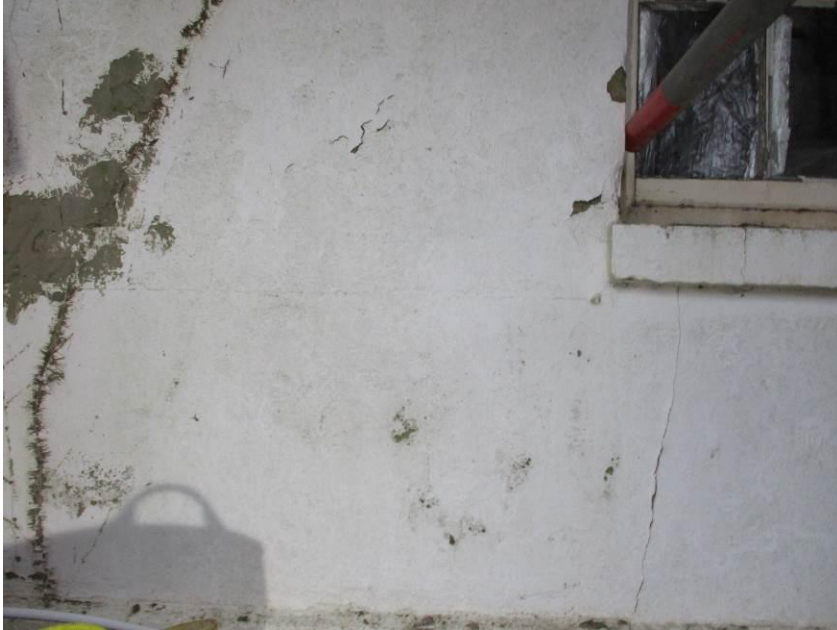
Rear (west) elevation. Painted render (assumed over brickwork). The faint lines of an incised detailing are visible within the render finish.

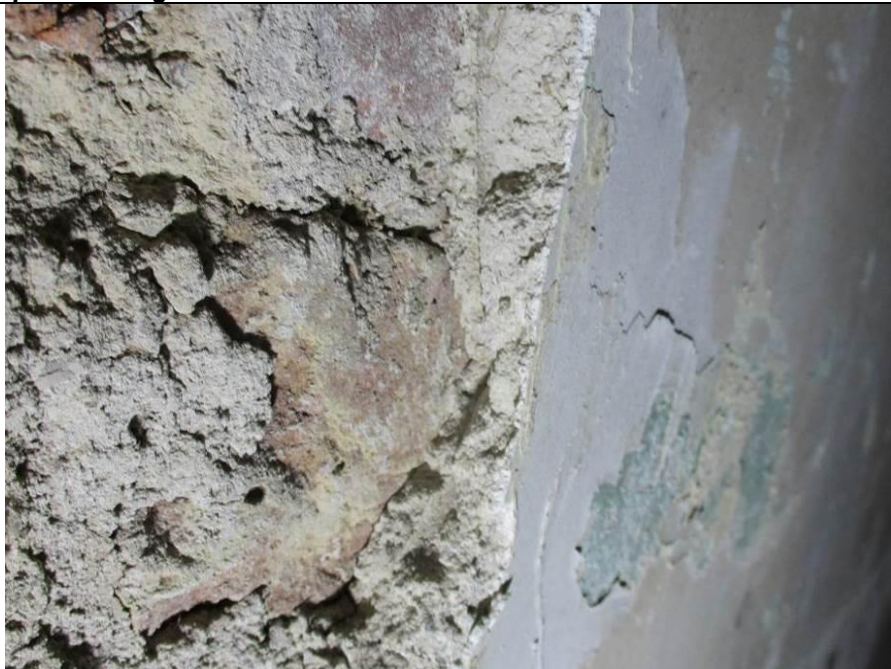
Room F1, showing the south wall which comprises of a plaster finish onto brickwork. The plaster finish comprises of a two-coat plaster - scratch coat and finish coat.

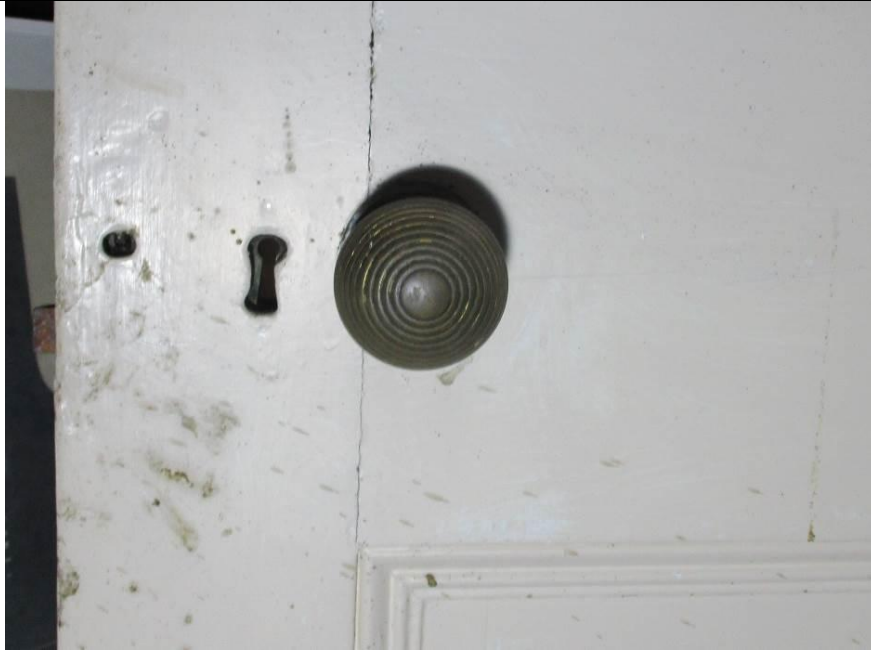
Room G3, showing beehive door handle.

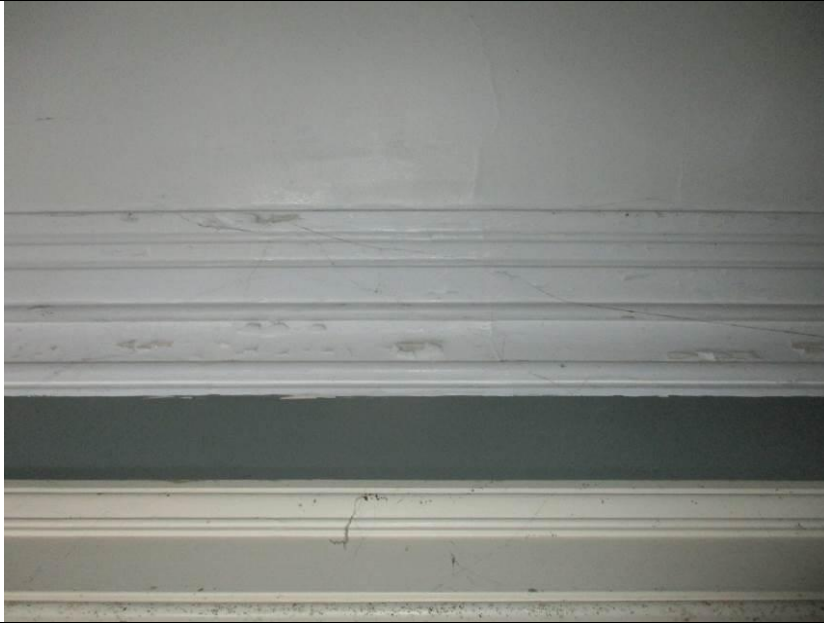
Room G3, showing cornice.

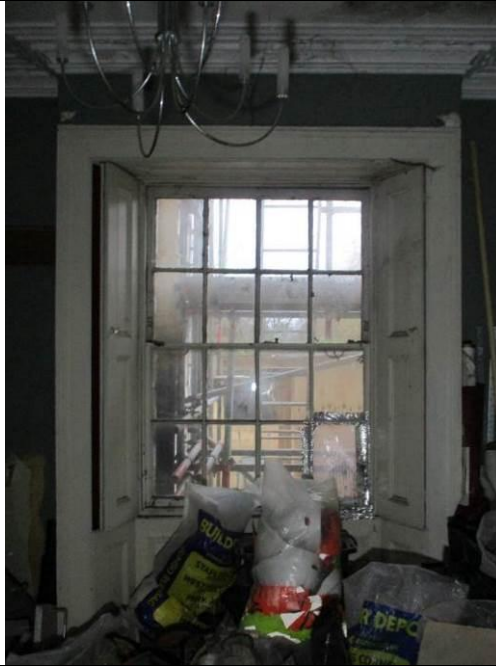
Room G3, showing window with splayed reveal and shutters.

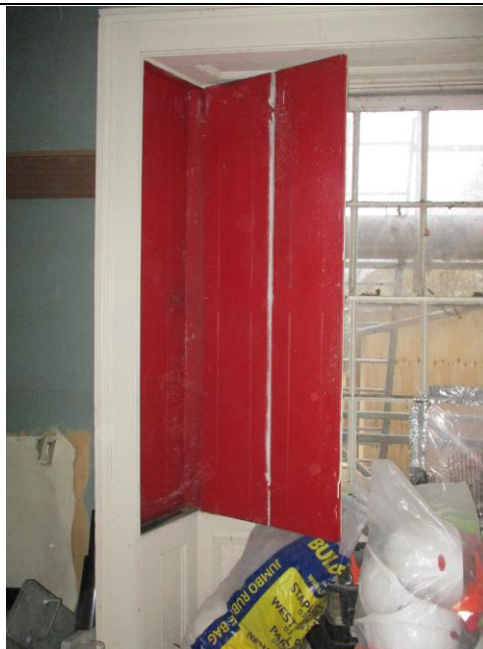
Room G3, showing window shutters.

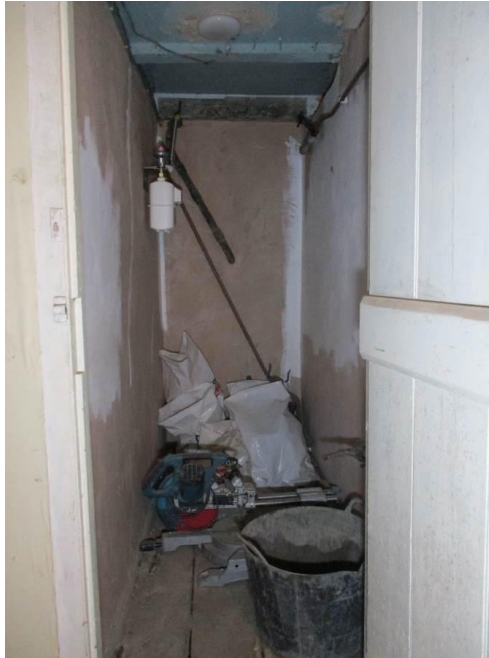
Room LG1b, showing the cupboard with undecorated gypsum plaster wall finishes.

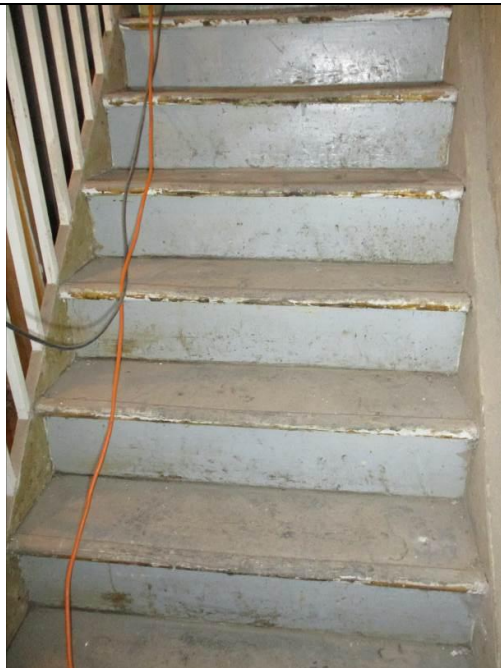
Room LG1, showing staircase (lower flight) between ground floor and lower ground floor.

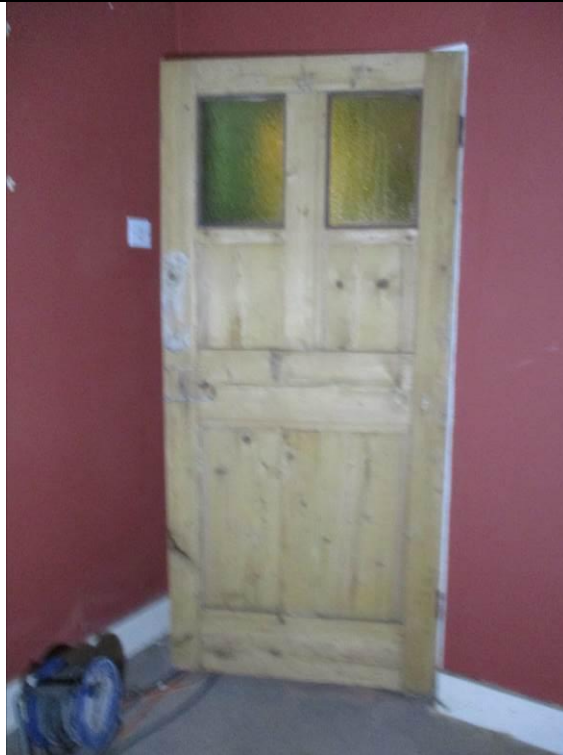
Room LG2, showing doorway.
