## LEVEL 2 HISTORIC BUILDING RECORD FOR 37 NORTH ROAD, HORNSEY

JOB NO. 162-58

DOUGLAS PASKIN, PKS ARCHITECTS

18 DECEMBER 2024

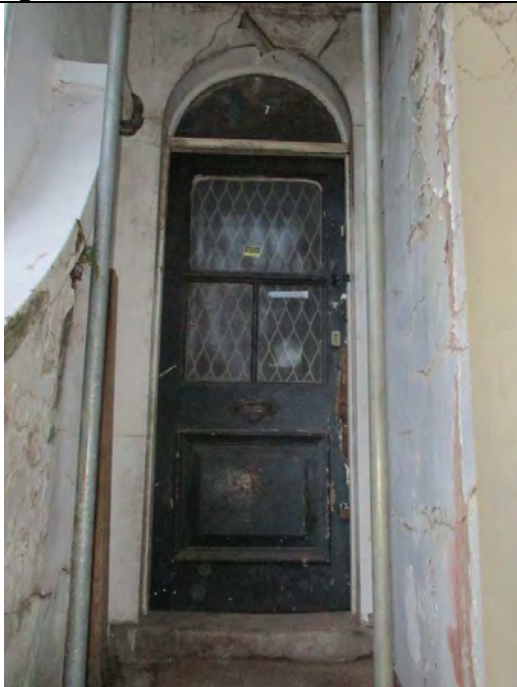
Front (east) elevation, front door.

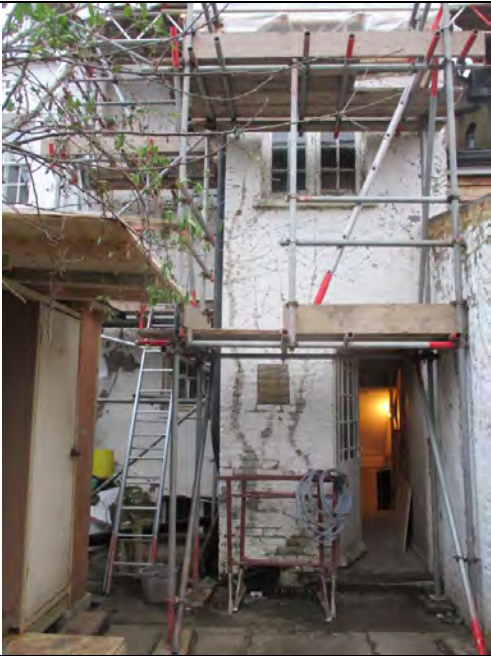
| Rear (west) elevation. |

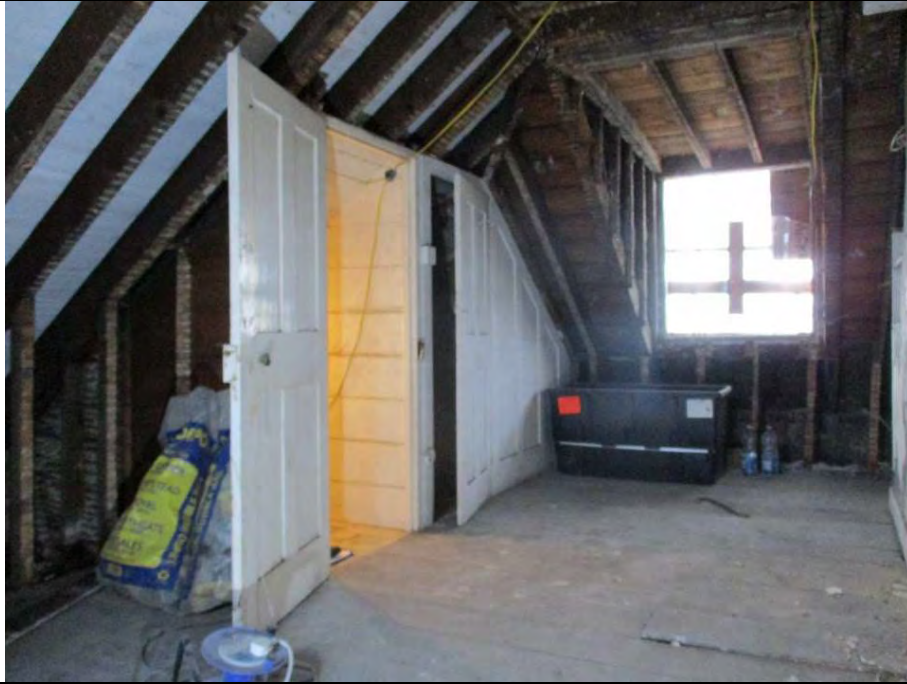
Room S1 looking west through room.

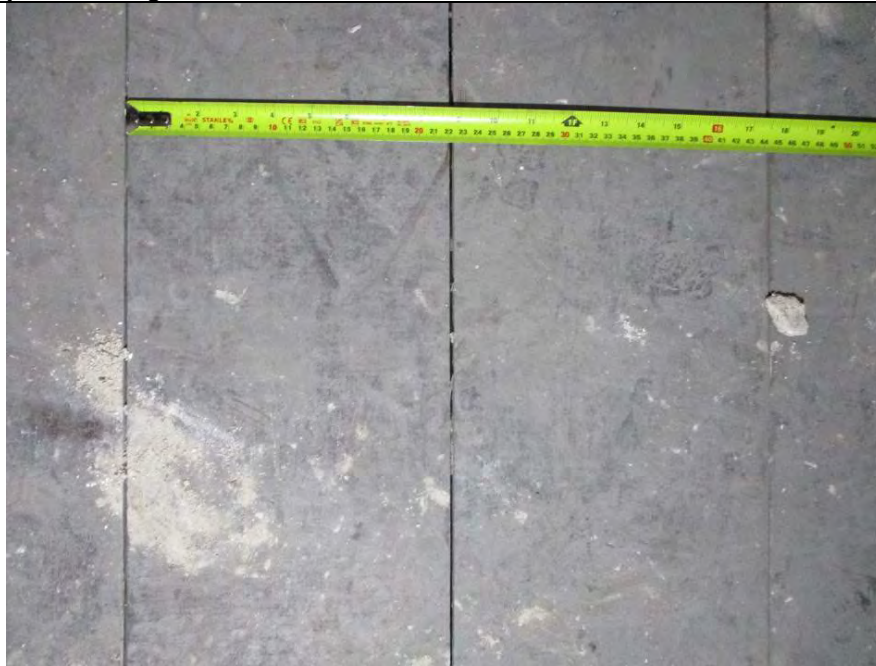
Room S1, showing floorboards originated north/south.

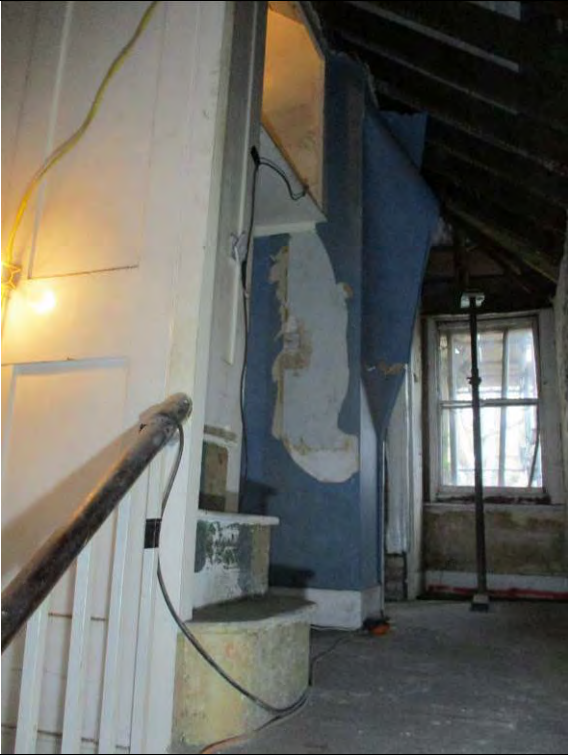
| <b><i>Photograph: General Context</i></b> | |
|---|--|
| Room F1, looking east across landing. | |

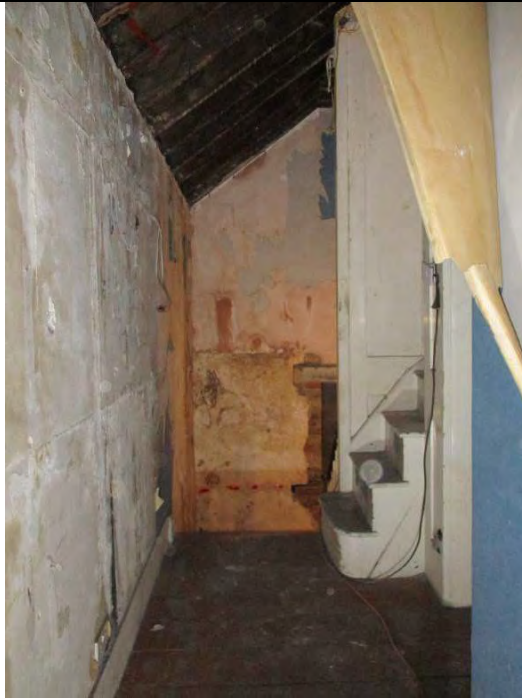
Room F1, looking west through landing.

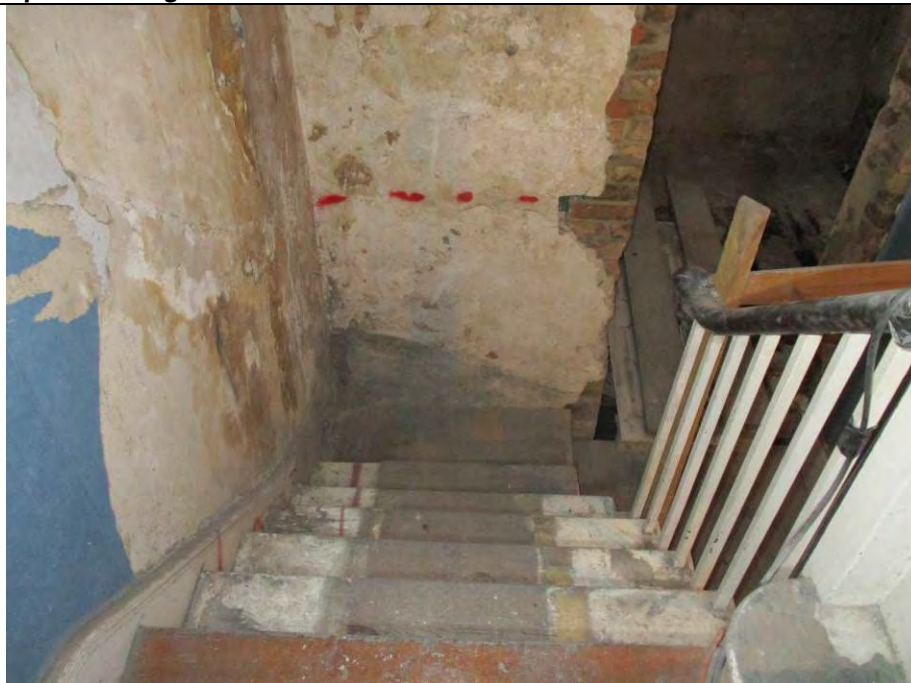
Room F1, showing the upper flight of stairs between from ground floor to first floor.

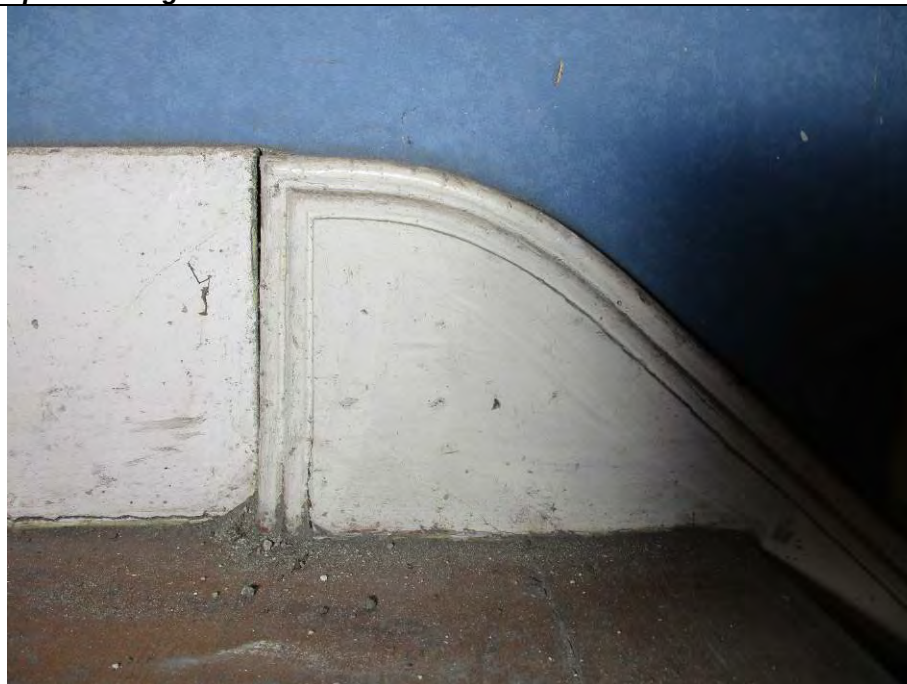
Room F1, showing the profiled staircase stringer at its junction with the adjacent plain (unprofiled) skirting.

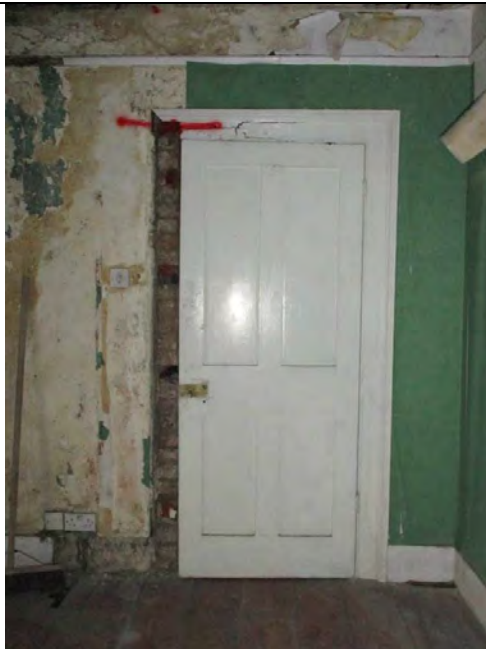
Room F2, showing internal door.

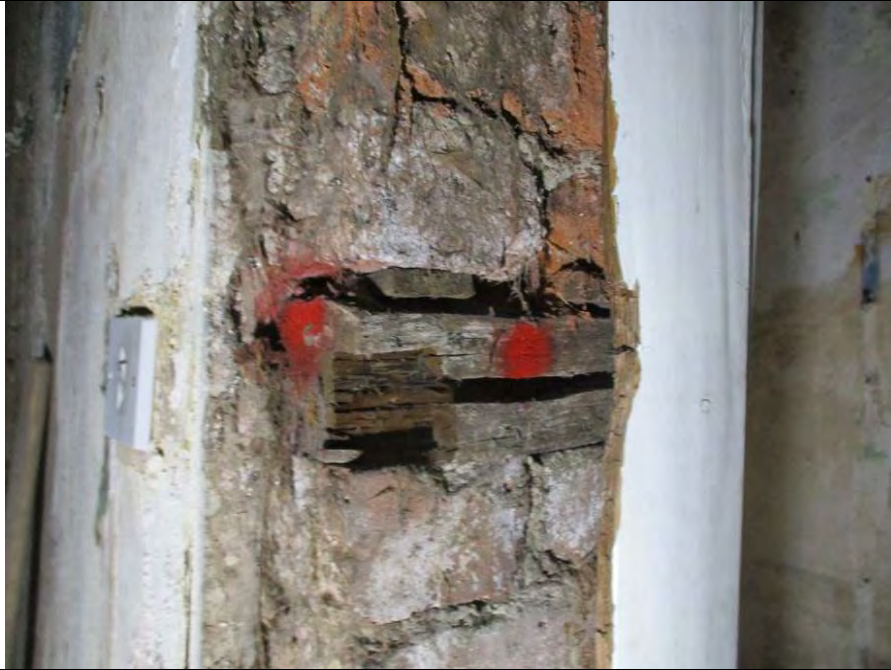
Room F2, showing timber grounds which affix doorway architrave to wall.

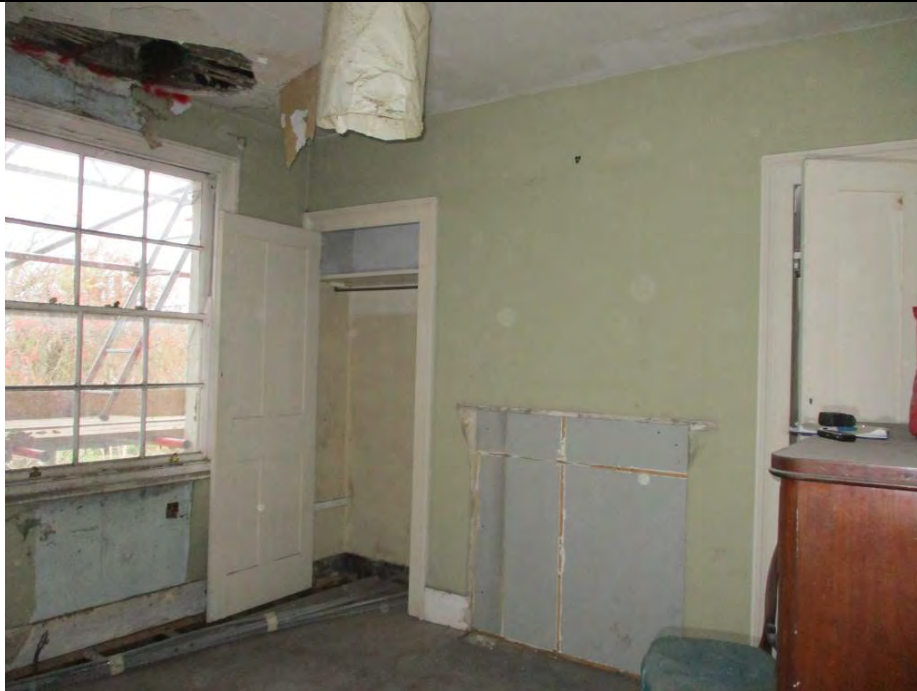
Room F3, looking northwest through room.

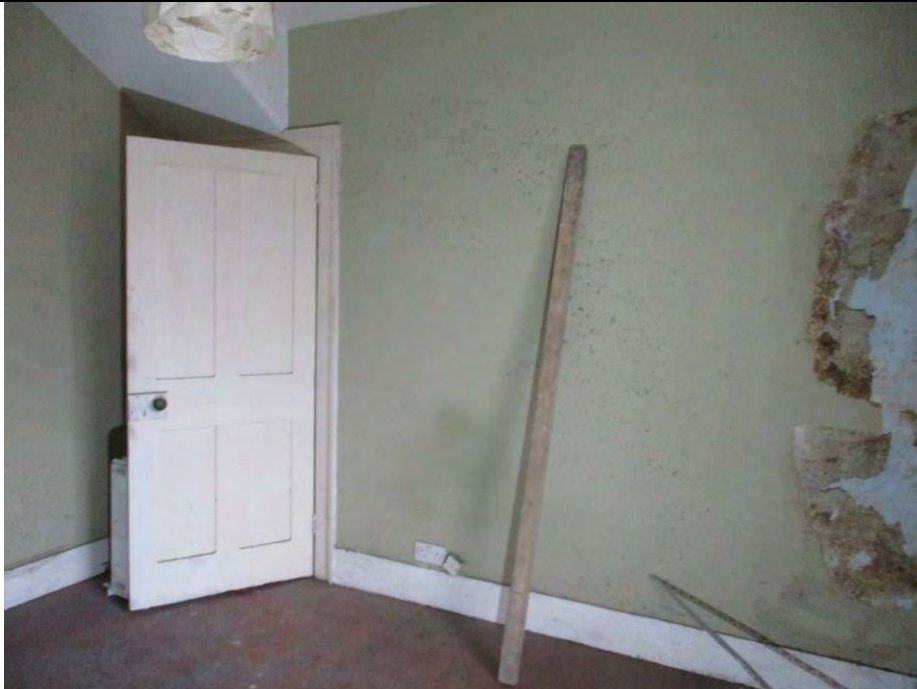
Room F3, looking southeast across room.

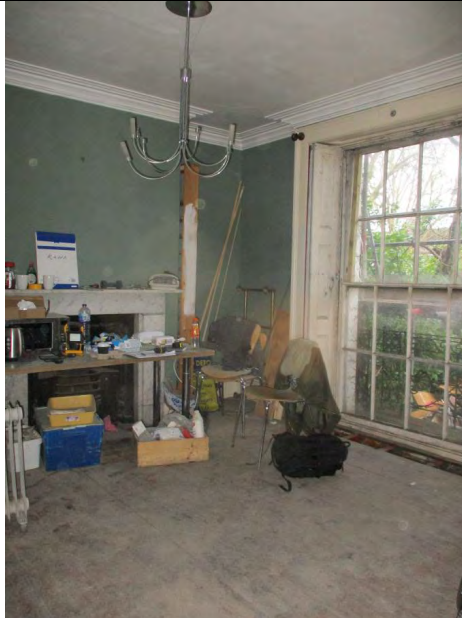
Room G2, looking east through room.

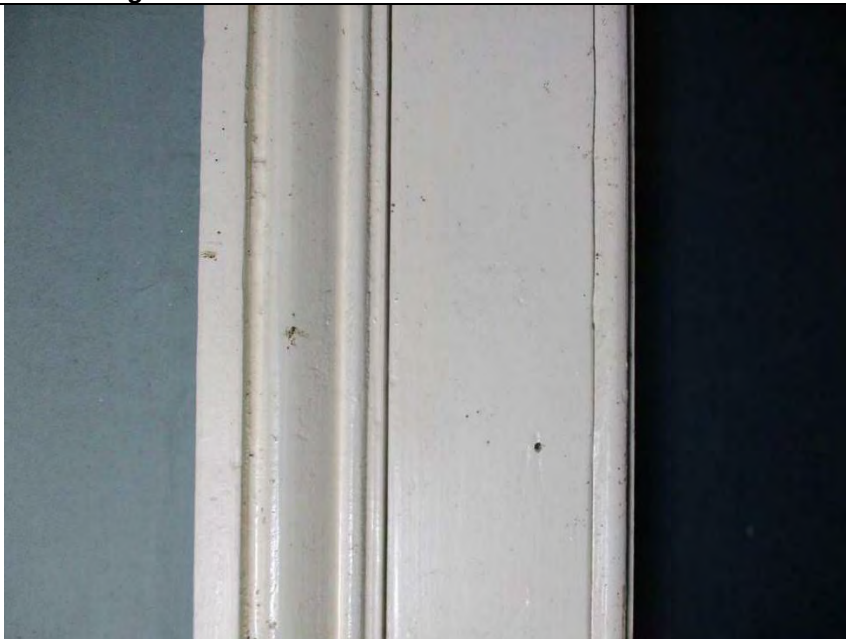
Room G2, showing doorway architrave.

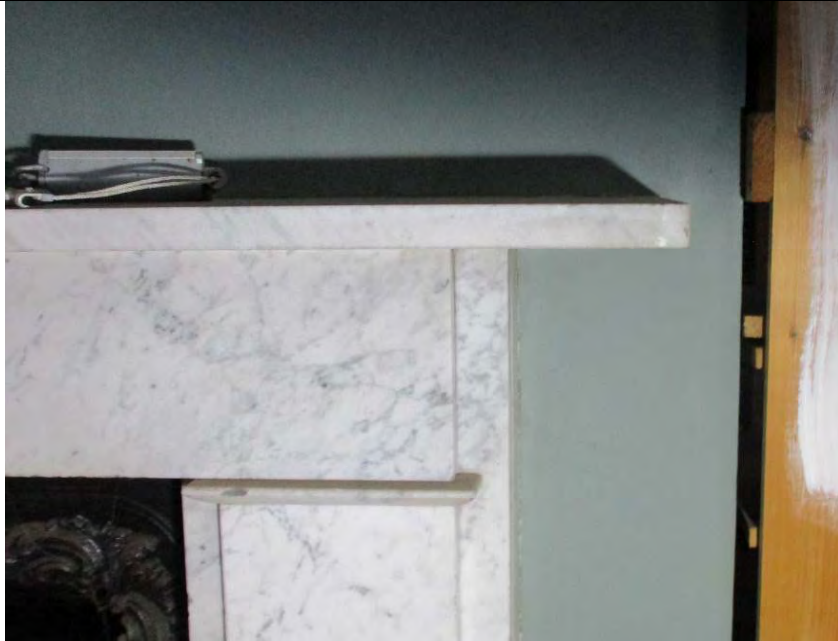
Room G2, showing detailing of marble fireplace.

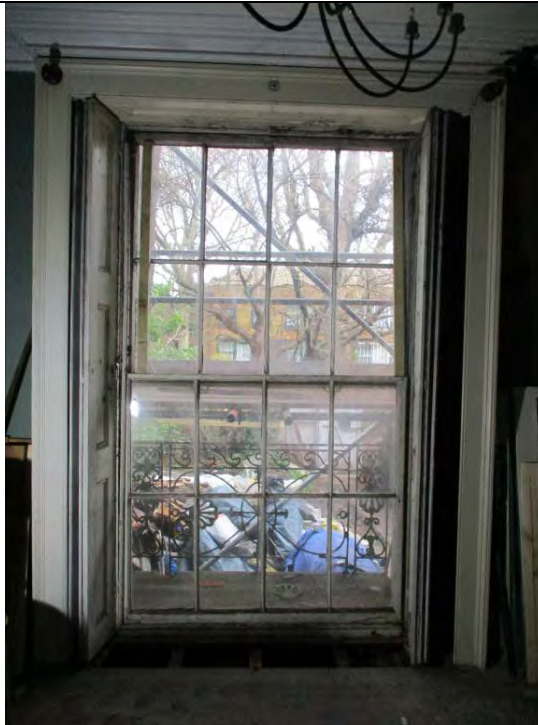
Room G2, showing window set within shutters.

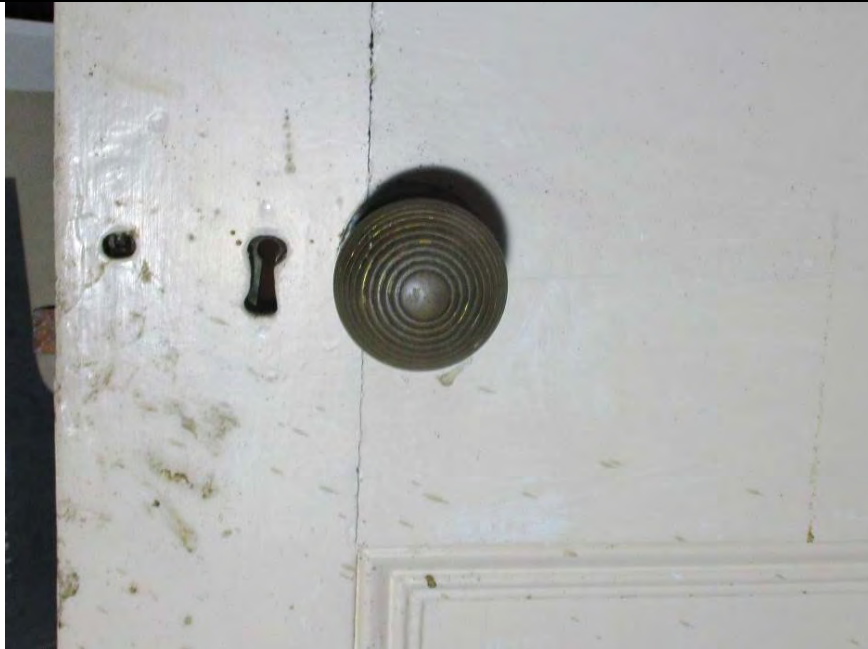
Room G3, showing beehive door handle.

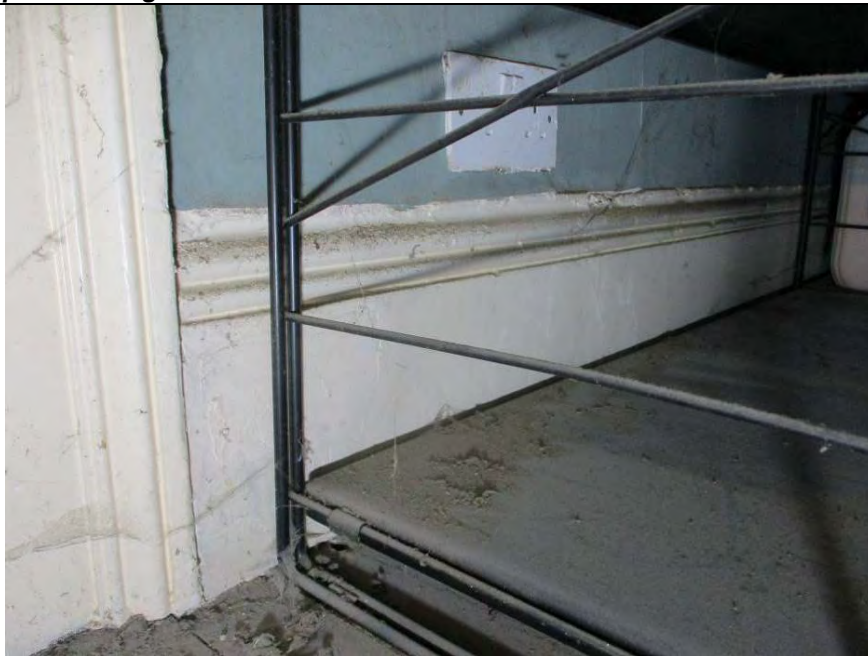
Room G3, showing skirting.

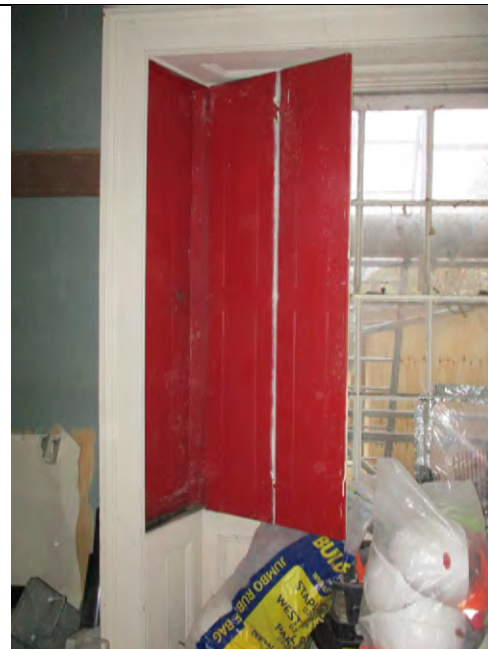
Room G3, showing window shutters.

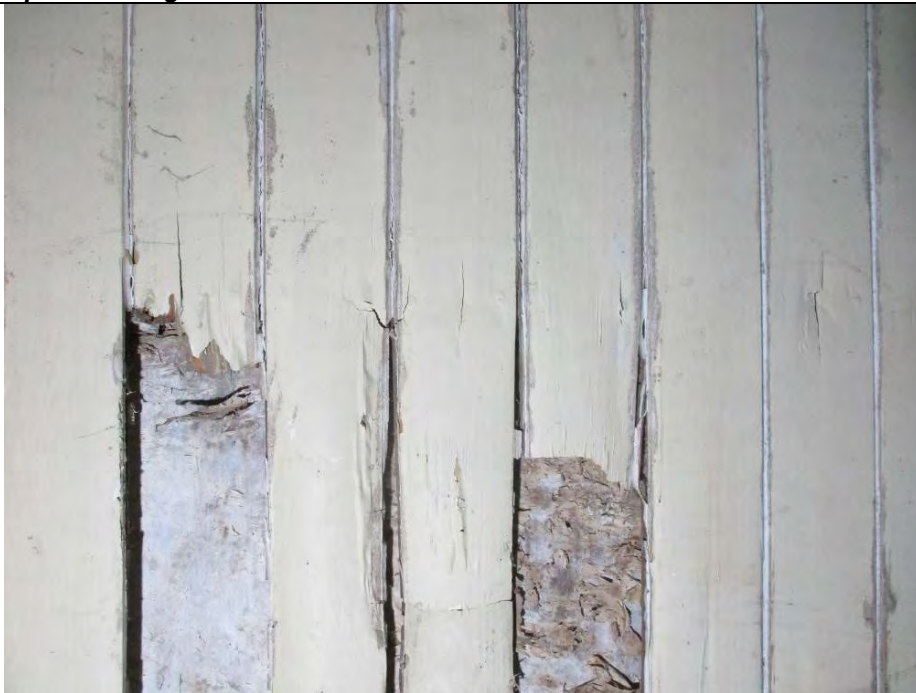
Room G4, showing wainscoting.

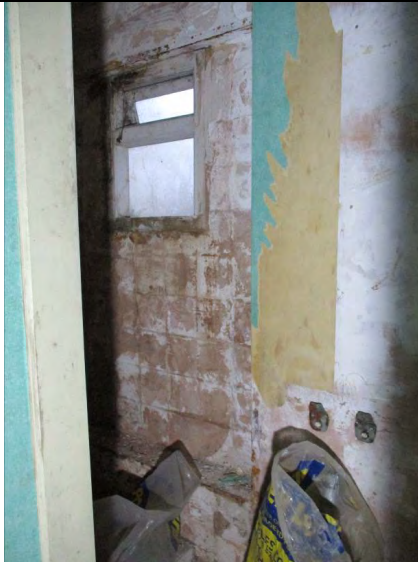
| <b><i>Additional comments</i></b> | Later addition.<br><br>Recorded in Winter 2024. The building has been vacant for around eighteen months and in a dilapidated and deteriorating state for at least a decade and this is reflected in the poor condition of internal fabric including fabric damaged by water ingress. |

Room G5 looking into room from doorway.

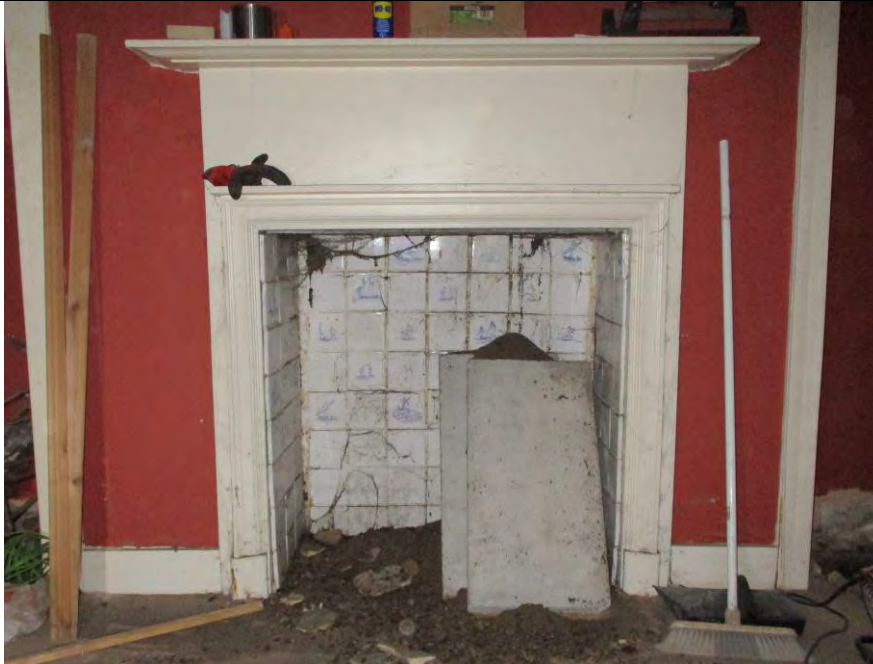
Room LG2, showing fireplace.

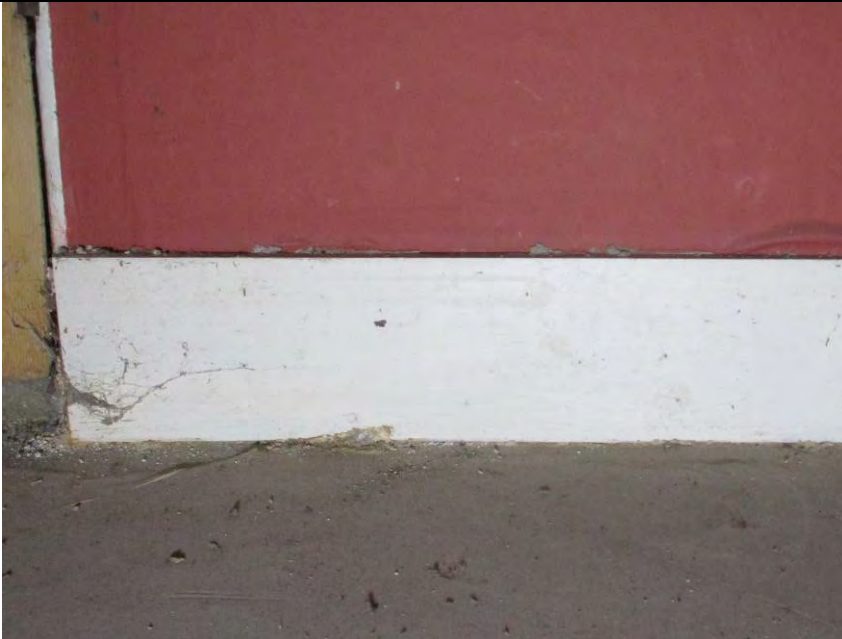
Room LG2 , showing plain skirting (without moulding).

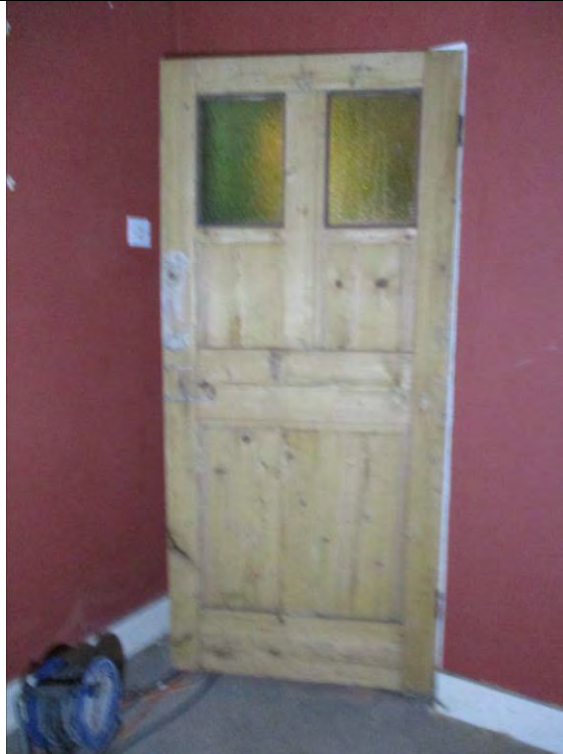
Room LG2, showing doorway.

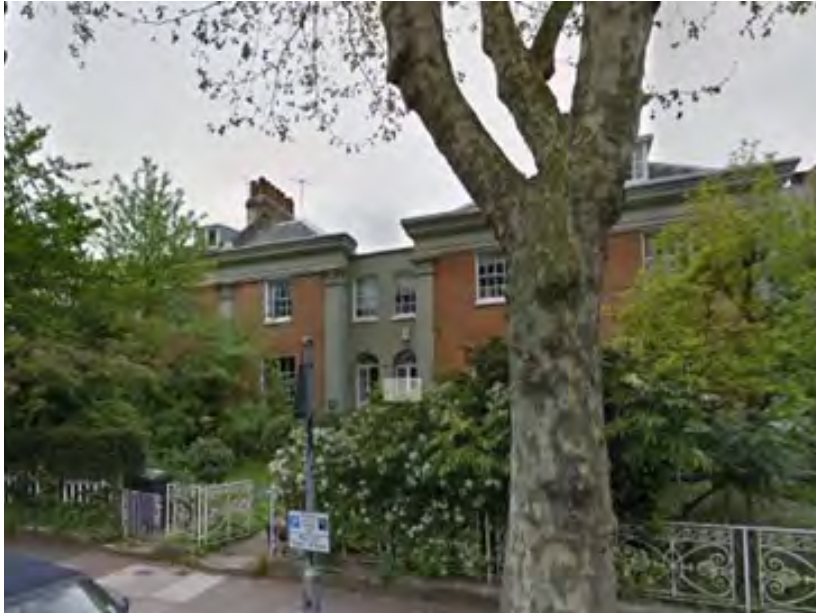
**Fig 5:**

**2012.** Google street view image showing 37-43 North Road, Highgate.

**2012:** Google street view image., showing 37 North Road. The south frontage and south side of the building appear to be in reasonable condition although some damp staining is evident to the parapet in this image.

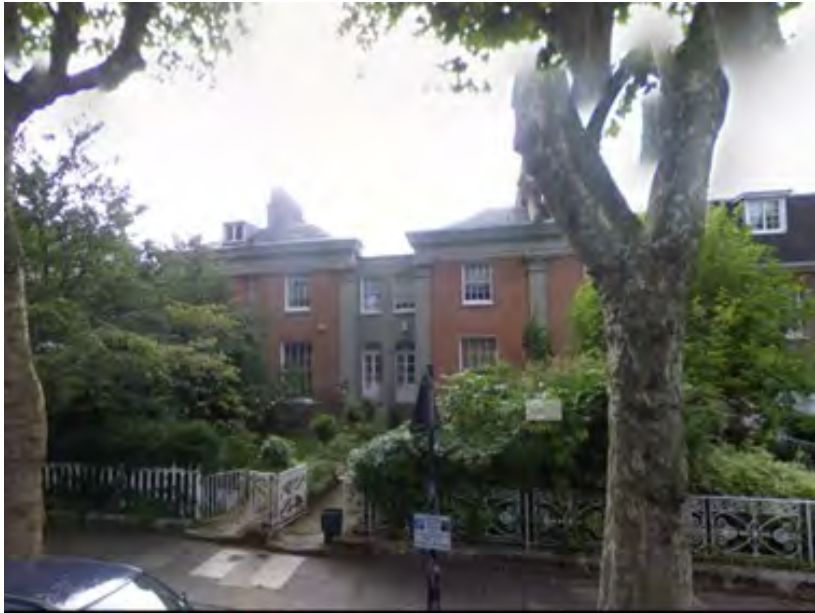
**Fig 7:**

**2008:** Google street view image., showing 37-43 North Road, Highgate.

**2008:** Google street view image., showing 37 North Road. The south frontage and south side of the building appear to be in reasonable condition in this image.
